Tucannon River Programmatic Habitat Annual Report

Project #: 2010-077-00

Annual Progress Report

(Reporting Period January 2018 to December 2018)

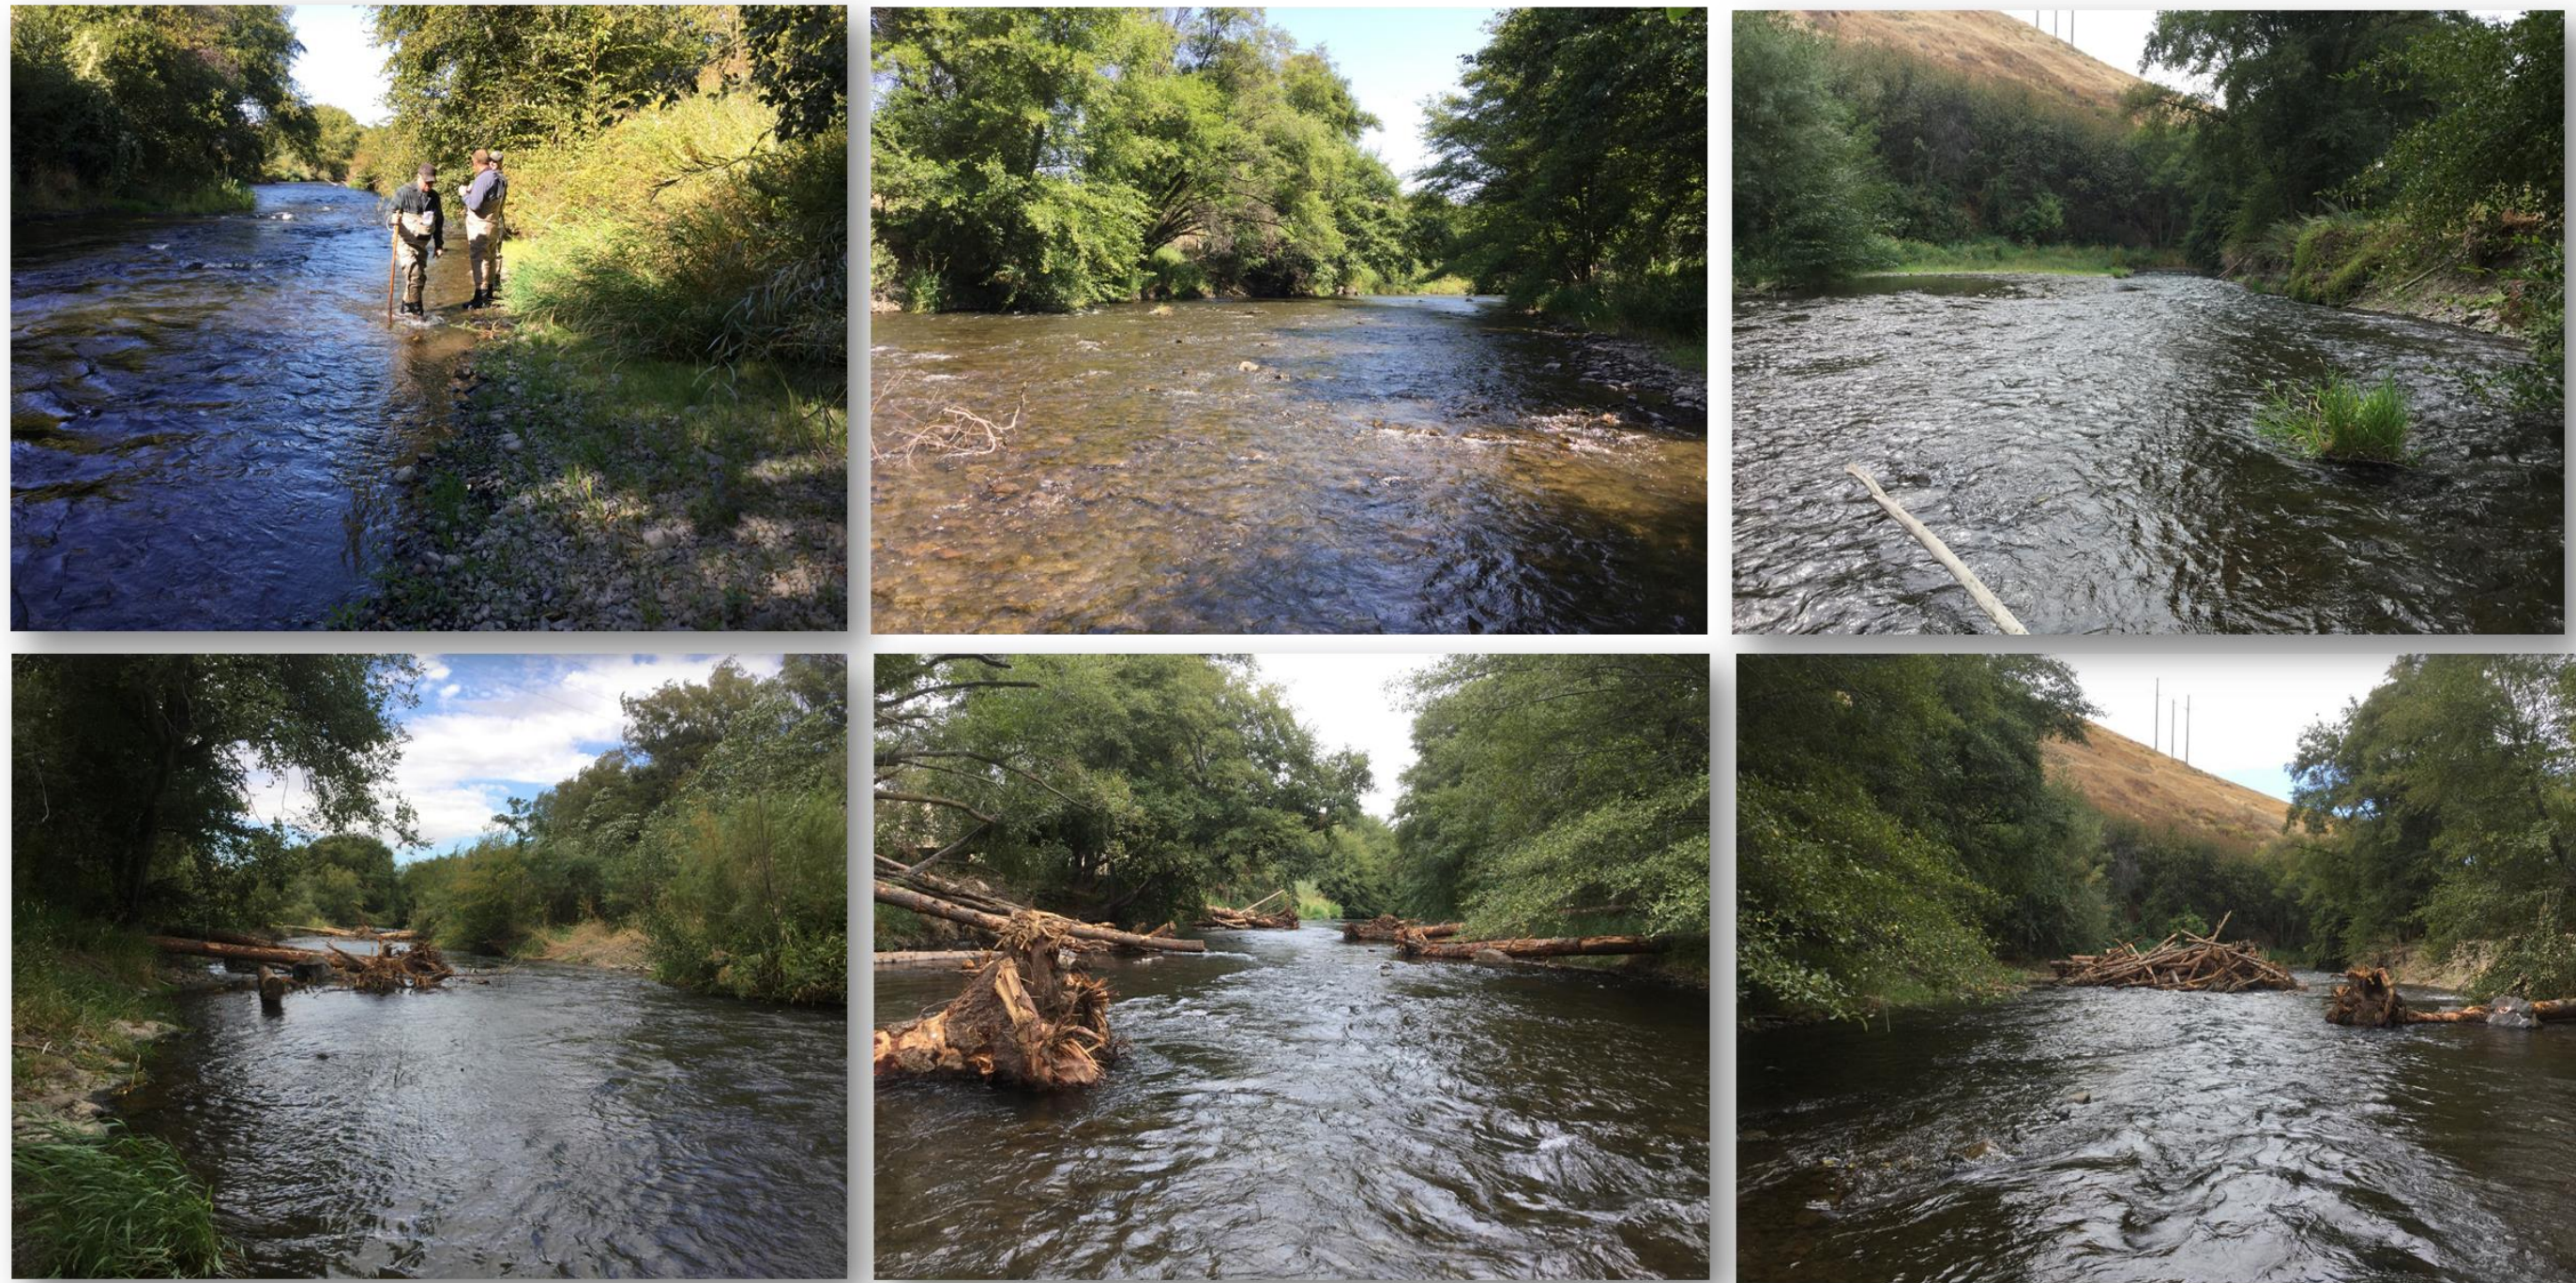
Figure 23: Project area 28 work completed in 2018 before after construction images, the left image showing a structure built for channel complexity and fish cover, the center channel complexity and cover and the right a floodplain connectivity structure design to split flows and develop in channel islands. The upper images are taken in July 2018 at ~125cfs and the lower images in September at ~70cfs. or a low base flow.

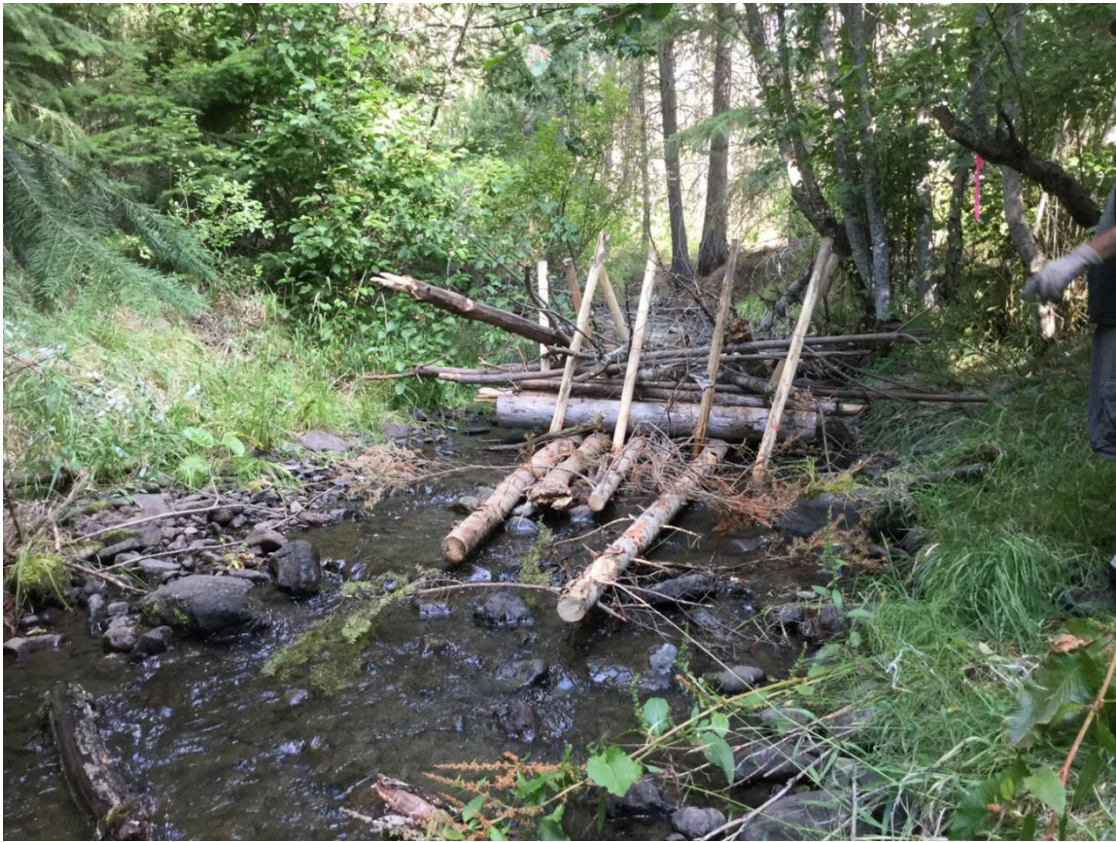
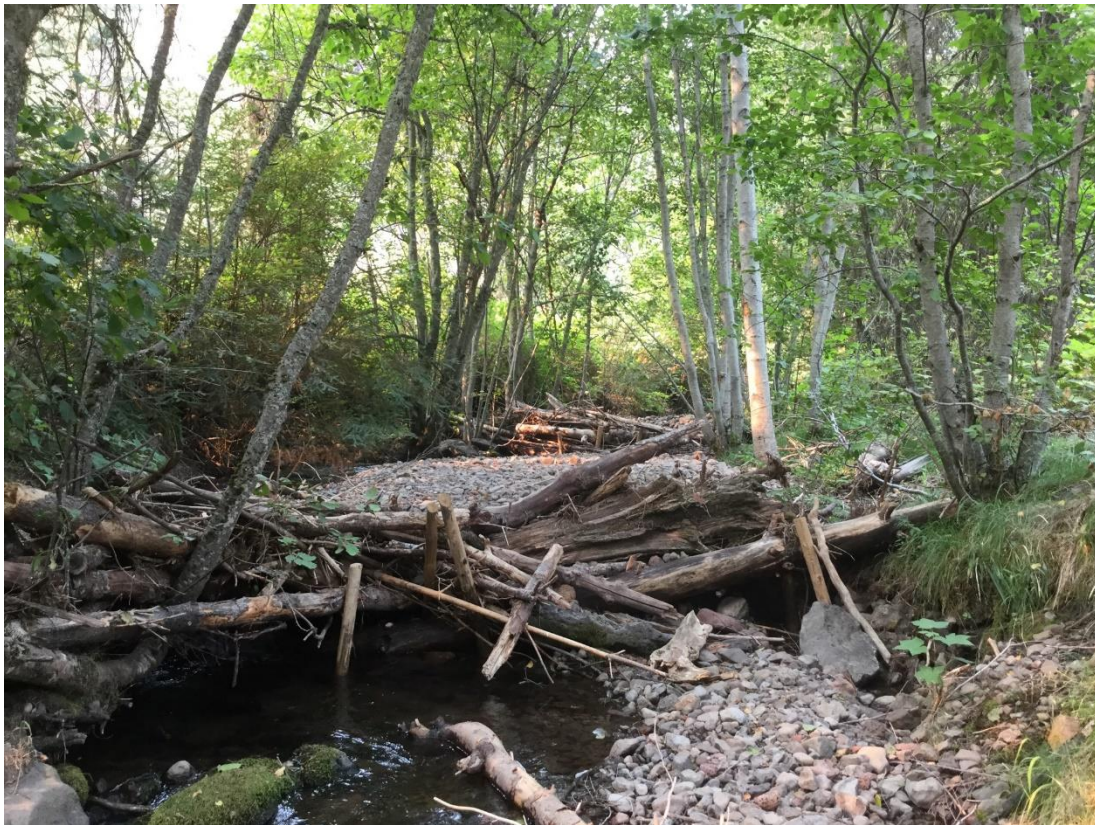
Figure 27: In 2018, the CCD conducted a Post Assisted Log Structure project on the Little Tucannon River for the purpose of generating bed load and storing it. The upper image is a post project photo before high flow and the lower image is a structure following flow and grave deposition around the structure.
