SEDIMENT TRANSPORT, WATER
QUALITY, AND CHANGING BED CONDITIONS
TUCANNON RIVER, SOUTHEASTERN
WASHINGTON

**SEDIMENT TRANSPORT, WATER
QUALITY, AND CHANGING BED CONDITIONS
TUCANNON RIVER, SOUTHEASTERN
WASHINGTON**

**USDA Soil Conservation Service
Spokane, Washington**

April 1982

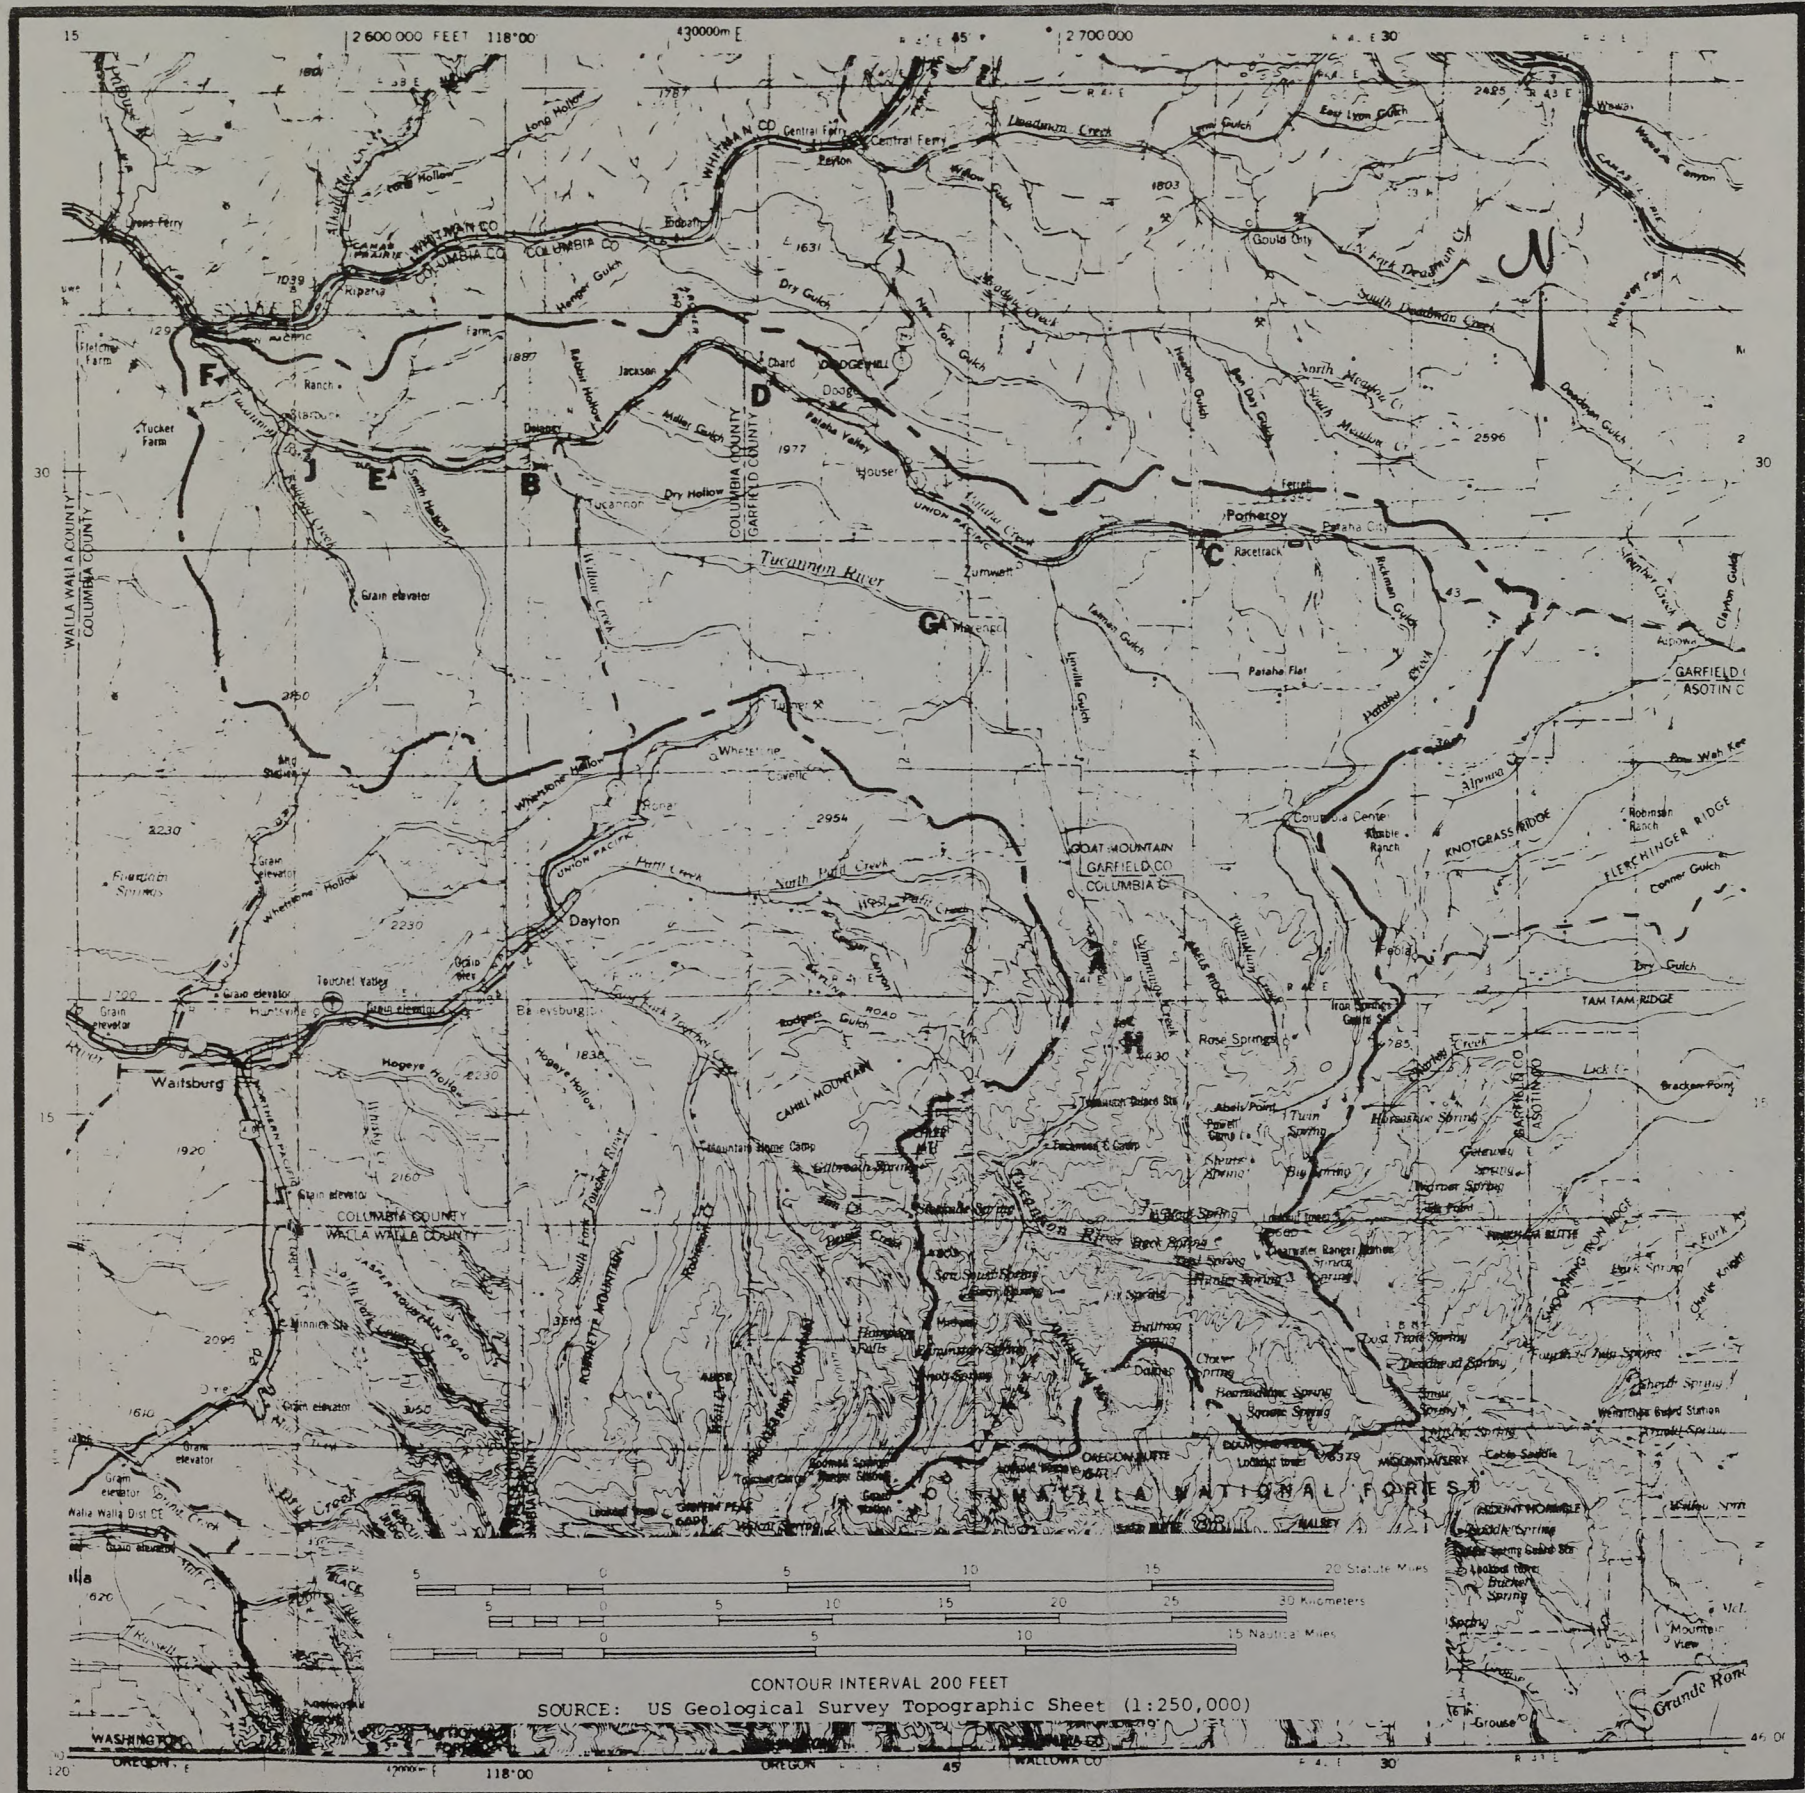
Figure 1.1.
Topographic Map of Tucannon
Watershed and Vicinity.
Monitoring program is explained
in Appendix A and in text.
