Tucannon River Programmatic

Project #: 2010-077-00

Annual Progress Report

(Reporting Period January 2013 to December 2013)

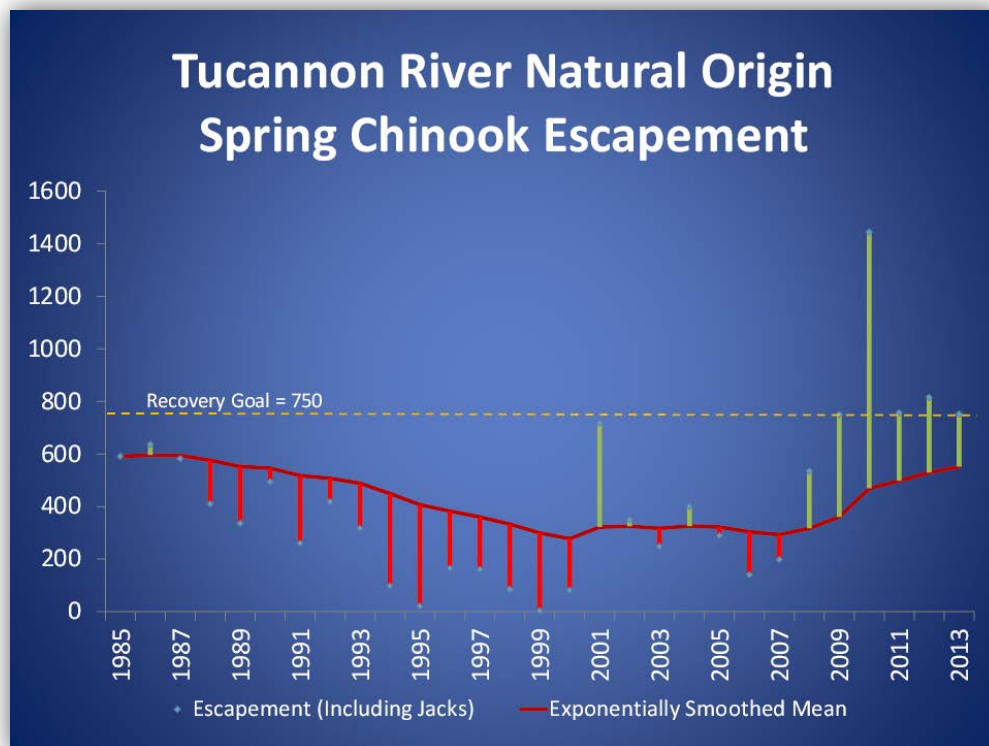
Figure 3. Mean natural origins spring Chinook escapement for the Tucannon River in relation to the recovery goal and the geometric mean, based on WDFW data collected by the WDFW Snake River Lab Dayton WA. The blue dots indicate the population estimate, the red curve indicates the geometric mean and the dashed line the recovery goal of 750 adults. The bars indicate divergence from the geometric mean. This table is for illustration purpose and is used by the SRSRB for informational purpose only.

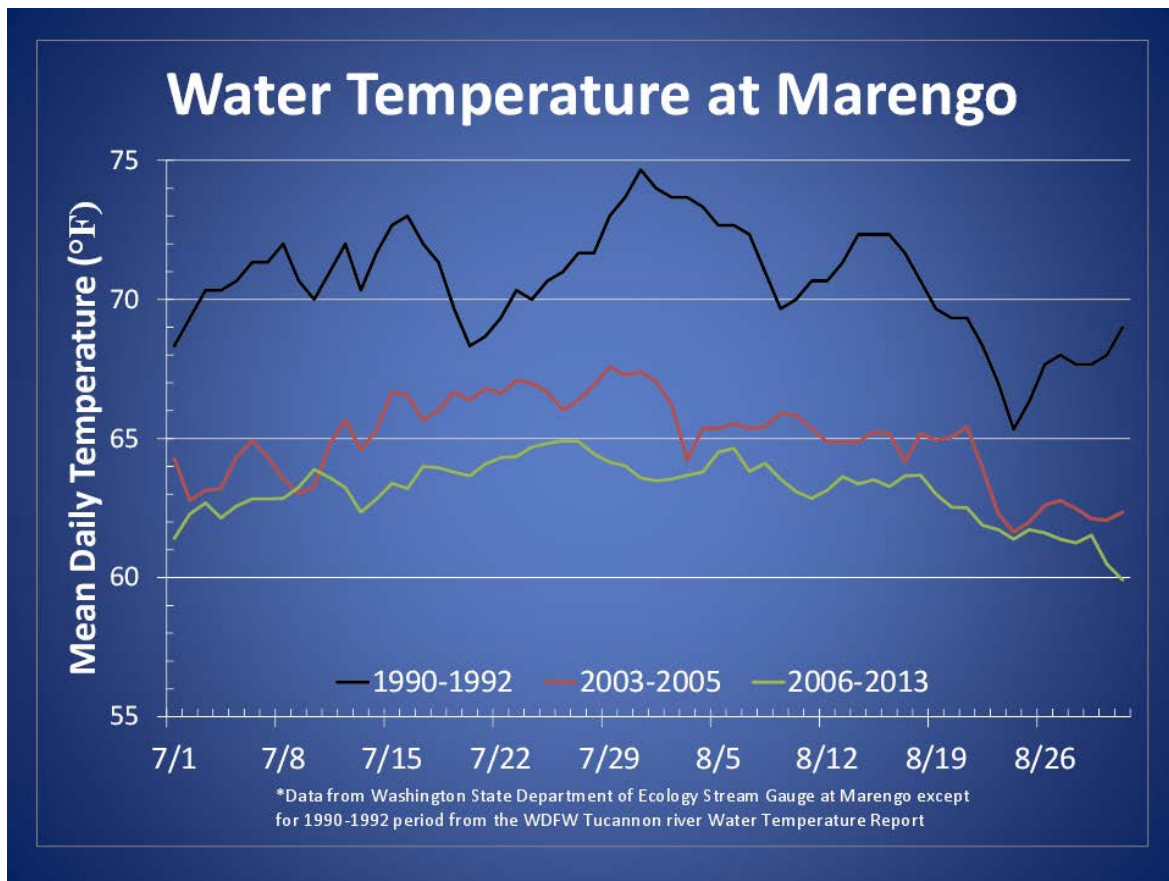
Figure 5: Mean daily stream temperature measured at Marengo on the Tucannon River between 1990 and present. Note the gradual decline in temperature from the 90's to present.

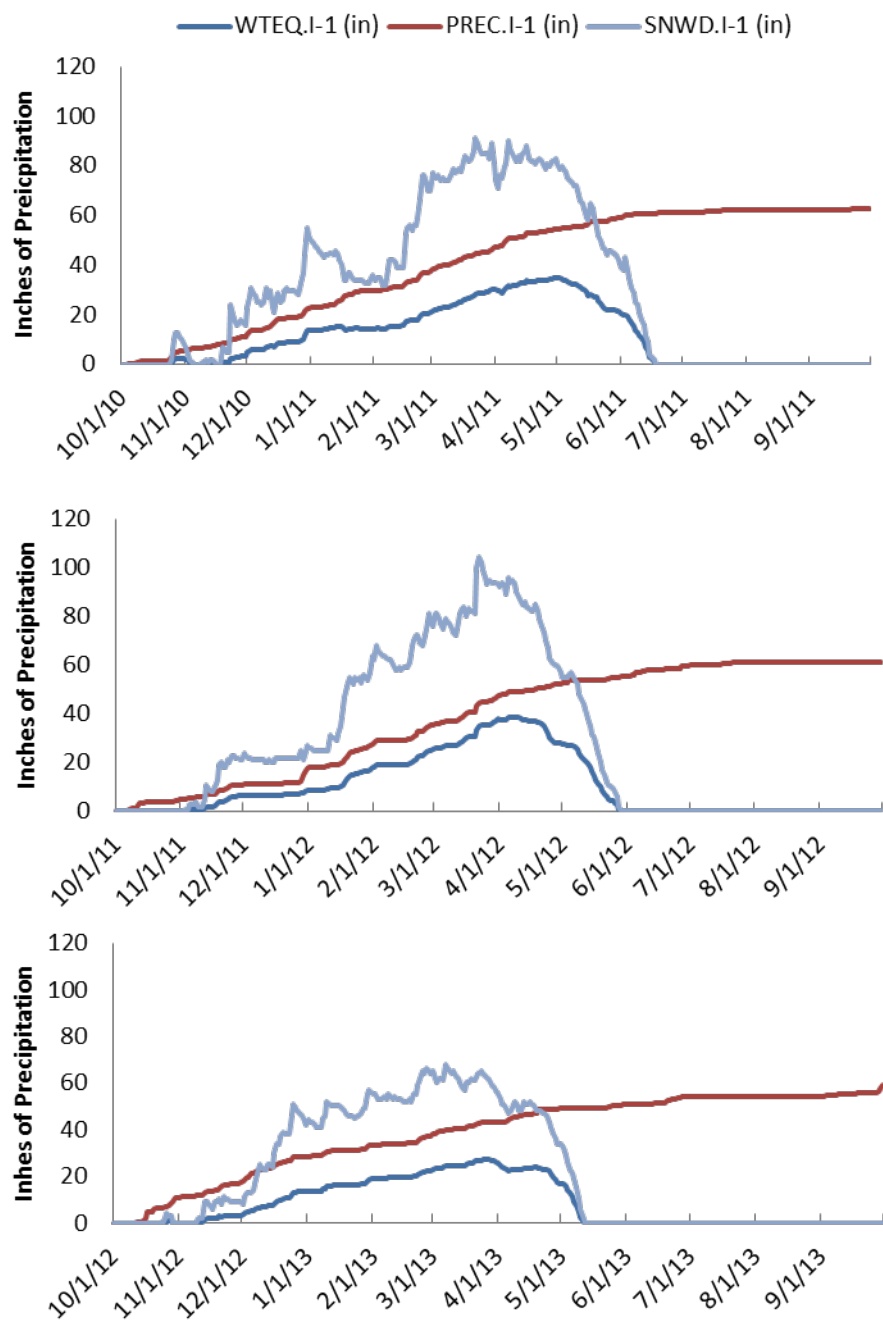
Figure 6: NRCS SNOTEL data reports for the 2011-2013 water years for the Touchet Station. The figure illustrates total precipitation in red, total snow depth in light blue and snow water equivalent in dark blue.

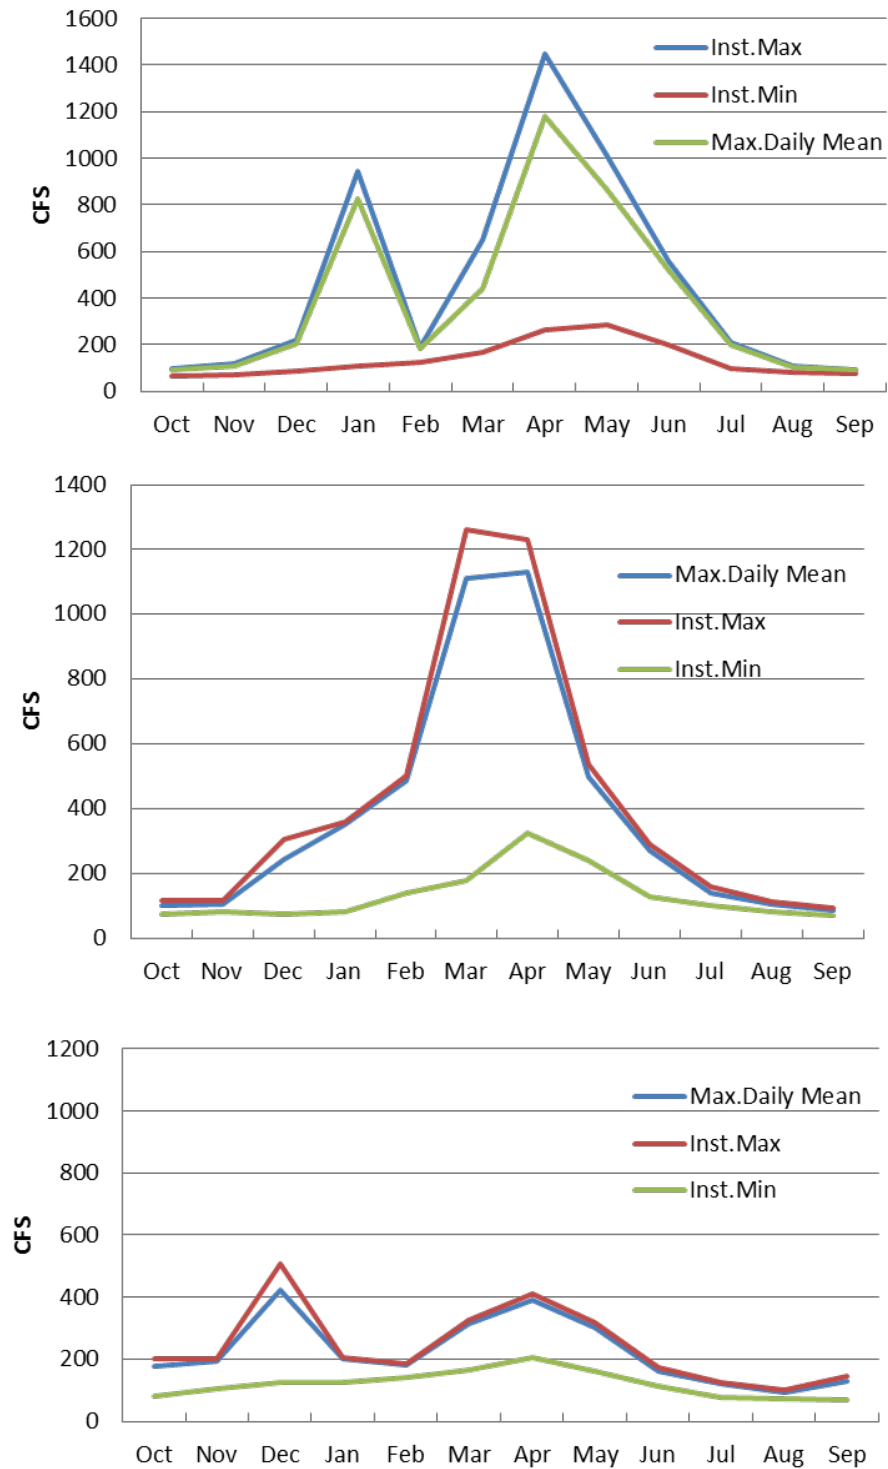
Figure 7: Washington Department of Ecology Stream Gage data from the Marengo gage on the Tucannon 2011-2013 water year. The upper graph is the 2011, the middle 2012 and lower 2013 water year. In each figure the max daily mean is plotted with the instantaneous max and min for each day.

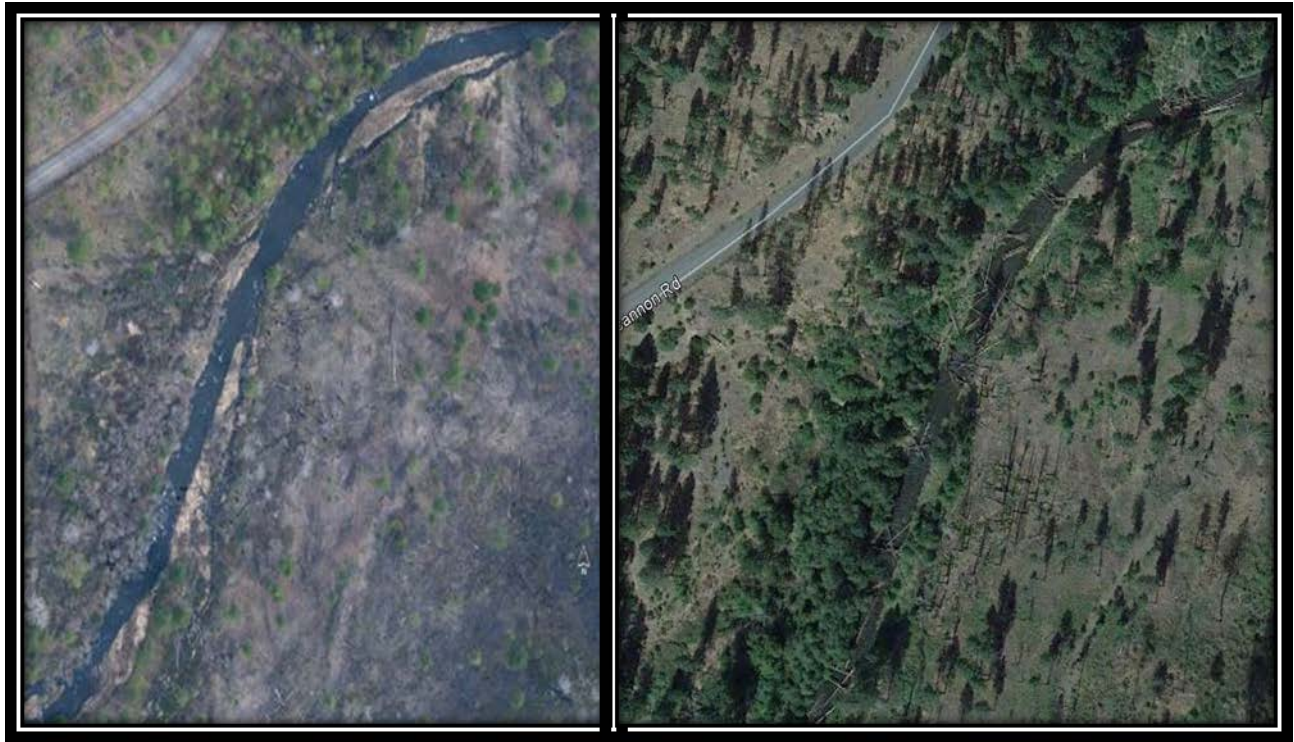
Figure 8: Tucannon River Project Area 10 April 2010 pre project photo (Left). (Right) same project reach post treatment in September 2013.

Implementation of PA 10 utilized a combination of constructed engineered log jams and unsecured log complexes. The unsecured logs totaled 291 whole trees ranging in length from 50' to over 100' and ranged in diameter from 15 inches to over 30 inches. An additional, 500 trees were transported to the project site ranging in size from 4-12 inches in diameter and 20-30 feet long and distributed throughout the project reach using the helicopter. These trees were placed to act as racking materials to the larger trees. The project also involved the construction of five log structures which were anchored and included another 65 logs. The project reach pre-treatment was mostly devoid of LWD prior to the LWD replenishment project, an example reach is illustrated in pre and post treatment in figure 8.

The design of PA-10 relied heavily on the river high flows >1,000 cfs to redistribute unsecured trees and to deposit cobbles and gravels to create much of the habitat. It was also anticipated that high flows would aid in scouring side channels and develop perennial side channels. In 2013, snow pack in the Blue Mountains was lower than average (Figure 6) followed by a less than favorable stream flow (Figure 7) for mobilizing bed load and driving channel formation. Even with low peak flows in 2013, PA-10 saw the development of approximately 0.57 miles of new side channel, 0.13 miles perennial and 0.43 miles ephemeral (>250cfs). Within the 0.13 mile perennial side channel a beaver colony was

established by the end of 2013. Observations made in 2013 lead us to anticipate that with high flows the ephemeral channel will become perennial. A full reach survey will be completed in the summer of 2014 to determine the extent of change in this reach, and a summery comparison of pre/post treatment will be made using the existing CHaMP sites located in the reach.

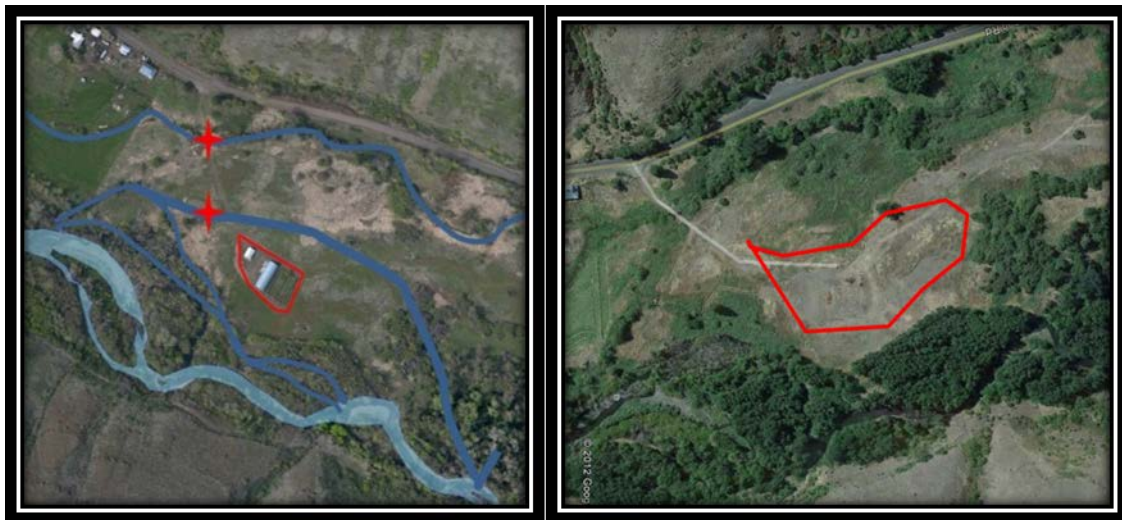
Figure 9. Project Area 18 floodplain restoration project. Image A illustrates the pre project condition. The blue lines on the image indicate the over land flows which occurred in 2009 and 2010. The red polygon highlights the infrastructure removed as part of this project. Image B illustrates the post project condition of the site in September 2012. The red polygon indicates the position of the removed infrastructure.

The floodplain work completed on PA 18 in August 2012, with the removal of buildings, wells and an old culvert located on the floodplain (Figure 9). This project was a very passive floodplain project targeting full floodplain connectivity in an area where past channel restoration had improved floodplain connectivity to the point that alterations were needed during high to protect the extant infrastructure. During the 2013 water year the flows did not engage the floodplain in this reach so channel and floodplain shape did not change significantly, however the site did continue to recover from its degraded condition and the impacts of demolition (Figure 10). It is anticipated that over time the area of infrastructure abandoned by the implementation of this project could be captured as a side channel and spur the establishment of forested riparian habitat as seen in adjacent reaches.

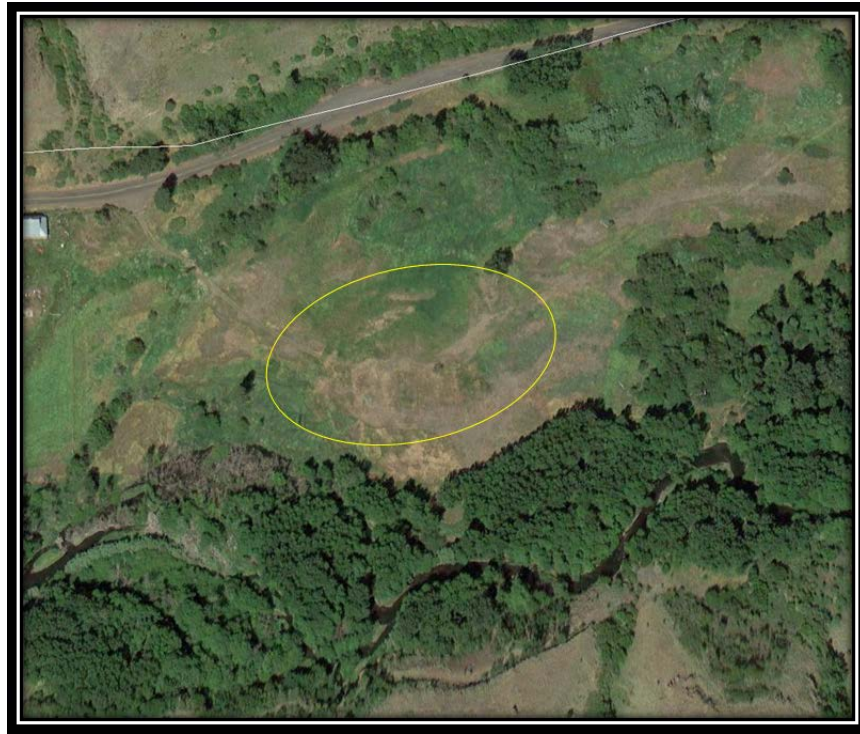
Figure 10: PA-18 Google image captured on July 4th 2013. Note (Area enclosed by oval) the recovery of soil and vegetation at the site of demolition.

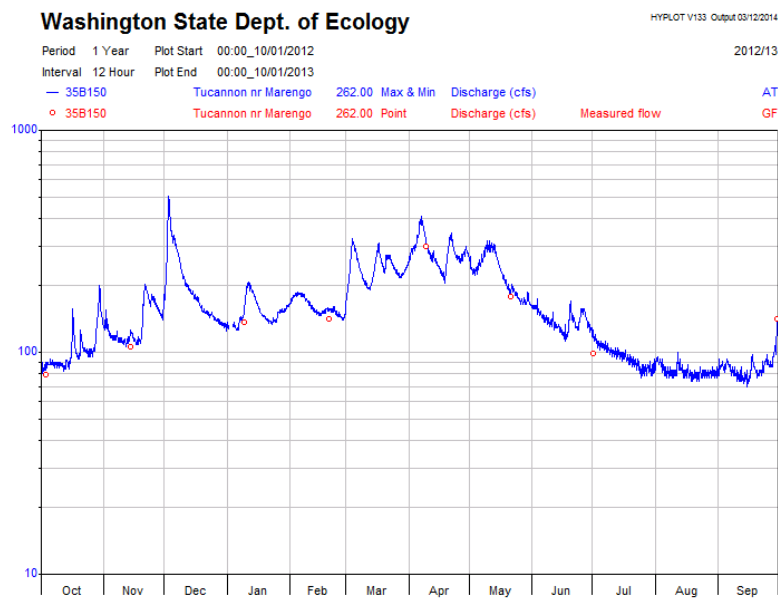
Figure 11. Stream flow measured at the WDOE stream gage at Marengo for the 2012 water year beginning October 1st 2011 through September 31st 2012. Flow is reported as daily mean for cfs.

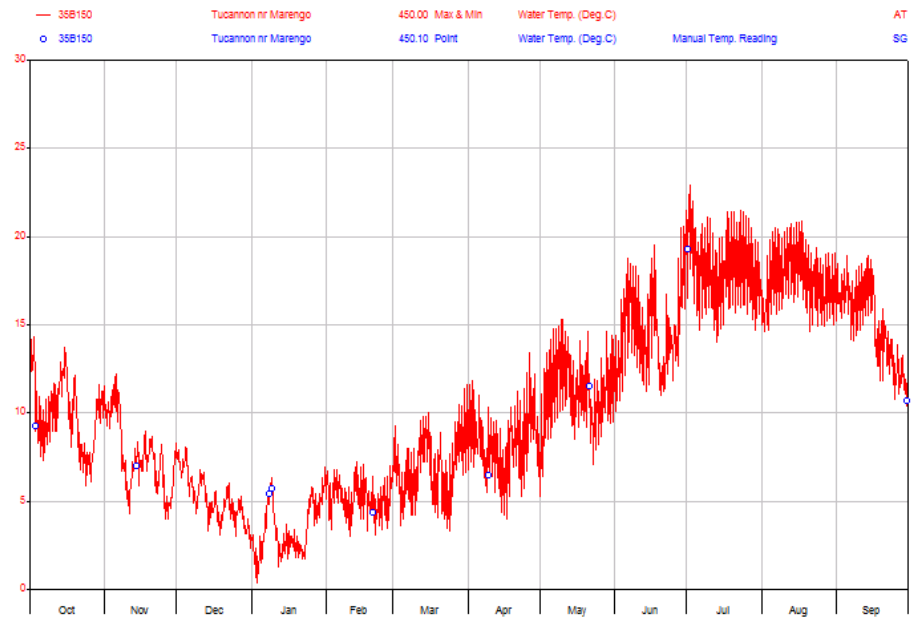
Figure 12. Stream temperature measured at the WDOE stream gage at Marengo for the 2012 water year beginning October 1st 2011 through September 31st 2012. Temperature is reported as daily mean in degrees Celsius.
