Tucannon River Programmatic Habitat Annual Report

Project #: 2010-077-00

Annual Progress Report

(Reporting Period January 2015 to December 2015)

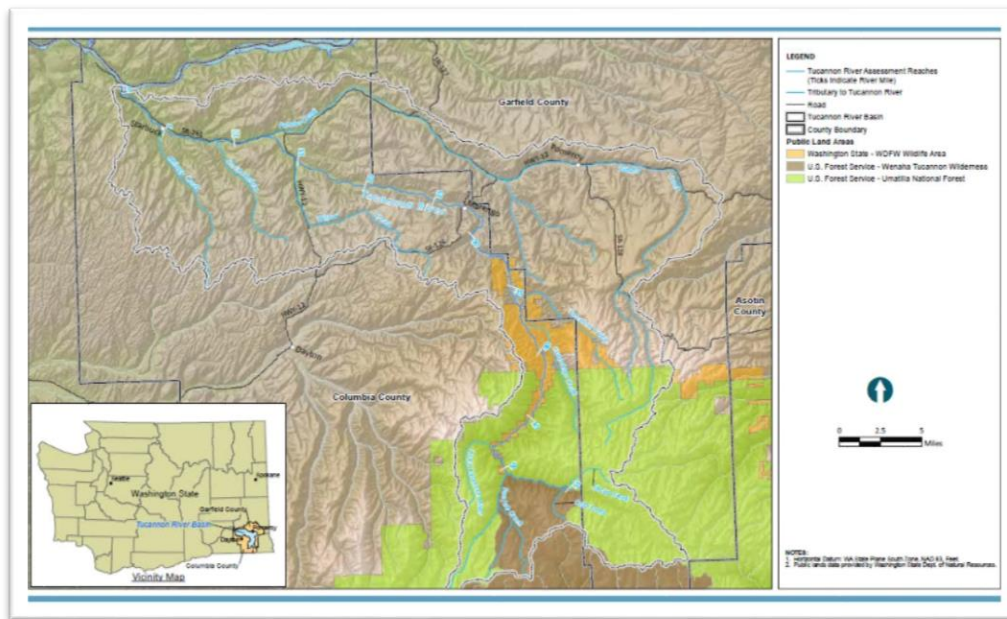
Figure 1. Tucannon River Watershed vicinity map (Anchor Nov, 2011). The gold shaded areas indicate the Wooten Wildlife Area, the green areas the Umatilla National Forest, the darker brown headwaters of the Tucannon indicate the wilderness area and the remainder of the watershed in private ownership.

The Tucannon River Programmatic Habitat project 2010-007-00 (Programmatic) is a restoration “Umbrella” project focusing on improving Snake River spring Chinook habitat in the Tucannon River, near Dayton, WA (Figure 1), through habitat restoration actions focused on the limiting factors (Table 1). The Snake River Salmon Recovery Board (SRSRB) works with its’ partners, the Confederated Tribes of the Umatilla Indian Reservation (CTUIR), Columbia Conservation District (CCD), Nez Peirce Tribe (NPT), US National Forest (USNF) and the Washington Department of Fish and Wildlife (WDFW) to implement the Tucannon River Habitat Restoration Plan (Anchor Nov, 2011).

The Tucannon River is a Snake River tributary originating in the Blue Mountains of southeast Washington (Figure 1) and is located in Columbia and Garfield Counties. The main channel is approximately 58 miles long and drains about 503 square miles before entering the Snake River approximately 3 miles upstream from Lower Monumental Dam. Several major tributaries drain into the main stem including, Pataha Creek, Tumalum Creek, Cummins Creek, Little Tucannon, and Panjab

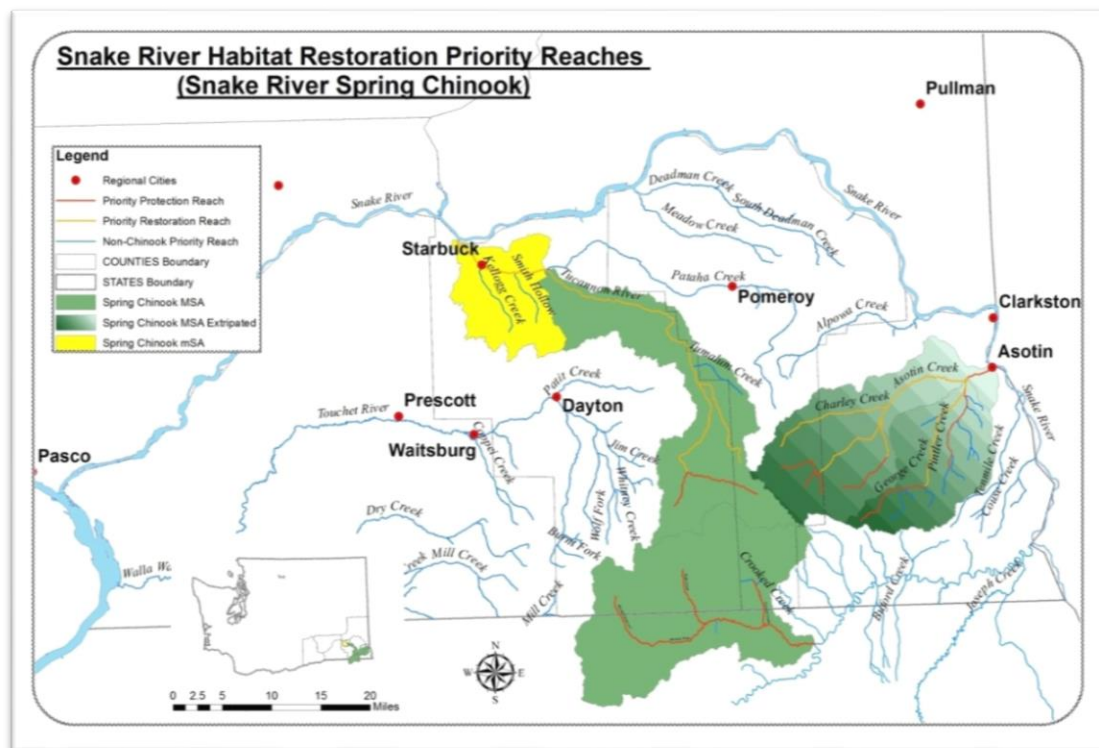
Figure 2. Snake River Salmon Recovery Plan priority areas for Snake River ESU spring Chinook. The map highlights the Tucannon, Asotin and Wenaha River basins. The green shaded areas are the major spawning areas (MSA) and the yellow area is a minor spawning area (mSA). The stream reach highlighted orange indicate the river reach where the SRSRB RTT supports stream channel restoration activities and the red reaches protection project types. The Asotin population is currently believed to have been extirpated.

The Tucannon supports populations of four threatened species including the Snake River ESU spring Chinook, Snake River fall Chinook, Snake River ESU summer steelhead, and the Columbia River bull trout. All reaches of the Tucannon River are utilized by all species during one or more life stage annually with fall Chinook being the exception using only the lower river. The lower Snake River spring Chinook is currently only found in the Tucannon River, having been extirpated from Asotin Creek (Figure 2).

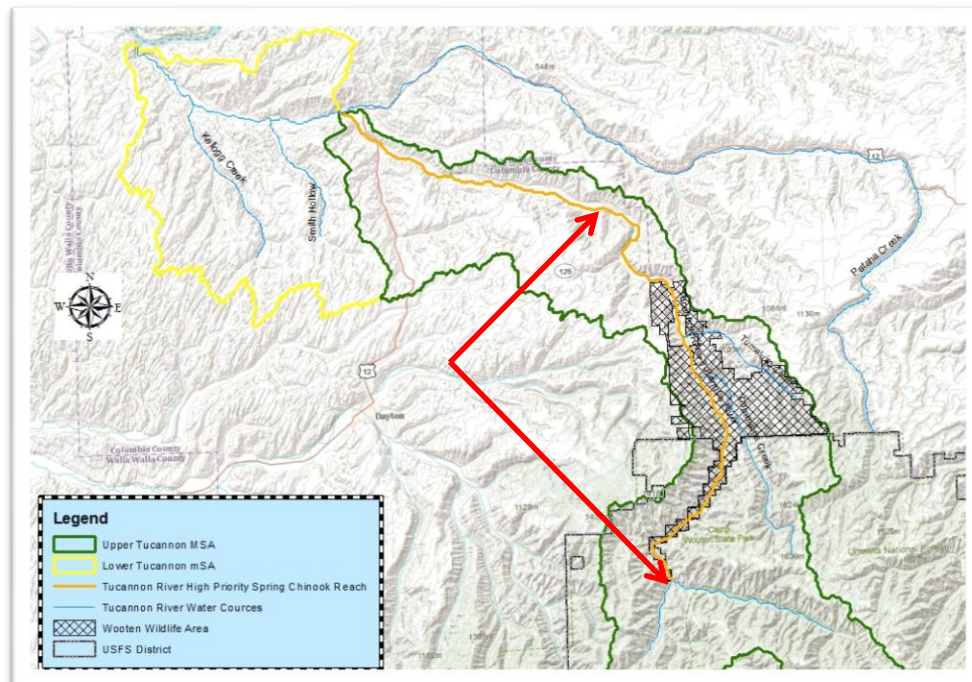
Figure 3: The Tucannon River spring Chinook priority restoration reach is highlighted in orange and indicated by the red arrows. The Tucannon major spawning area is represented by the green polygon and the minor spawning area by the yellow polygon. See legend for additional map detail.

The Programmatic habitat implementation approach targets the priorities (limiting factors) identified for restoration action under the Tucannon Geomorphic Assessment and Conceptual Restoration Plan (Anchor 2011 April & November). The priority restoration reach is based on the known (historic and current) spawning and rearing areas of Tucannon River spring Chinook approximately RM 20 to RM 50 (Figure 3). Restoration actions focusing on limiting factors identified in the Salmon Recovery Plan for South East Washington (2011) (Table 1), improving bed and channel form (6.1), increasing channel complexity (6.2), side channel and wetland condition (5.1) and floodplain connectivity (5.2) within the priority reach (Figure 2 &3) receives highest priority for implementation funding under the

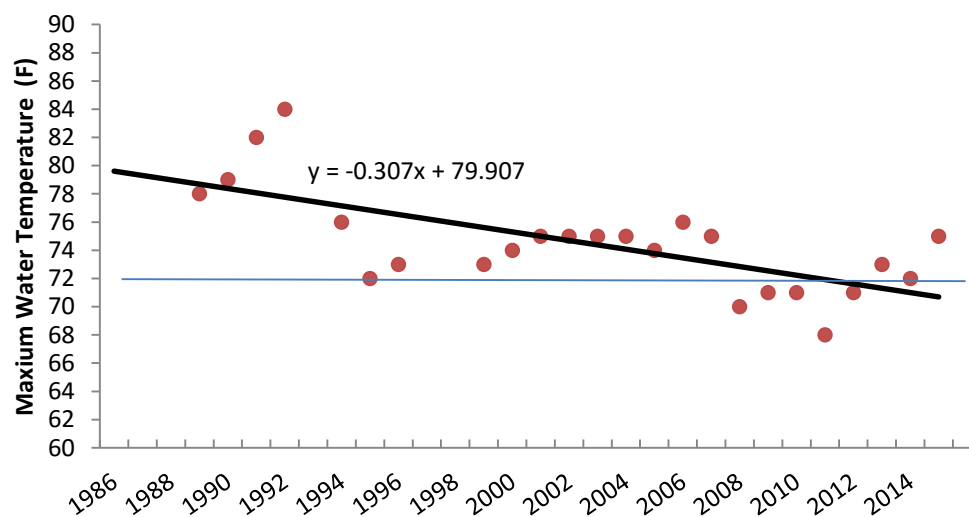
Figure 4: Mean daily maximum stream temperature measured at the Tucannon River Washington Department of Ecology Marengo gage between 2003 to present. The time periods prior to 2003 was collected near Marengo by WDFW monitoring. The fine horizontal line indicated the recovery objective of <4 days greater than 72°F annually. Data provided by Washington Department of Ecology (<https://fortress.wa.gov/ecy/eap/flows/station.asp?wria=35>).

Over the period of habitat restoration (~1999-present) in South East Washington, improvements in the habitat factors limiting spring Chinook (Table 1) production have been increasing, for example fine sediments and stream bed embeddedness have improved and are not currently considered to pose a significant impact to salmonids in the Upper Tucannon assessment unit (CHaMP, RTT communication 2014, 2015 Expert Panel Discussion, Grout 2008). Water temperatures have also begun to respond in the Tucannon with summer daily mean high water temperature declining (Figure 4) from what was

experiences in the 1980' and 90's. Summer high water temperature in the Tucannon at the Marengo Stream Gage in the late 1980's and early 1990's regularly reaches 80°F (WSU 2001, HDR 2006). These conditions were caused by low stream flow, poor width to depth ratios and impacted (absent) riparian habitat (SRSRB 2005, HDR 2006). Over the period of record at the WDOE Marengo stream gage, the mean daily maximum temperature has been declining with exceptions in 2014 and 2015, two exceptionally dry and hot summers. In 2015, daily mean ambient air temperature measured at the Marengo stream gage (WDOE data) showed a significant increase > than the period of record (Figure 5) likely leading to elevated 2015 stream temperatures (Figure 4). In 2015, June mean air temperatures were >15°C above average lengthening the duration of the hot season beyond that previously experienced in the Tucannon. It is also noteworthy that the 2015 work window was one of the higher fire risks observed in recent times.

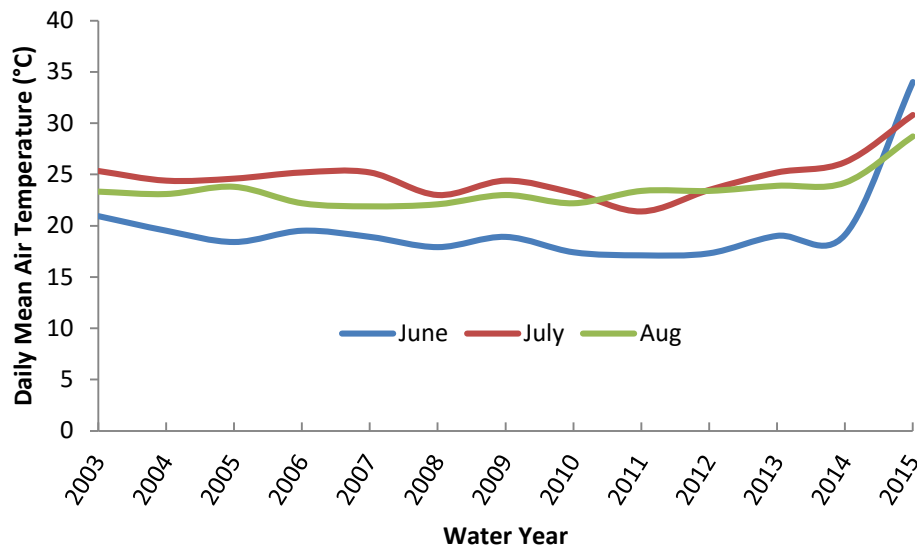
Figure 5: Daily ambient mean air temperature measured at the WDOE stream gage in Marengo for the period of record 2003 to 2015. Daily mean temperatures are plotted for June, July and August separately to illustrate 2015 as an anomaly leading to higher than recent summer water temperatures experienced in 2015 (Figure 4). The water year for 2015 experienced record temperatures particularly for June but overall trends are not detectable and therefore not plotted. Data provided by Washington Department of Ecology (<https://fortress.wa.gov/ecy/eap/flows/station.asp?wria=35>).

Two very provocative observations were made in 2015; firstly, even with record high air temperatures the Tucannon did not experience significantly above average water temperatures and secondly significantly lower than average precipitation did not lead to the lowest flows for the period of record.

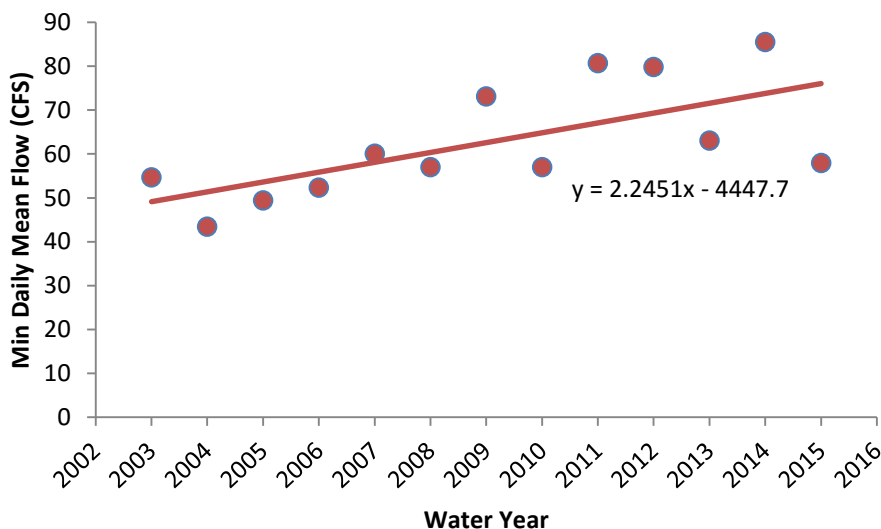
Figure 6: Minimum daily mean flow measured at the Tucannon River Marengo stream gage from 2002 through 2015 water year. Data provided by Washington Department of Ecology (<https://fortress.wa.gov/ecy/eap/flows/station.asp?wria=35>).

Over the same time period (2003-present) summer stream flows have shown improvement at the WDOE Tucannon Marengo stream gage. This is particularly of interest because flows have increase to an extent that it would seem cannot be explained by the environmental conditions alone (Figure 6, 7 & 8). Even during the 2015 drought, the second driest in the period of record (Figure 7), flows in the Tucannon remained relatively high in comparison to other regional streams (Figure 8) and historical Tucannon conditions (Figure 6). The North Fork Touchet River, a generally wetter watershed (Figure 7) had one of its lowest flows of record in 2015, while the Tucannon remained above average. Additionally, Asotin Creek had its lowest flow on record while Alpowa Creek a spring source stream, remained relatively average (Figure 8).

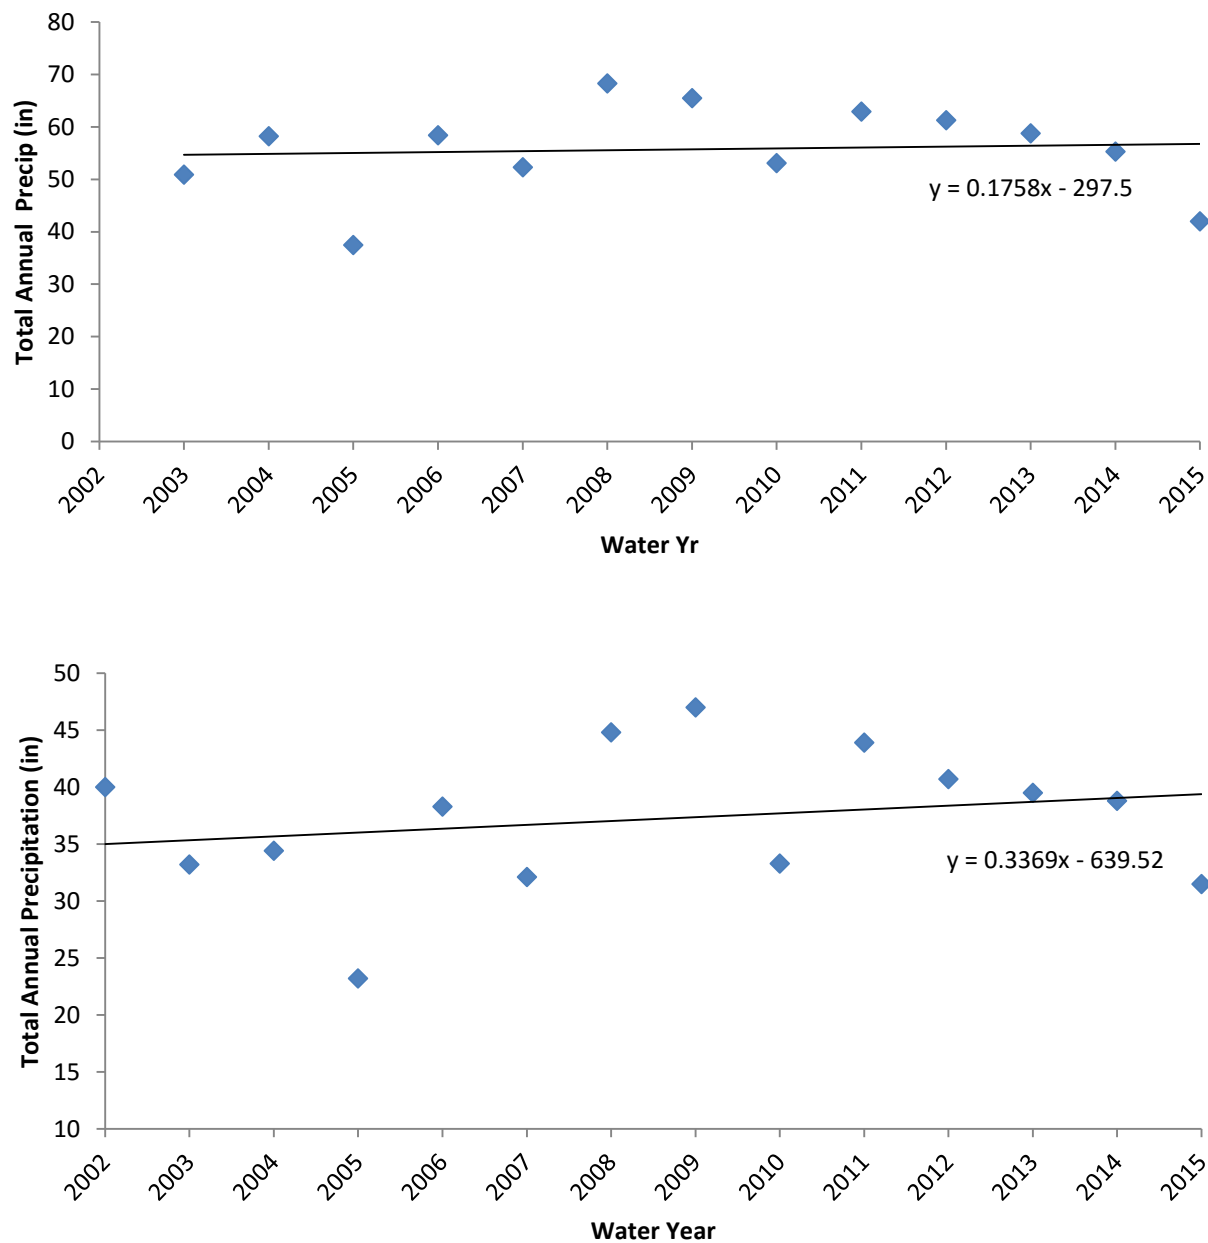
Figure 7: Total annual precipitation measured at the NRCS SNOTEL gage for the period of record at the Touchet (upper) and Spruce Springs (lower) gages. The Touchet gage is located near the Tucannon basin and the Spruce Springs gage is located south eastern most part of the Tucannon Basin.

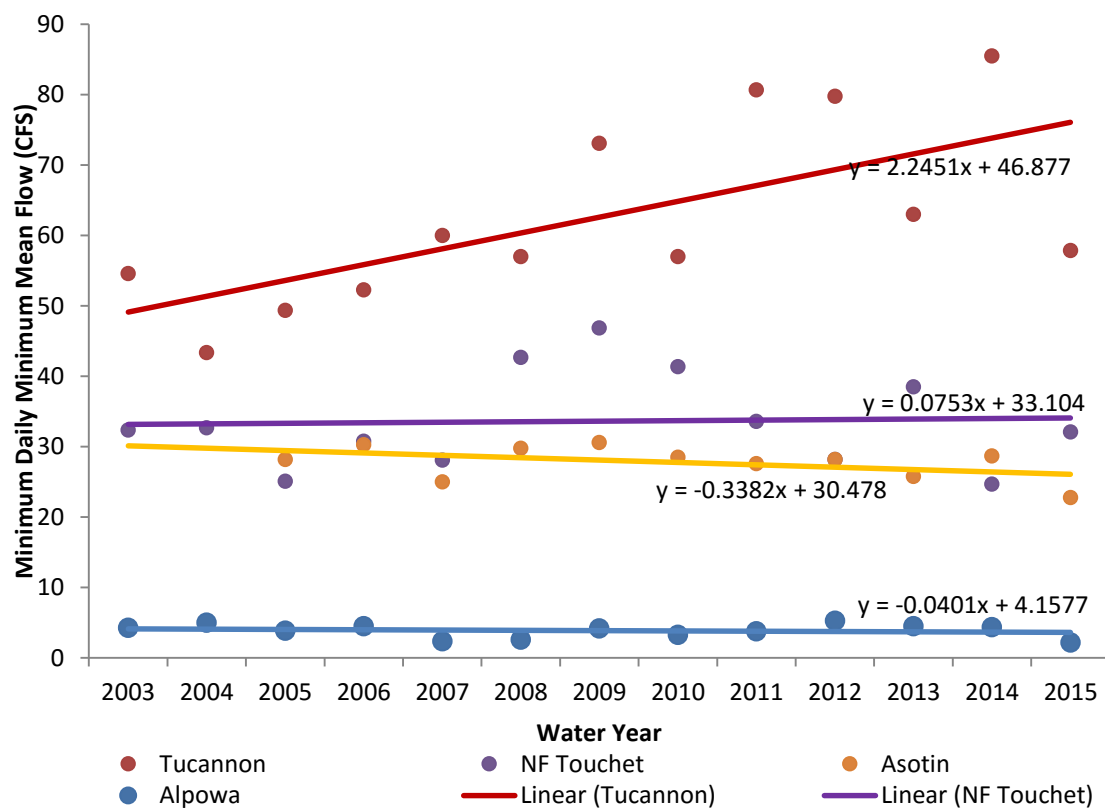
Figure 8: Minimum daily mean flow (cfs) by water year for the Tucannon River at Marengo, North Fork Touchet above Dayton, Asotin Creek above George Creek and Alpowa Mouth. Trend line and slope provided for each watershed over the period of record. Data provided by Washington Department of Ecology (<https://fortress.wa.gov/ecy/eap/flows/station.asp?wria=35>).

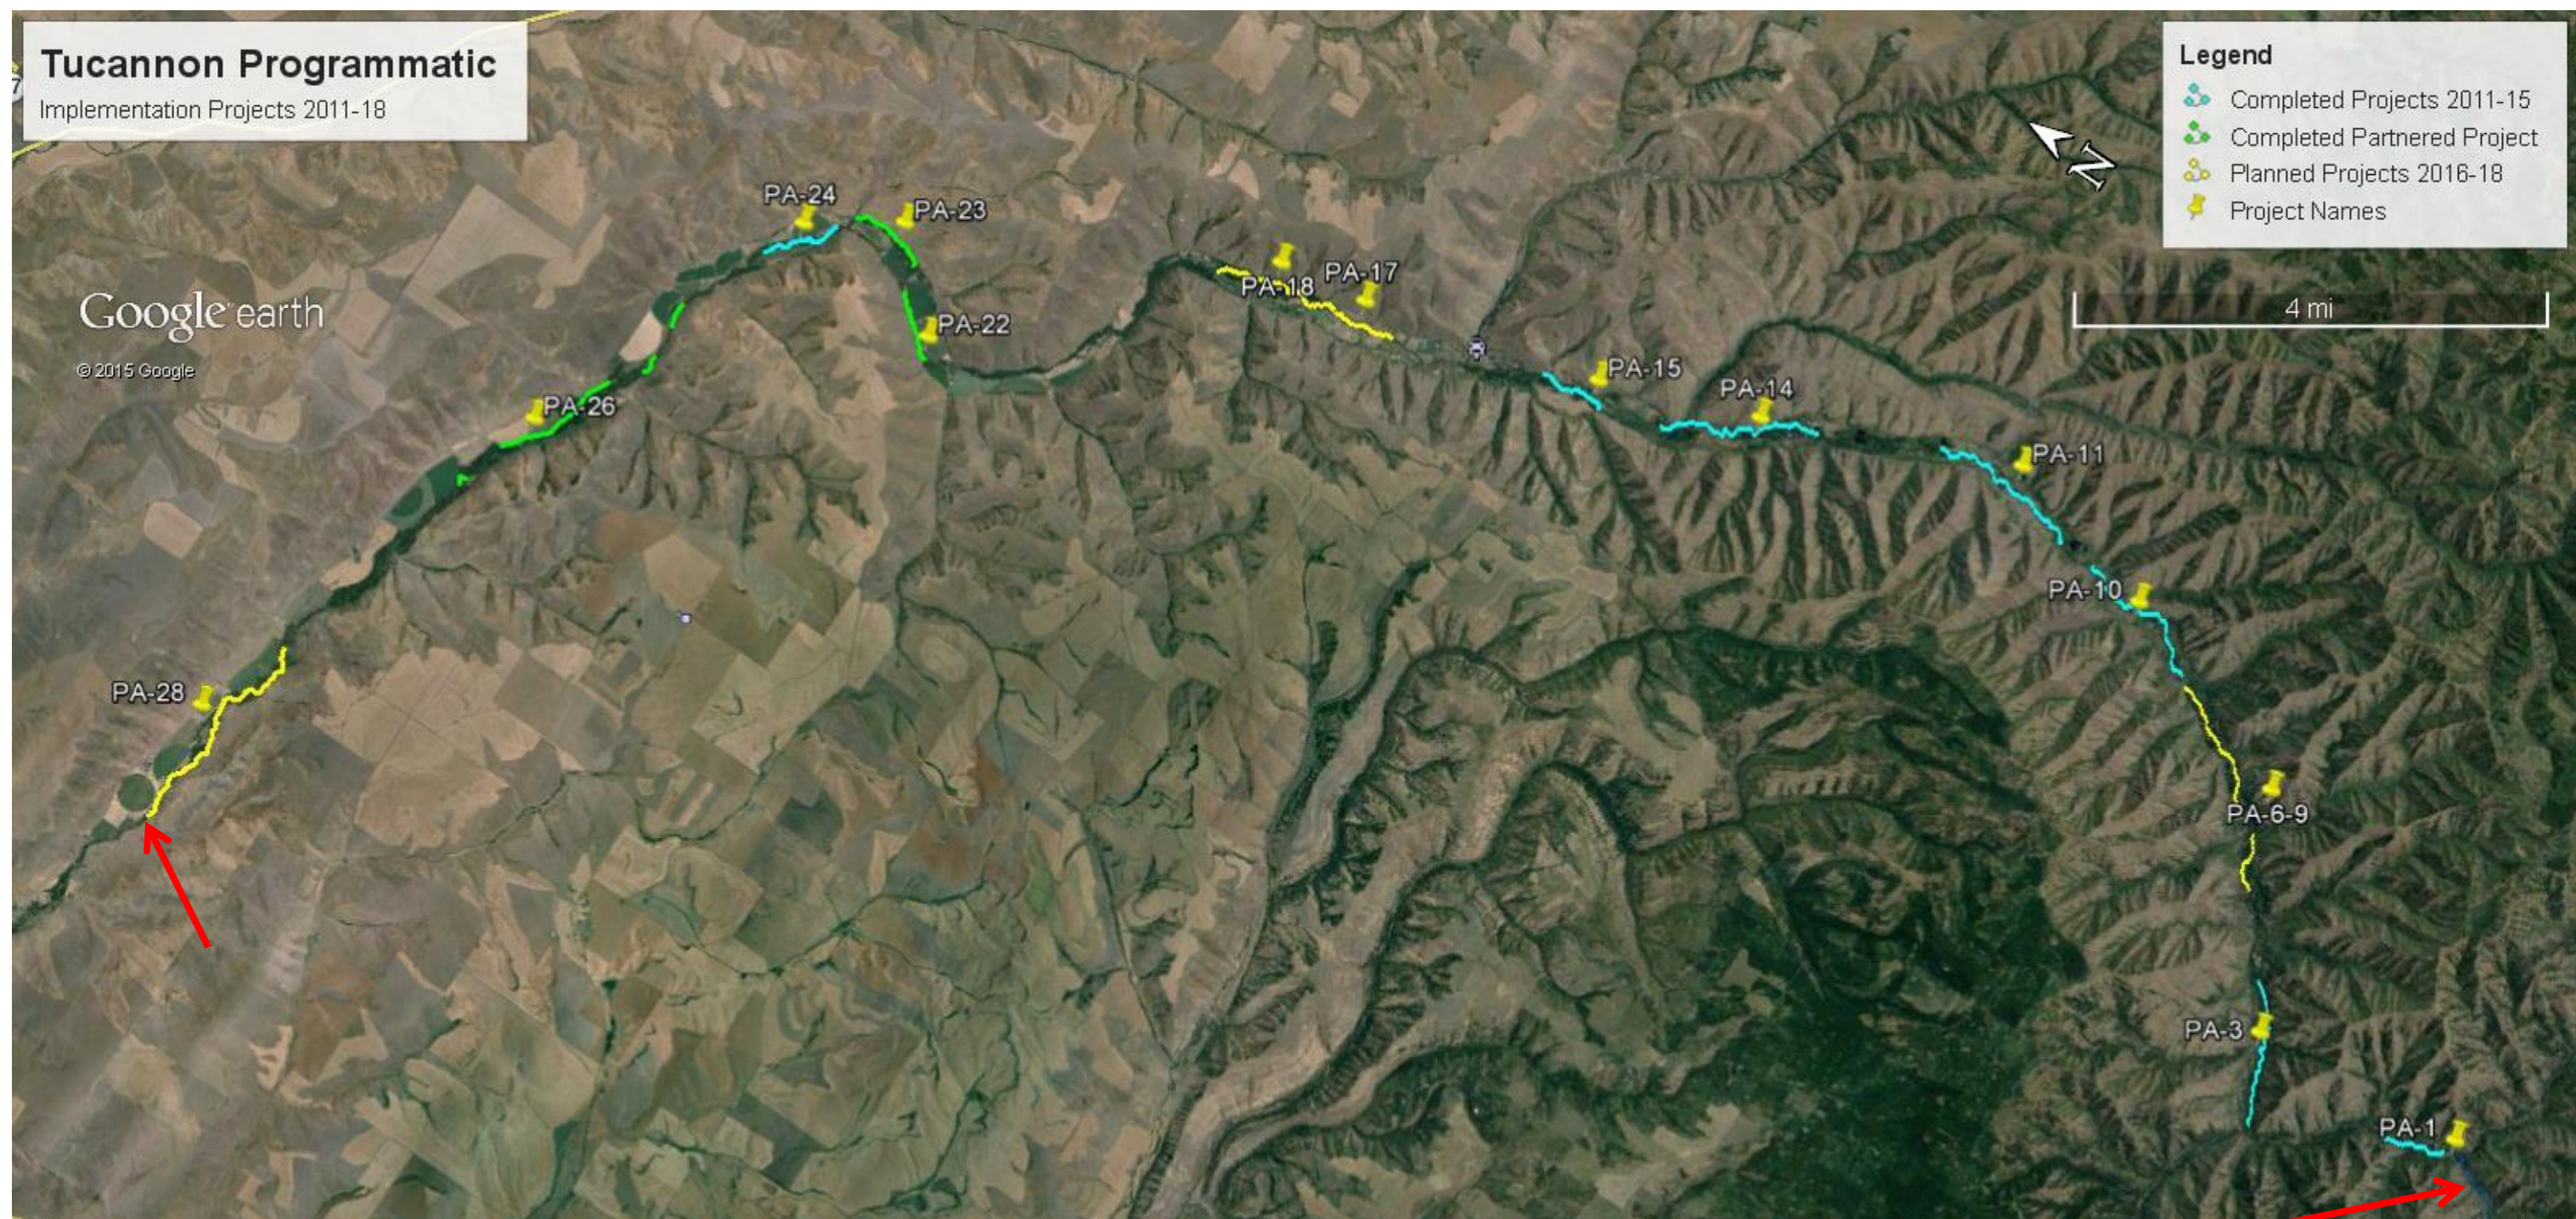
Figure 9: Tucannon Programmatic Habitat focus area from RM 20 (left red arrow) to RM 50 (right red arrow). Project reaches completed under the Tucannon Programmatic Habitat since its start in 2011 are highlighted in blue (10.07 stream miles total). Programmatic also provided non-fiscal partner support to the Columbia Conservation District in the completion of three additional projects, highlighted in green. Project scheduled to be funded and completed by the end of 2018 are highlighted in yellow (6.36 miles total).

Projects completed to date (2011-2015) using Programmatic funding, are illustrated in a Google Map (Figure 9), with the seven completed projects highlighted in blue. Since the initiation of the Programmatic over ~10 stream miles have been treated for complexity by the Programmatic placing 3,244 key LWD pieces (>6m long & 0.3m dia) into ~ 524 log configurations (390 multi log type jams & 134 single logs) (Table 2 & 3). All stream reaches treated for wood complexity under the Programmatic now meet the minimum restoration goal of >2 key logs/ bank full width (>6m long & 0.3m dia). Additionally, stream reaches were treated for floodplain connectivity through the removal of confining features (1,877' levee removed) and reversal of incision through wood placement, totaling >6.36 miles reconnecting ~36 acers of low lying floodplain and creating and reconnecting/enhancing 5.8 miles of side channels (Table 2 & 3).

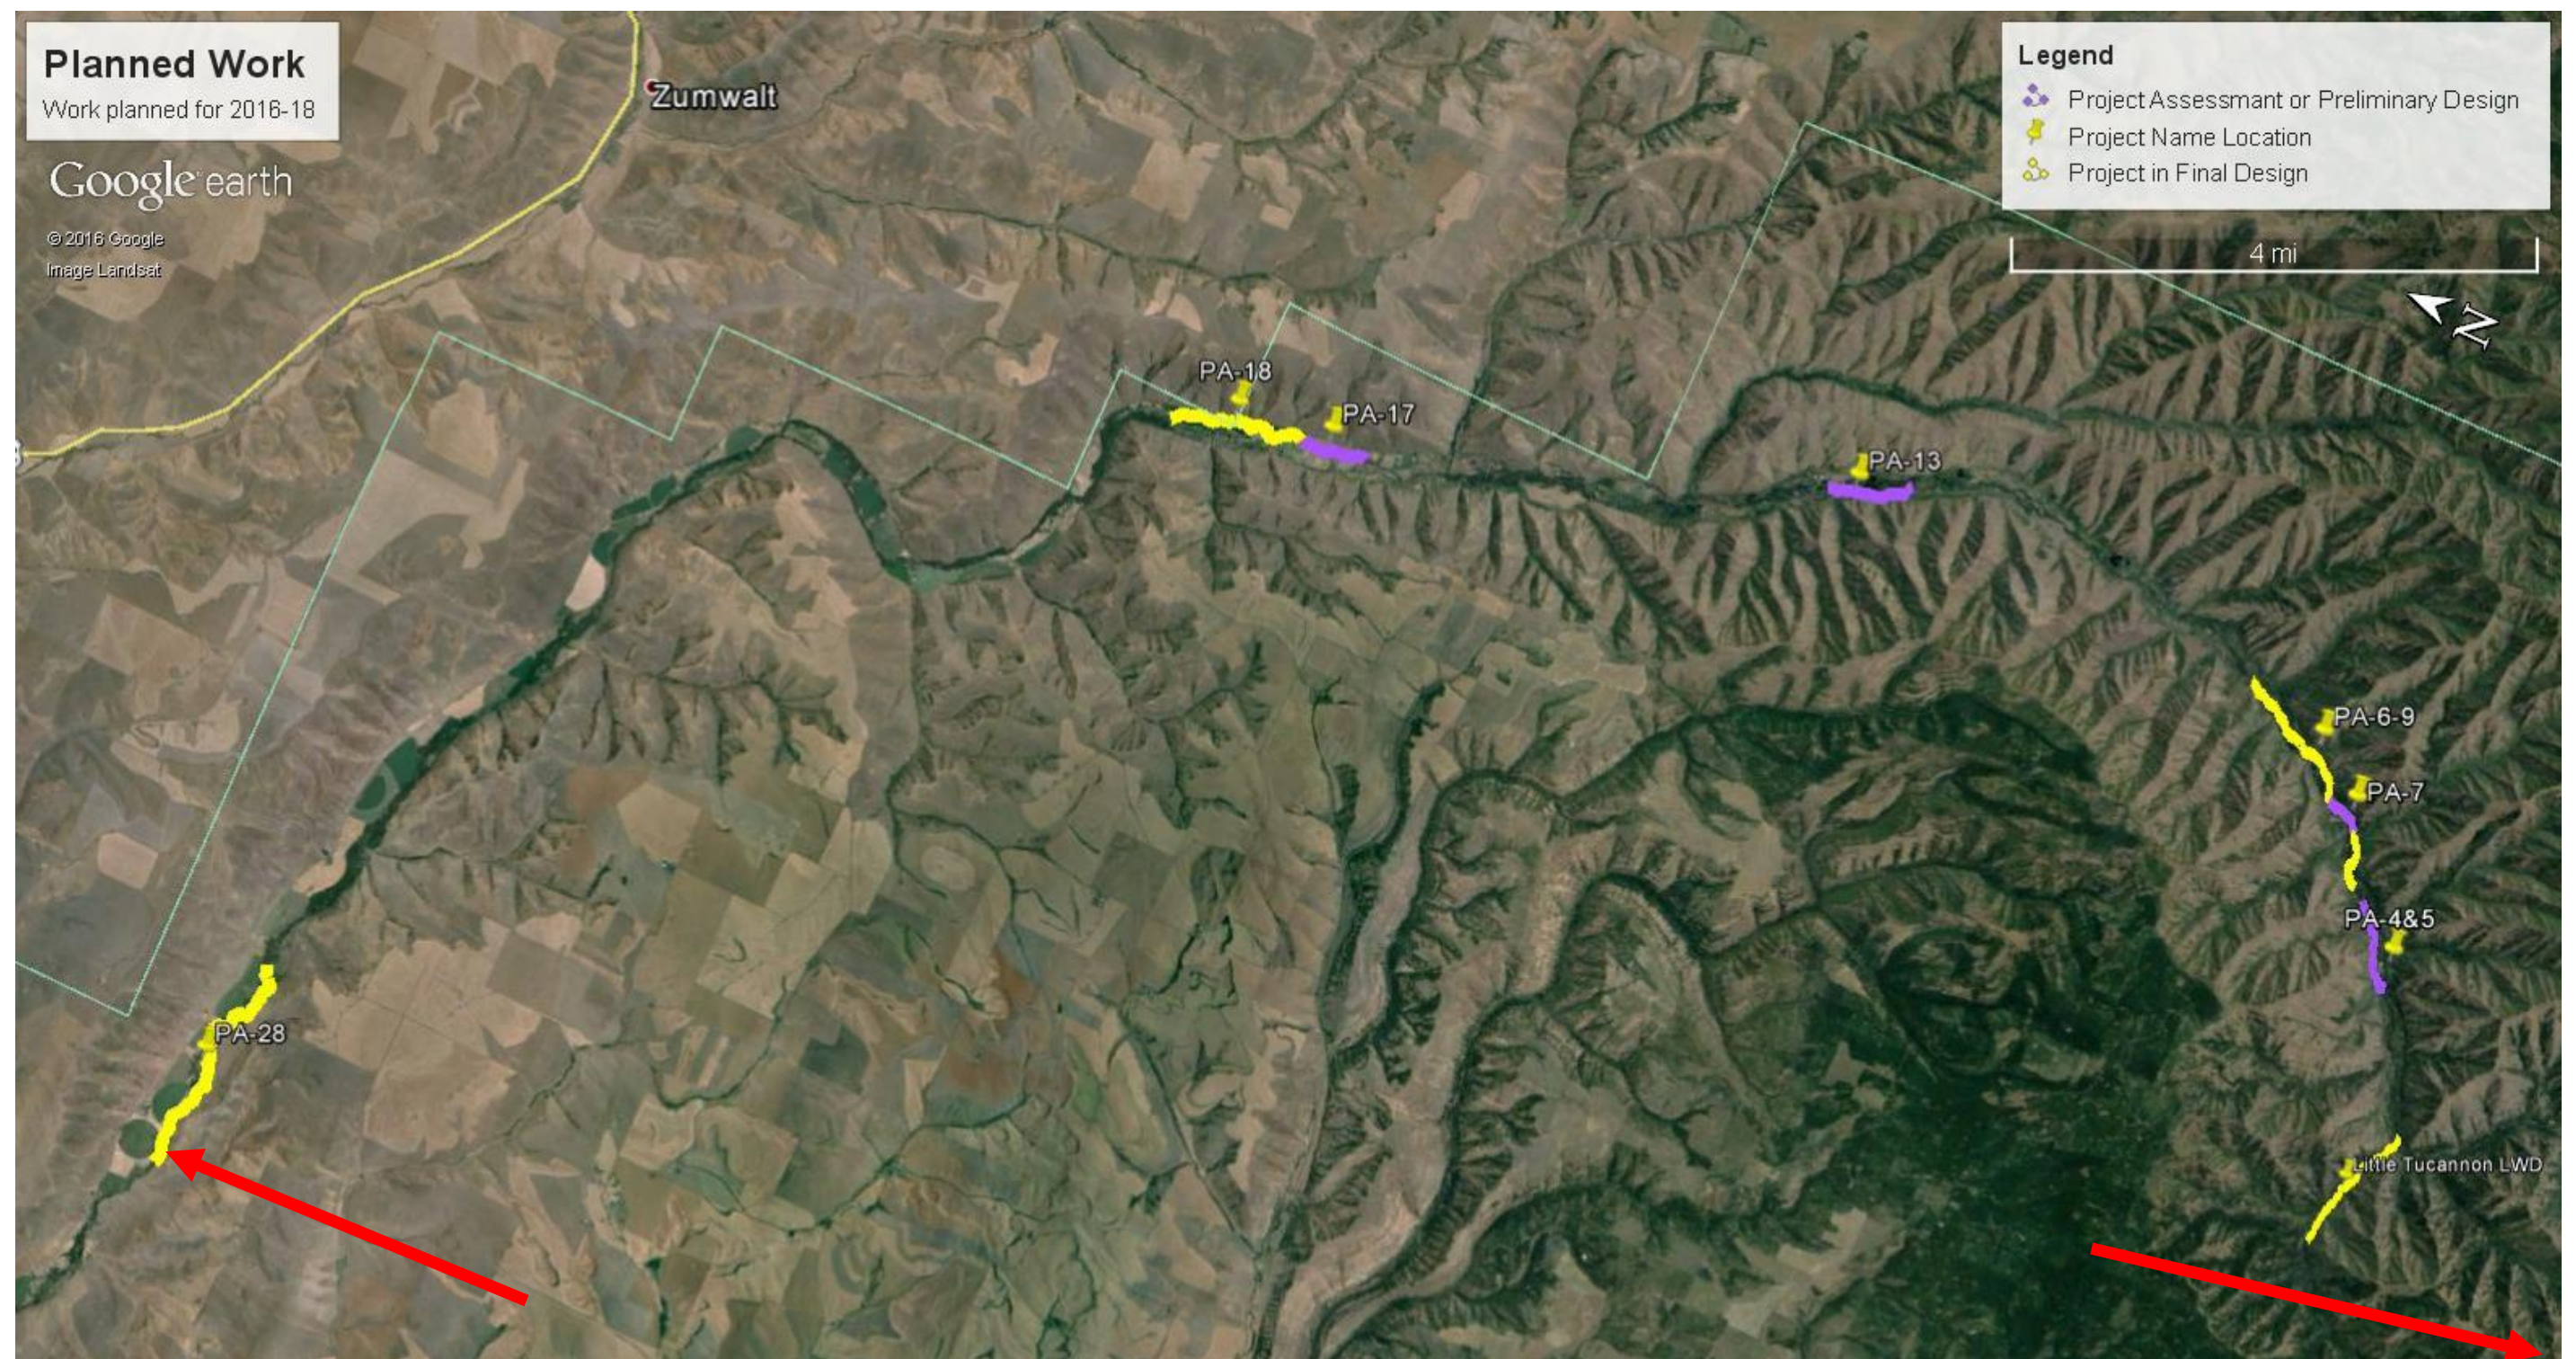
Figure 15: Tucannon Programmatic Habitat focus area from RM 20 (left red arrow) to RM 50 (right red arrow). Highlighted reaches are project areas to be designed and implemented in coordination with the Tucannon Programmatic Habitat in 2016-18. Projects ready for implementation in 2016-17 are highlighted yellow, assessments and preliminary design products are highlighted in purple. The Programmatic will also provide non-fiscal partner support to the Columbia Conservation District in the completion of one project in the Little Tucannon River.

In 2015, WDFW completed a field assessment and design for the project areas PA-6, 8 & 9 RM 43.9 to RM 44.9 and RM 45.3 to RM 45.9 (Figure 9 & 15). It was initially determined that PA-7 would be included in this design but during the site assessment it was determined to have higher risk restoration elements and would require additional review and assessment. At that point the project was added to the USFS feasibility assessment for PA-4 & 5, now named PA-4, 5 & 7 and is not included in this design project. The overall project goal is to improve channel shape and increase complexity. The objective will be to place LWD in configurations to increase off channel and side channel habitat and increase floodplain connectivity (Appendix 4 – Slide 1&2). The project will place approximately 82 LWD structures using > 600 logs and trees, placed using a helicopter to minimize impacts to existing high quality riparian areas during construction. In total, the project would place wood structure in 1.8 miles of the Tucannon, increasing LWD key piece (>6m long & 0.3m dia) densities from the existing 0.6 key pieces per bank full width to a minimum of 2 pieces. Additionally, from the removal of small spoil berm running adjacent to the river in the upper most end of the project (Appendix 4 – Slide 2), the project will reconnect >1,000' of existing side channel and floodplain. During the project large volumes of racking and slash will be incorporated in the project construction with the intended purpose of shorting the time to structure interaction with the typical flows.

The Project Area 13 assessment/feasibility was conducted in 2015 by WDFW, in preparation for design development in 2016. The project is located between RM 39.2 and RM 40 (Figure 15) on the WDFW Wooten Wildlife Area and would be designed by WDFW staff environmental engineer. The project site is currently confined by river levees and the Rainbow Lake impoundment on the east bank, and by the upstream Tucannon Hatchery Weir and the Tucannon Hatchery Rd on the downstream end (Appendix 8 - slide 1). River complexity and floodplain connectivity through the entire reach are impacted providing an excellent opportunity to increase salmon habitat (Appendix 8 - slide 2).
