Tucannon River Restoration Effectiveness Monitoring: 2014 Results

Snake River Salmon Recovery Board

September 15, 2015

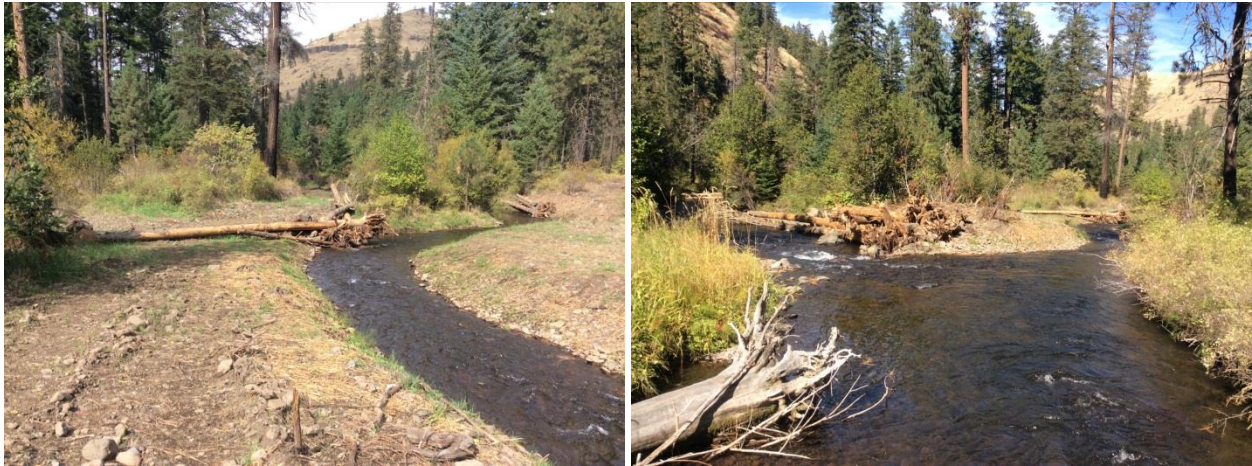
Figure 3. Restoration implemented in Project Area 1 included the creation of side channels and installation of LWD structures. Photos courtesy of the SRSRB.

Restoration in Project Area 1 (RM 49.5-50.1) downstream from Panjab Creek was implemented in 2014. The objectives of this project were to increase channel complexity and side channel habitat. Approximately 231 key pieces of LWD were added and over 550 meters of side channels were reconnected or created (

Figure 3). More information about this project can be found at: [Project Area 1](#).

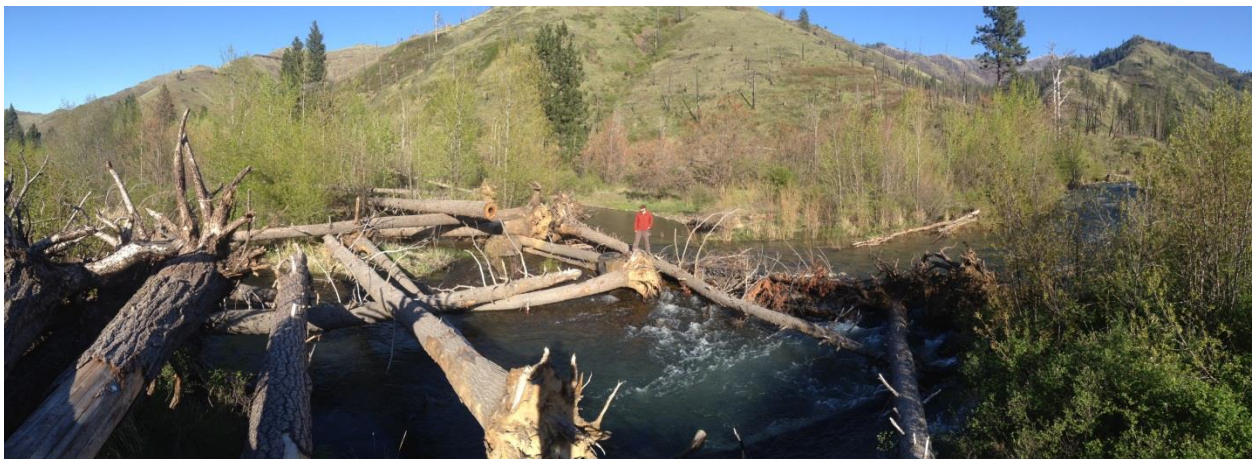
Figure 5. Restoration implemented in Project Area 10 included the addition of LWD.

Restoration in Project Area 10 (RM 42.4-44.0) between Beaver/Watson Lake and Big 4 Lake was implemented in 2012. The objectives of this project were to reduce channel confinement and incision as well as increase channel complexity. Over 350 key pieces of LWD were added during restoration (Figure 5). More information about this project can be found at: [Project Area 10](#).

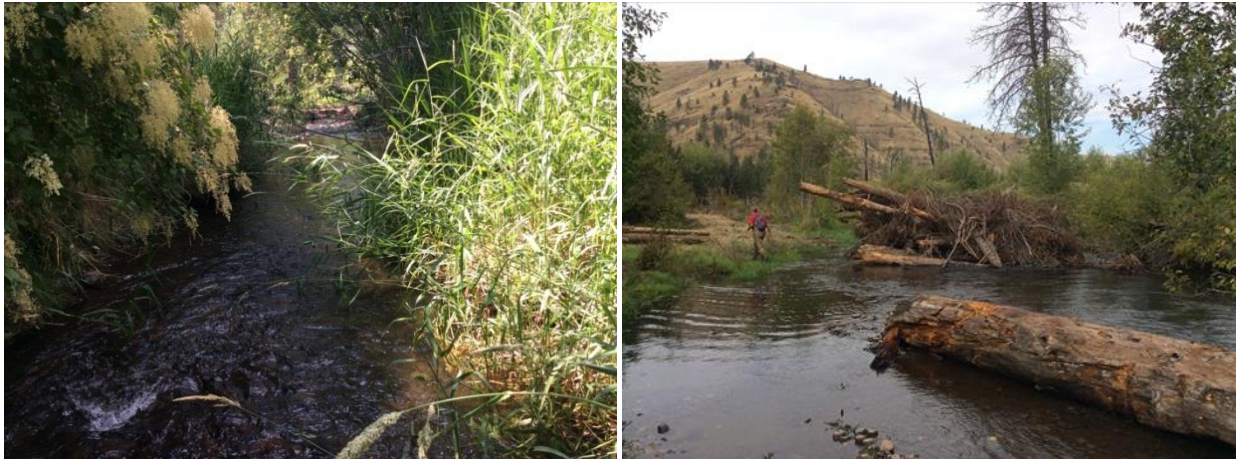
Figure 6. Restoration implemented in Project Area 14 included the creation and reconnection of side-channels (left photo) and installation of LWD structures (right photo). Photos courtesy of the SRSRB.

Restoration in Project Area 14 (RM 37.2-39.2) between Cummings Creek and the Tucannon Fish Hatchery was implemented in 2014 and included the addition of over 700 key pieces of LWD and the creation or reconnection of over 2200 meters of side channel habitat (Figure 6). The objectives of this

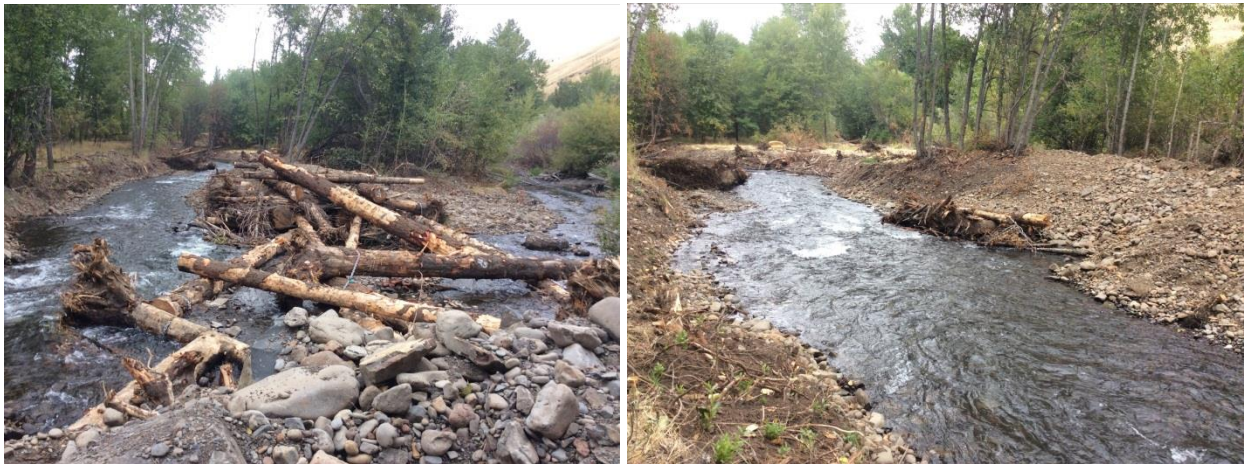
Figure 7. Restoration implemented in Project Area 15 included the installation of LWD structures (left photo) and the creation of new side channels (right photo). Photos courtesy of the SRSRB.

Restoration began in Project Area 15 (RM 36.4-37.2) downstream from the Wooten Wildlife Area headquarters in 2014 and will continue in 2015. The objectives of this project include increasing channel complexity and side channel development (Figure 7). In 2014, approximately 210 key pieces of LWD were added and 400 meters of new side channels were created. More information on this project can be found at: [Project Area 15](#).

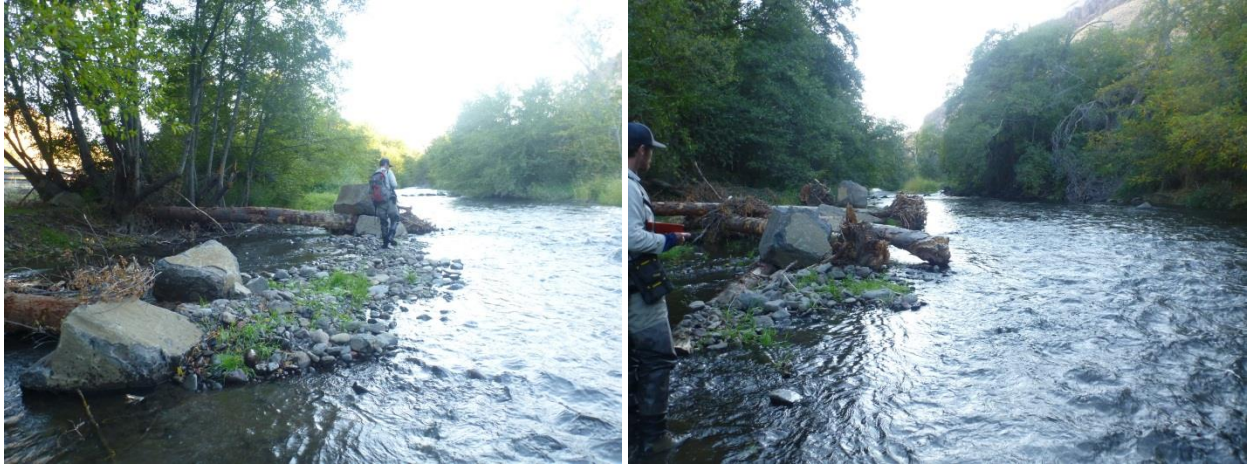
Figure 8. Photos showing two of eight LWD structures placed in Project Area 22.

Restoration in Project Area 22 (RM 29.3-30.3) upstream of Marengo was implemented in 2014. Eight LWD structures consisting of 36 key pieces of LWD were placed in order to increase channel complexity and pool habitat (Figure 8). More information on this project can be found at: [Project Area 22](#).

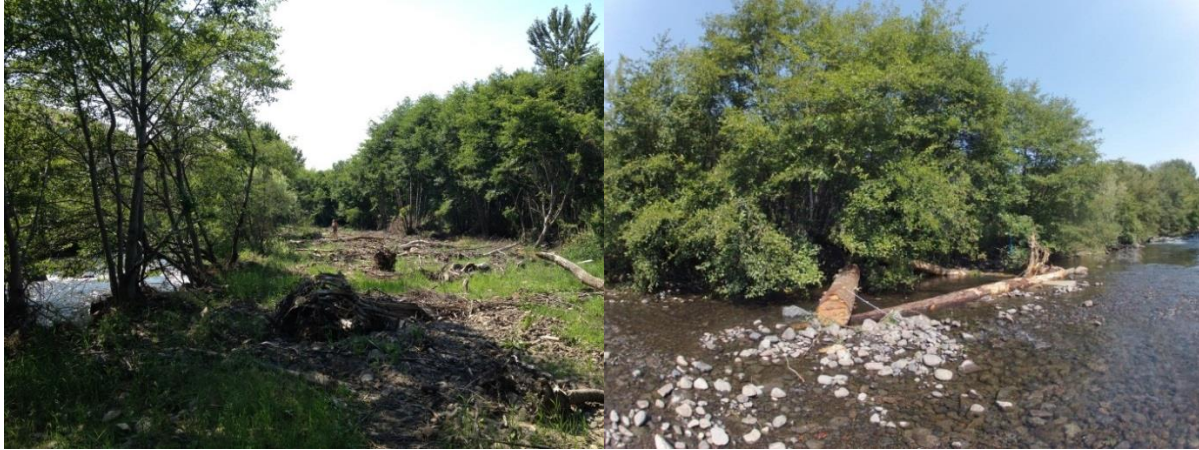
Figure 9. Restoration actions implemented in Project Area 26 included levee removal (left photo) in 2011 and LWD placement (right photo) in 2012. Photos courtesy of the SRSRB.

Restoration in Project Area 26 (RM 23.7-26.9) downstream of Marengo was first implemented in 2011. The objective of this project was to reconnect the disconnected floodplain and riparian habitat by removing and setting back over 2500 and 3700 meters of levee, respectively (

Figure 9). In addition to the 2011 levee removal/setback, in 2013, 17 structures comprised of 78 key pieces of LWD were constructed. The objective of this additional restoration action was to provide habitat complexity and encourage channel migration. More information on this project can be found at: [Project Area 26](#).

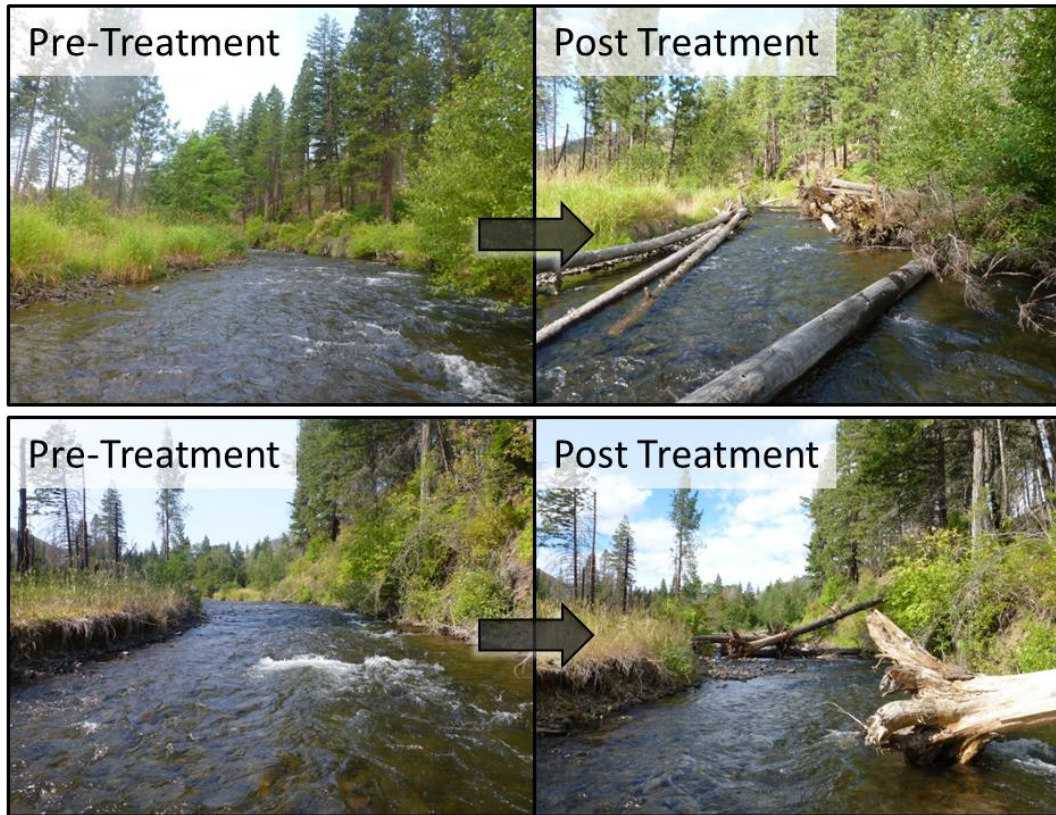
Figure 11. Images showing differences in large wood between pre-treatment and post treatment samples at Site 169855.

The implementation of restoration actions in Project Area 10 are directly evidenced by the number of new large pieces of wood now occupying the stream channel (Figure 11). Preliminary data suggests that the addition of wood into the channel may have attributed to an increase in the number of channel units at the site through the interaction of high flows with the wood to scour new pools and sort sediment, although the direct link between wood and channel units is uncertain. Geomorphic change detection results indicate some changes in bed scour near the bottom of the site but relatively minor changes in the stream channel in the upper 2/3 of the site (Figure 12).

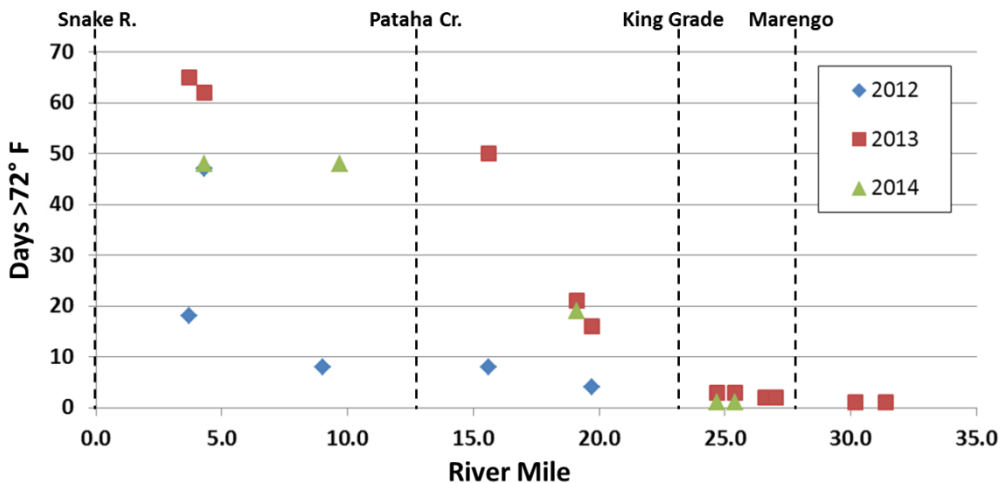
Water temperature data at CHaMP sites from 2012-2014 indicate that 4 sites in 2012, 5 sites in 2013, and 3 sites in 2014 exceeded the restoration target of less than 4 days greater than 72 degrees (

Figure 15). All of the sites sampled in the lower watershed exceeded the 72 degree threshold for each year where data was available. Sites exceeding more than 4 days in the upper watershed were all located below King Grade.

Figure 15. Number of days water temperature exceeded 72° F at CHaMP sites from 2012-2014 by river mile.

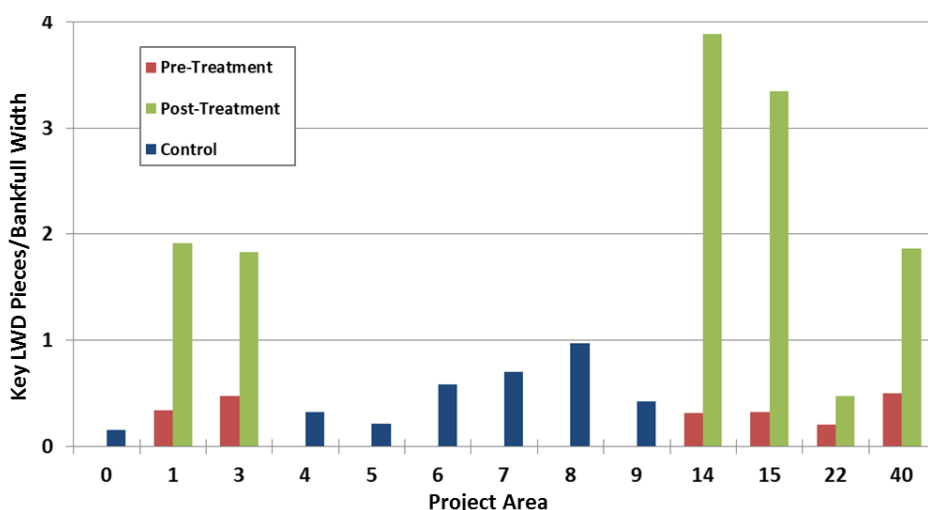
Results from the rapid habitat survey of key pieces/bankfull width indicate that four out of the five project areas that were treated in 2014 exceeded the restoration goal of one key piece of LWD per bankfull width (Figure 16). Key pieces in Project Area 22 did increase due to restoration but this project was on a much smaller scale than other projects implemented in 2014. The average number of key pieces/bankfull width at post treatment project areas was 2.22 pieces compared to an average of 0.48 pieces in control project areas. The overall average of key pieces for all project areas (treatment + control) surveyed was 1.28 key pieces/bankfull width.

Figure 16. Rapid habitat survey results showing the number of key LWD pieces in each project area surveyed in 2014. The overall restoration goal is 1 key piece per bankfull width. Data collected by SRSRB and Eco Logical staff.

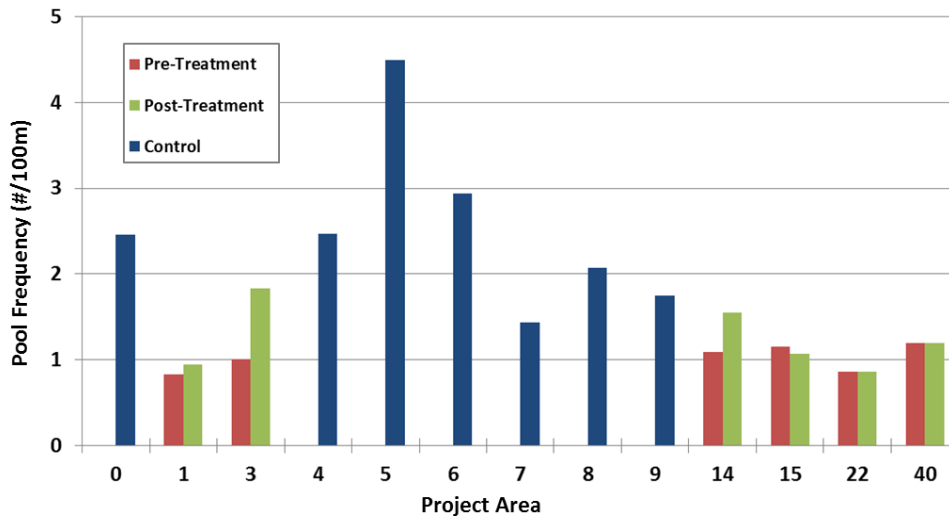
Rapid habitat survey results summarizing pool frequency within each project area indicate a greater number of pools on average within control project areas (2.22 pools/100m) compared to post treatment results in restoration project areas (1.24 pools/100m; Figure 17). In general the number of pools within treated project areas did increase post treatment from 1.02 to 1.24 pools/100m, likely as a result of excavation or damming of the river from LWD placement. In the future, we expect pool frequency to further increase as LWD has the chance to interact with high flows to scour out more pool habitat. We will continue to conduct rapid habitat surveys in 2015 to fill in project areas not accounted for in 2014.

Figure 17. Rapid habitat survey results showing pool frequency in each project area surveyed in 2014. Data collected by SRSRB and Eco Logical staff.
