Annual Monitoring Report:

## Mahogany Creek Culvert Replacement Project

Contract No: 27255  
BPA Project No: 1992-026-01

February 21, 2008

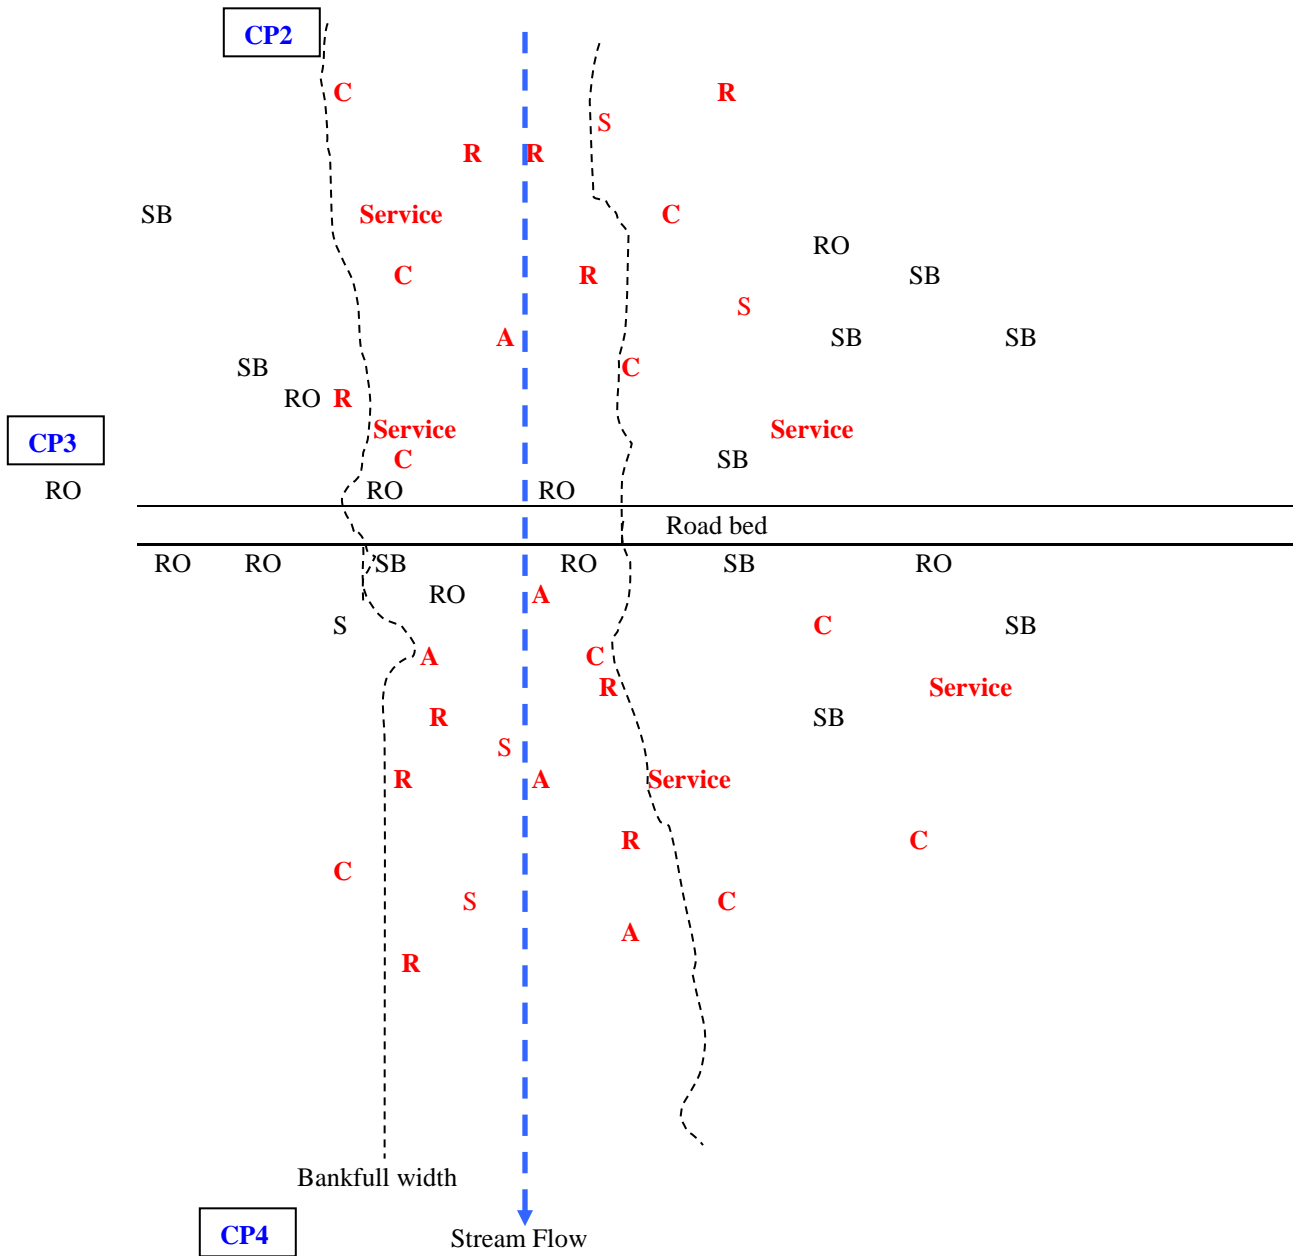
**Figure 7.** Diagram depicting the planting locations, species and control points.

Figure 7 is a diagram depicting the planting locations for non-willow species utilized to reclaim the site after construction. These species were planted in late October 2006 by NPT staff. There are three control points depicted in blue font. These control points correspond to the permanent photographic monitoring points discussed in the next section.

Table 2 below shows the first year’s survival rates for Cottonwood, Thinleaf alder, Syringa, Serviceberry and Dogwood planted in 2006. These species are depicted in red font in Figure 7, above. Rose and snowberry survival rates were not determined as they are common on site, will likely regenerate naturally within a relatively short time frame, and are of a lesser importance for long term recovery of the site. Survival rates will be monitored again for the 3-year and 5-year monitoring report.

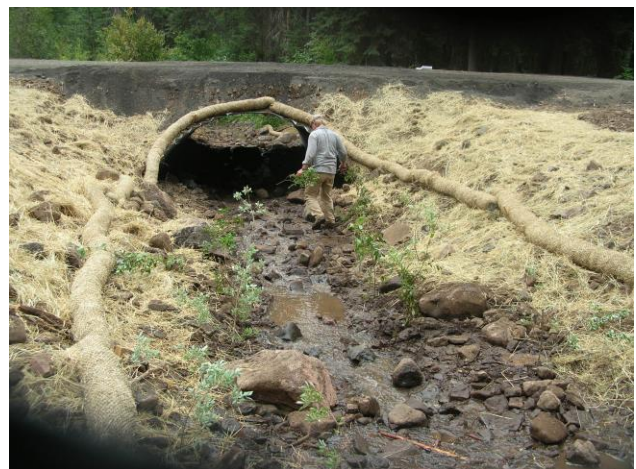
Immediately following construction of this project, seventy-five willow plants that were salvaged from the site prior to implementation were planted along the newly constructed channel, shown in the picture to the right. Additionally, all disturbed areas were hydro-mulched on October 20, 2006. The hydro-mulch mixture was comprised of a native grass seed mixture suitable for this site that was obtained from the Forest Service.
