## APPENDIX J.1

### TIER 1: TREATED PROJECT AREAS

## Project Area 1.1 Description

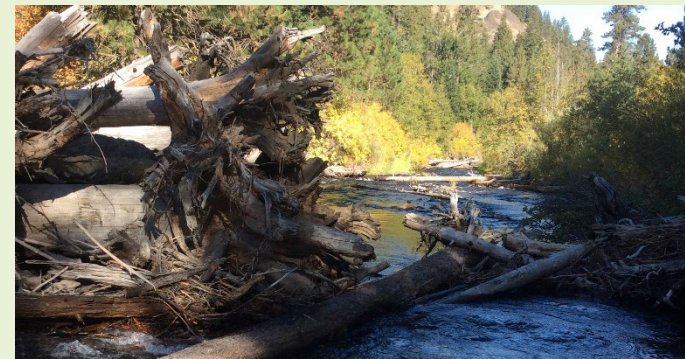
### Project Area 1.1

**Engineered log jam with large wood recruits at the upstream end of PA 1.**

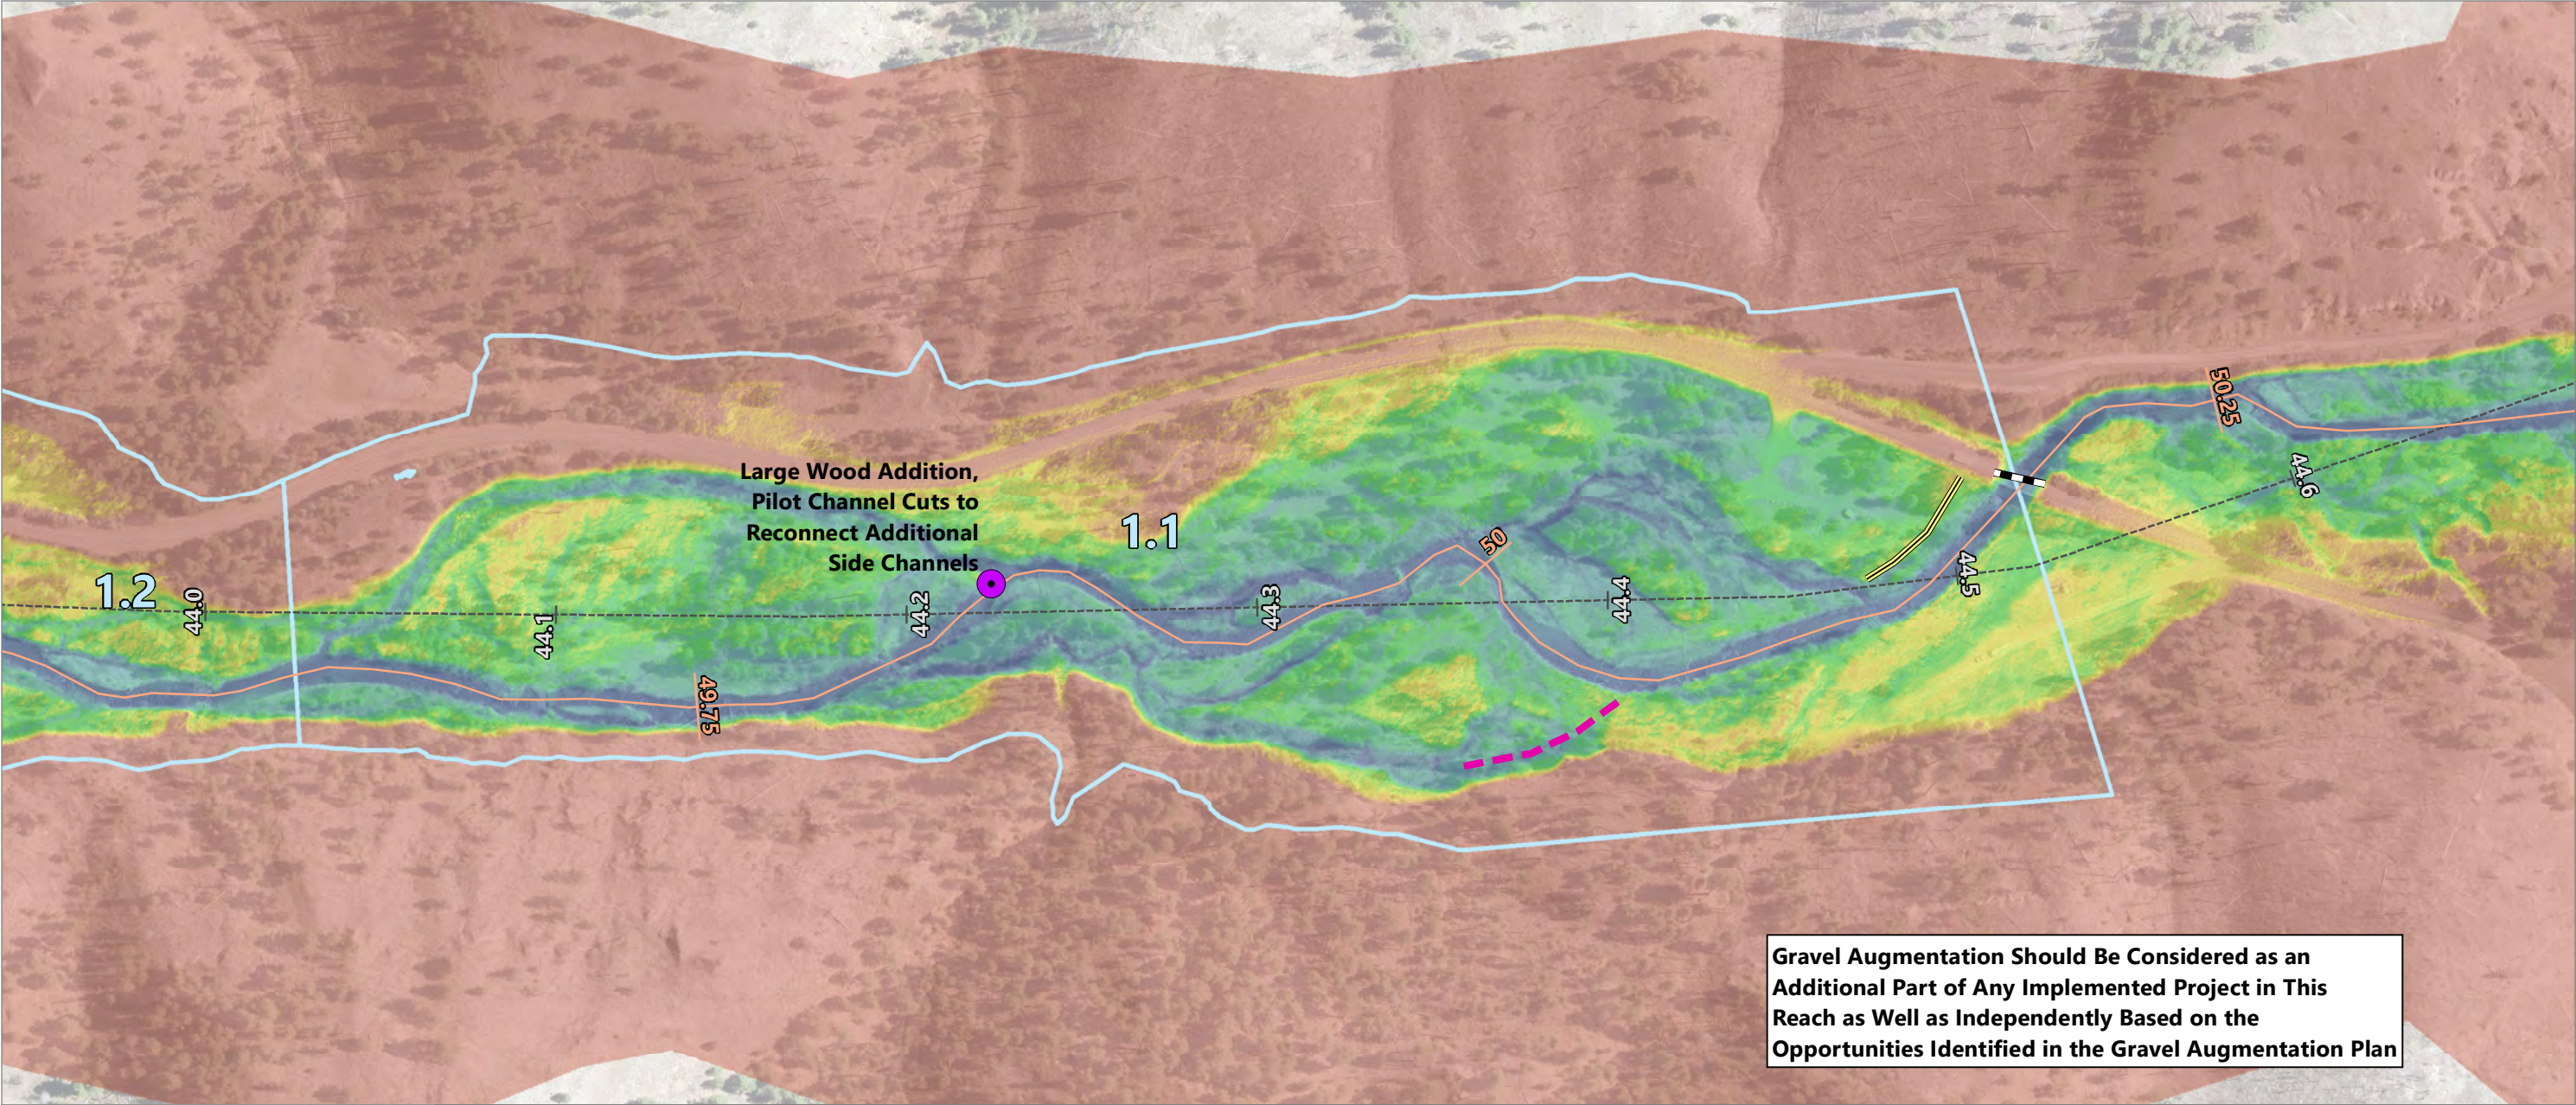
Where the second side channel splits off from the main channel, the log jam and pilot channel are again evident with some minor aggradation on the right bank (box 3). Further down on the main channel, a large bank barb shows a small scour pool off the front (box 4). Finally, a log jam in the downstream side channel has caused some erosion on the right bank (box 5).

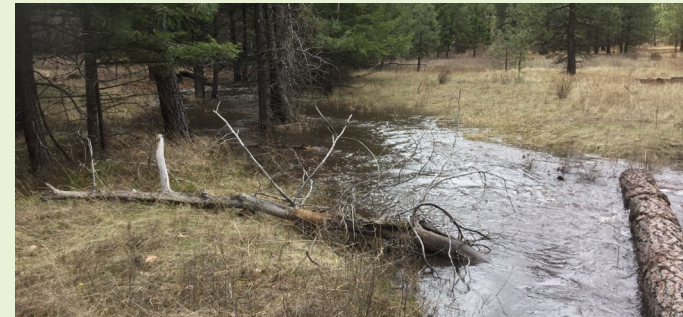
### Project Area 3.2

**Post-project photograph taken May 7, 2019, post high flow. The log jams placed in 2018 captured disconnected floodplain channels.**

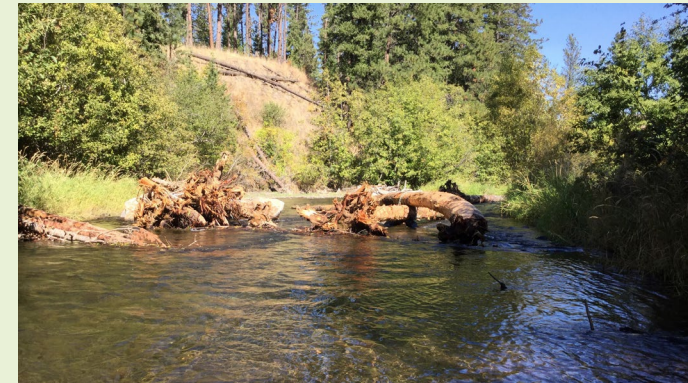
### Project Area 9

**Channel-spanning ELJ placed using a helicopter in July 2017; photograph taken in September 2017.**

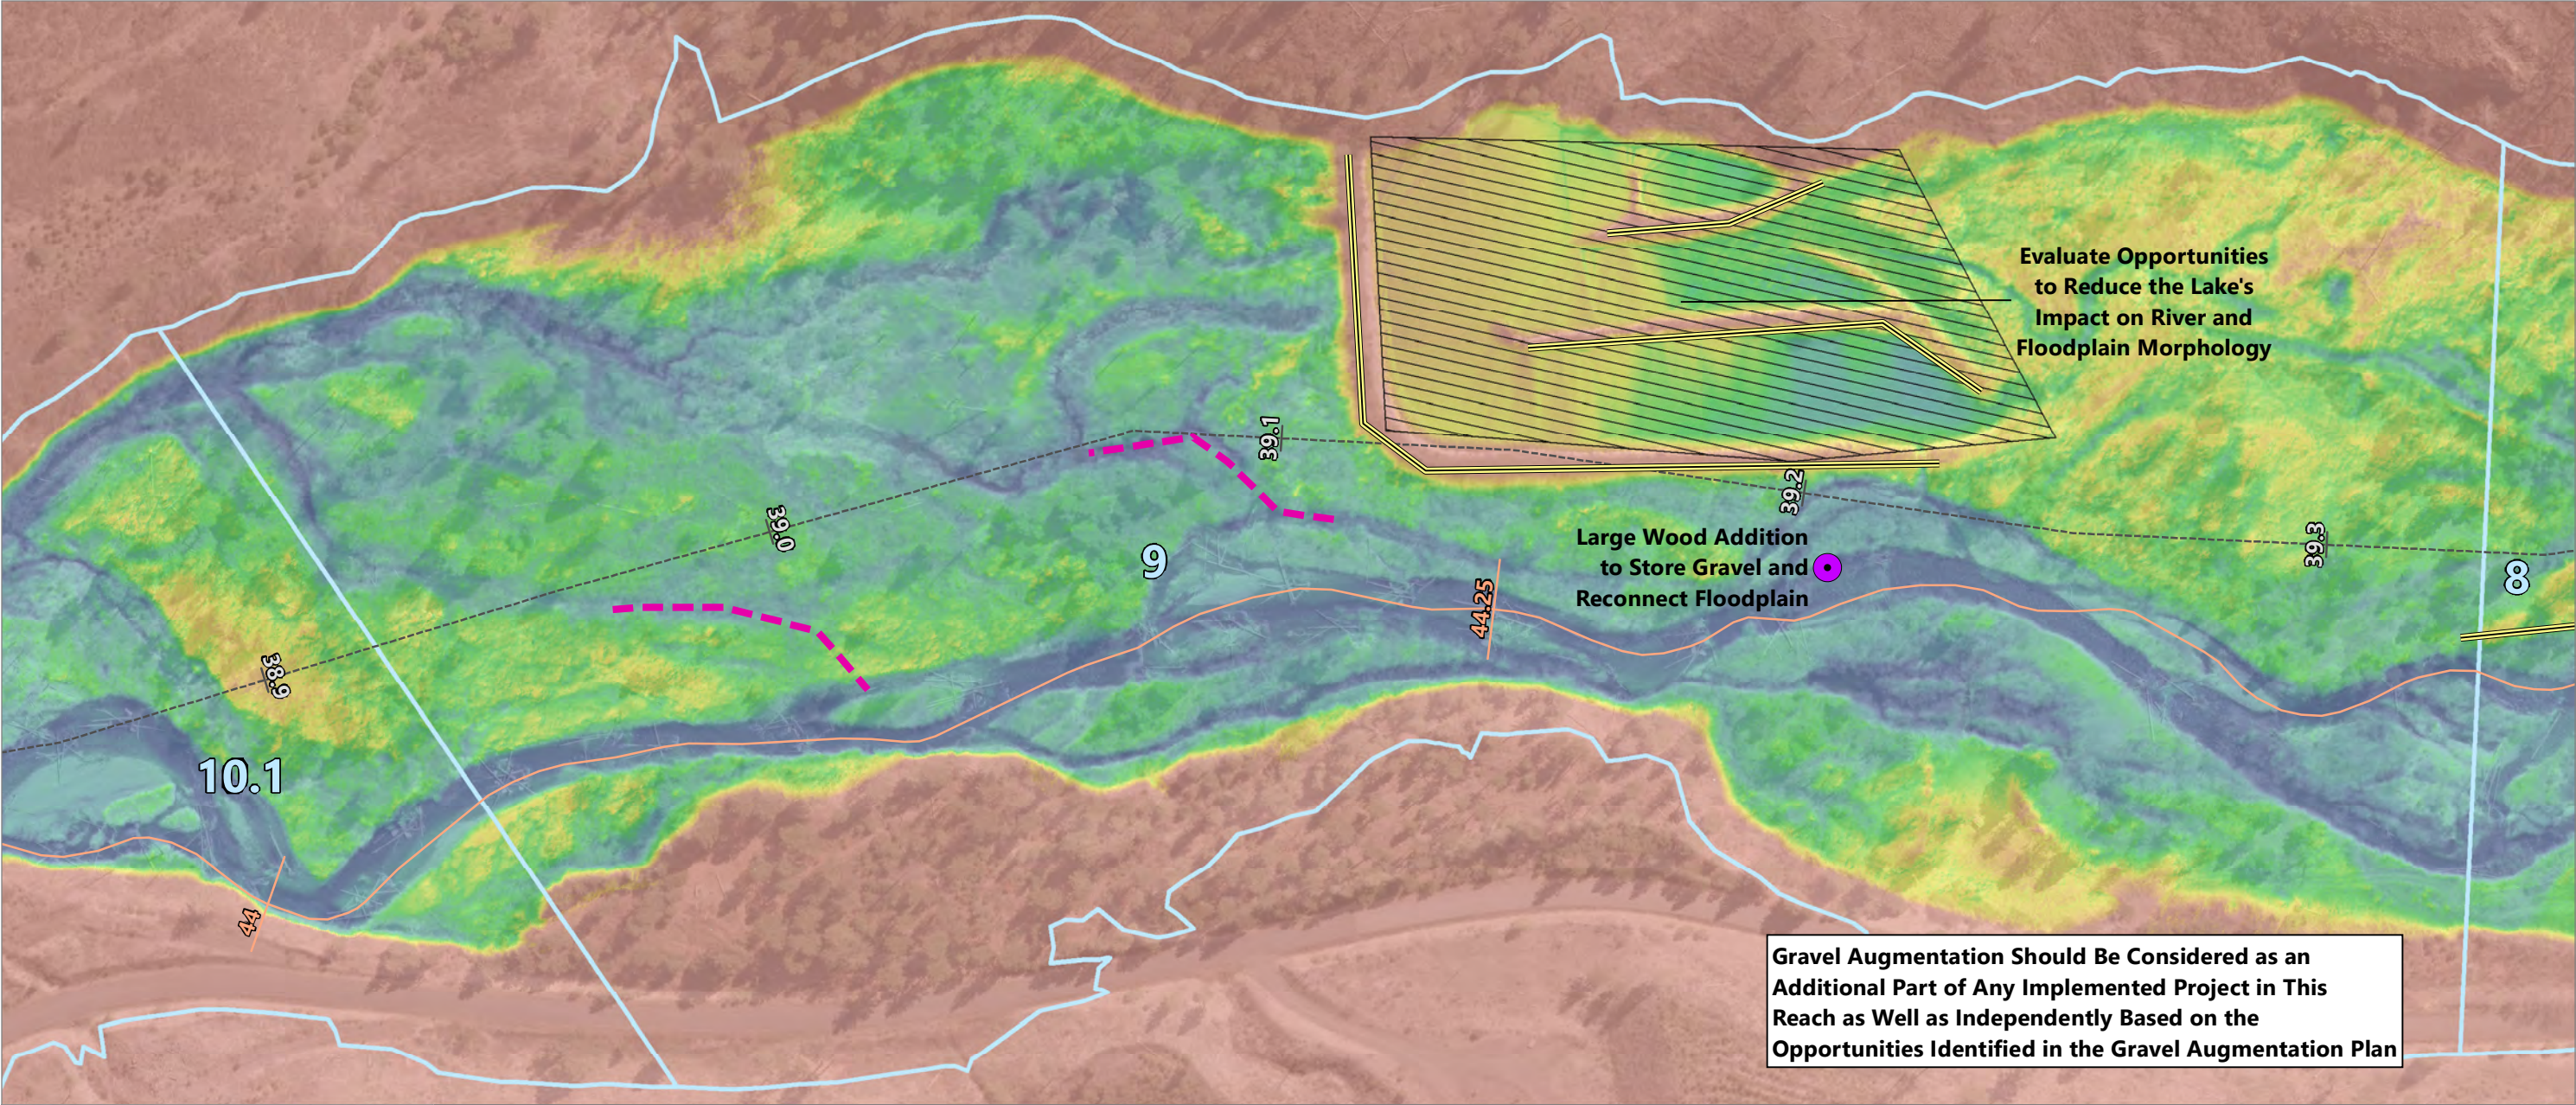
At the upstream end of PA 9, a large split flow has formed from a mid-channel log jam located in PA 8, and the resulting mid-channel bar in PA 9 is apparent as aggradation in the change analysis. This has caused some minor bank erosion as well on the left bank in this area (box 1). 400 feet downstream of this split flow, additional deposition is apparent in the floodplain that appears to be associated with a channel split flow, indicating that this side channel receives higher flows during flood events to allow sediment to deposit (box 2).

Additionally, if this area can be connected at the mean-winter flow or lower, this would also be a significant boost to the complexity in this reach by adding a long and potentially complex side channel. It should be noted that, while the main channel was heavily treated with instream wood, none of this additional potential area was treated on the floodplain, and adding wood to

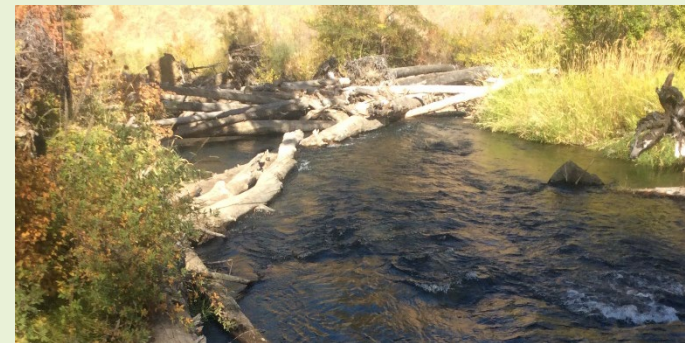
### Project Area 14.2

**Engineered log jam with channel-spanning recruits likely from upstream structure losses.**

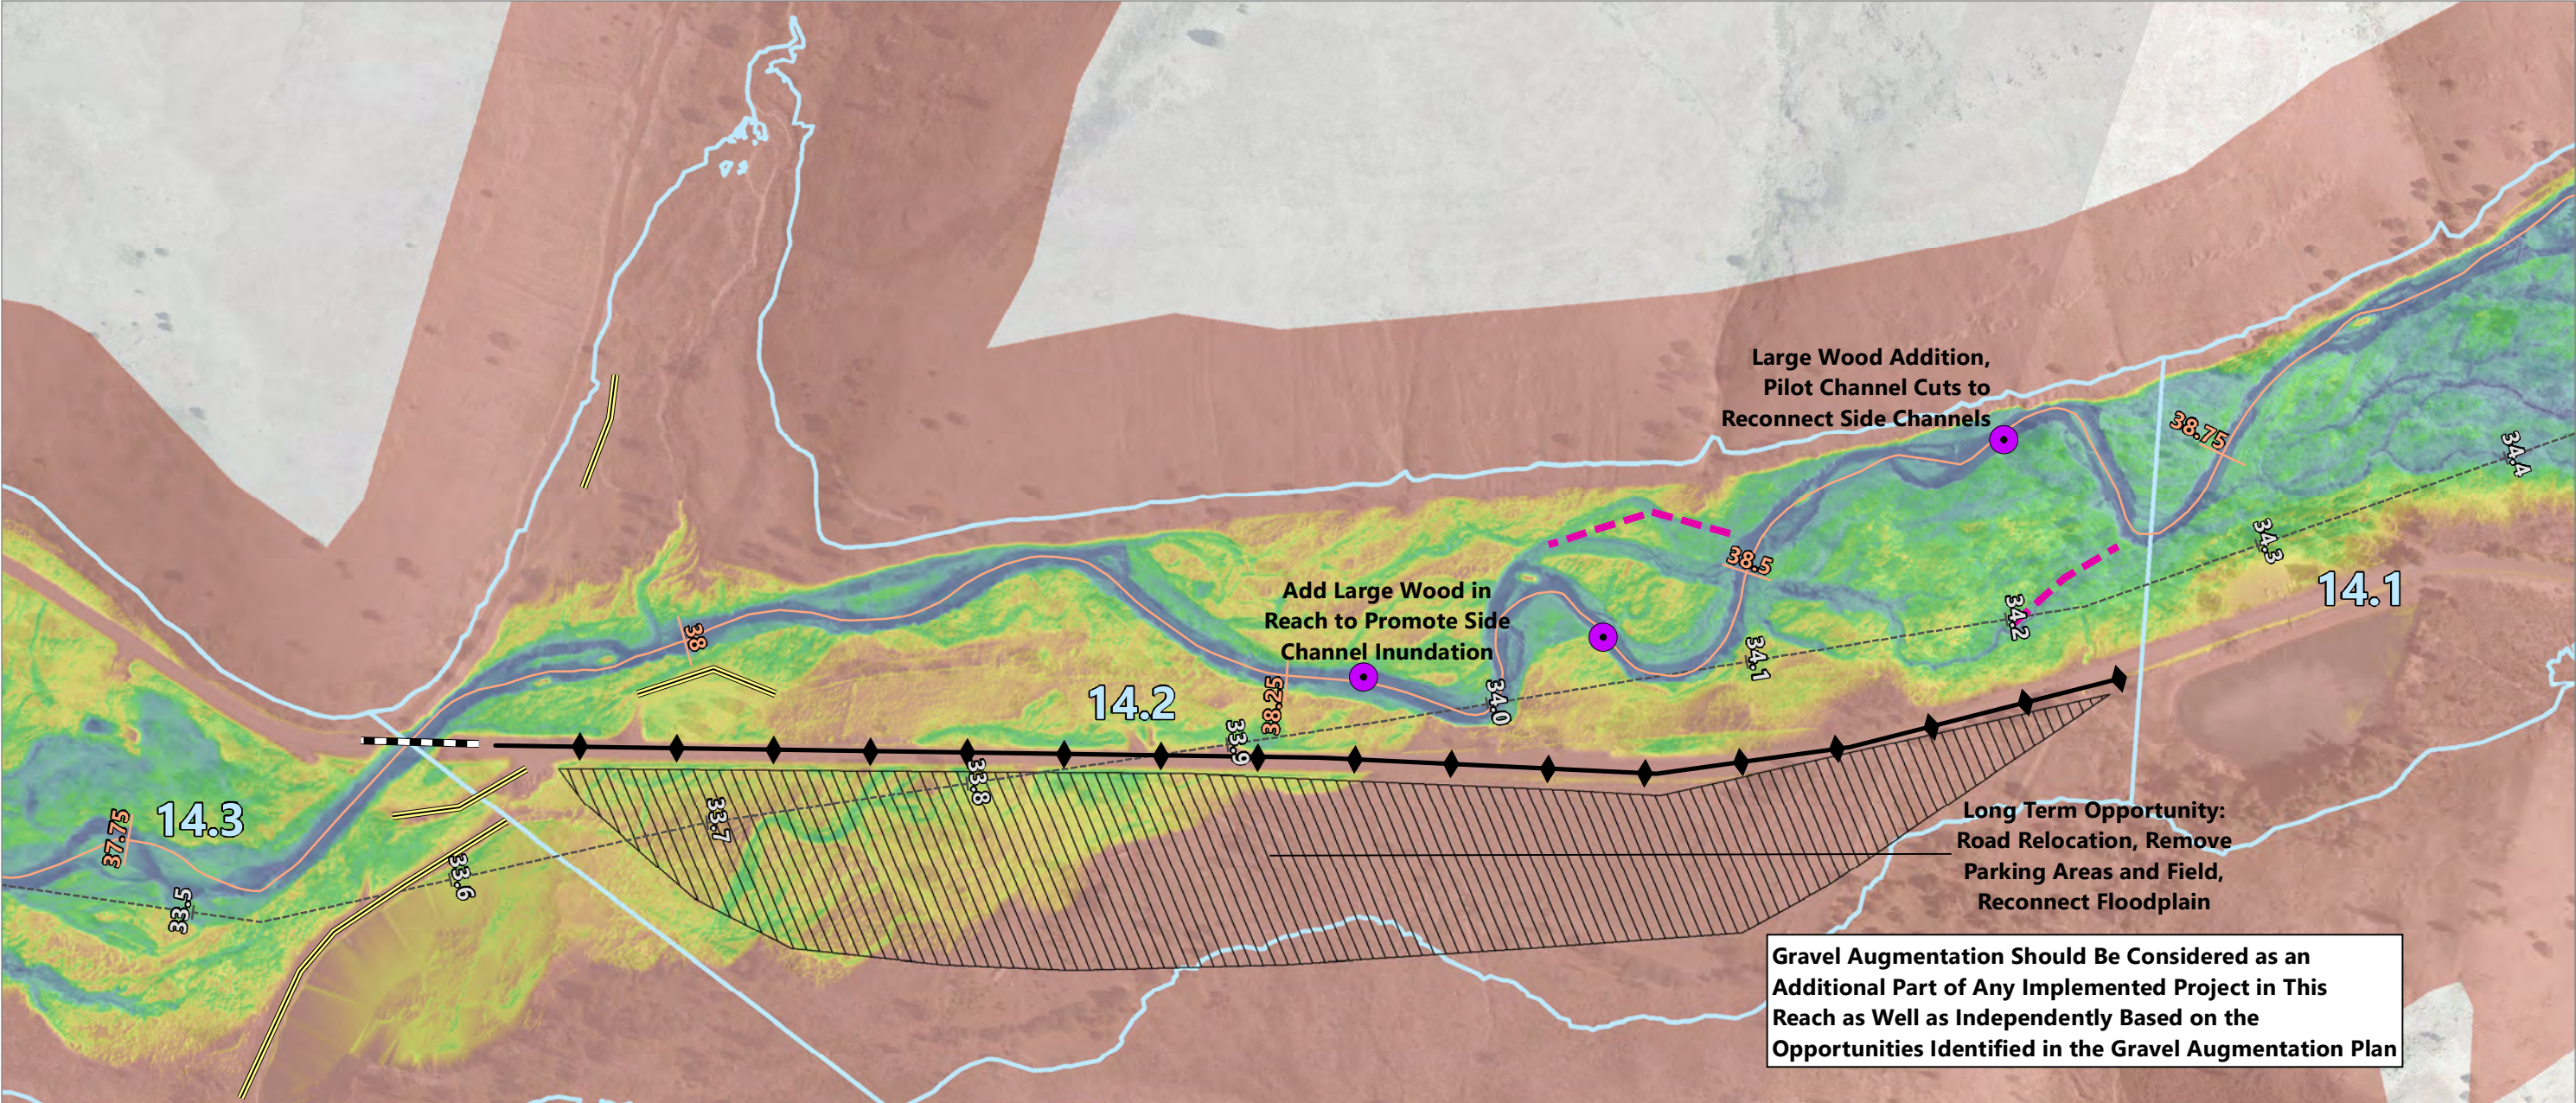
Analysis of the difference between the 2010 and 2017 LiDAR data shows multiple locations of significant geomorphic change, many of which were likely caused by the restoration actions in the reach. At the beginning of the reach, a large erosional area in a sharp bend has formed a deep pool and is associated with bar building on the right bank. This change does not appear to be forming as a result of a restoration structure (box 1).

Near the middle of the reach, a large mid-channel engineered log jam has caused a large depositional area both immediately upstream of the log jam and downstream on the left bank. A small area of bank erosion likely from scour is located on the left bank next to the log jam (box 2). This log jam is one example of several mid-channel structures in this reach that have caused localized geomorphic change, not all of which have been highlighted for this narrative.

Immediately downstream of here, a bank barb type structure on the left bank has caused some localized erosion on the left bank and a depositional bar building on the right bank (box 3). The next highlighted area occurs around the next bend, and includes another mid-channel log jam, but this time with a large depositional area immediately upstream. On the bank immediately behind this log jam in the same area, erosion has occurred in the start of a floodplain side channel (box 4).

At VM 34, a series of channel-spanning log jams and a left bank log jam has caused bank erosion on the right bank and deposition on the left bank. Some minor bar building has occurred immediately downstream of these log jams on the right bank and is associated with erosion on the left bank (box 5). The next channel-spanning jam has also caused erosion and a minor avulsion to the right bank (box 6).

Finally, at the downstream end of the reach and downstream of Cummings Creek, two large engineered log jams have caused a major avulsion towards the right bank (box 7).

However, based on the relative elevation map, several side channel opportunities exist between the bends in these reaches. While wood structure has already been added to this reach, it was noted during field observations that several long stretches could benefit from more wood structure. The primary enhancement strategy for this reach should be to connect

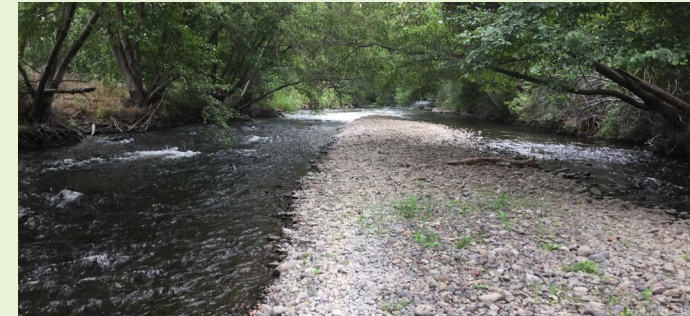
### Project Area 26

Looking downstream near the upper end of the 3-mile project area in July 2019. Note mobile gravel material forming the mid-channel bar.

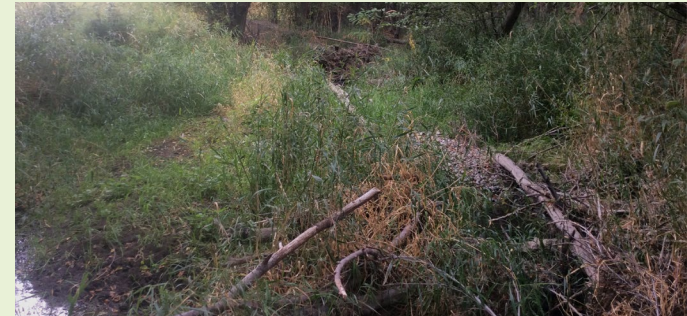
### Project Area 40

**Side channel opened up as part of PA 40 project, no flow was present at time of site walk but would be connected at a slightly high-flow stage.**

A high-flow channel splits off on the right bank in a location where the old levee has been breached. At the head of this channel is a large rootwad structure that has accumulated some debris and sediment that is partially blocking the side channel. While this channel was not flowing at the time of the site visit, it likely sees slightly higher flows than what were noted when the 2017 aeries were taken in April. This channel runs along another old levee on the right bank that separates it from another low spot in the floodplain before reaching the new, well-maintained levee that currently protects the field on the right bank. There is a large amount of in-channel wood, structures, and channel complexity when there is flow. This channel has been opened up to high flows, but more floodplain on the right bank is available for access.

The opening to the side channel established during the last restoration effort was observed to be partially blocked during the 2018 site visit. To address the complexity in this project area, a management strategy should be to ensure that this side channel allows perennial flows. In addition, the island created by this side channel contains several low-winter flow paths easily visible in the relative elevation model. Some high banks may need to be removed to establish perennial connection. Reconnecting these side channels through pilot cuts and adding instream wood to push flow into these channels should be a targeted enhancement strategy. Finally, the main channel through PA 40 is plane-bed and uniform with very little in-channel structure. Regardless of other restoration enhancement strategies that may be pursued, adding instream structure and LWD should be the primary restoration enhancement strategy pursued in this project area.

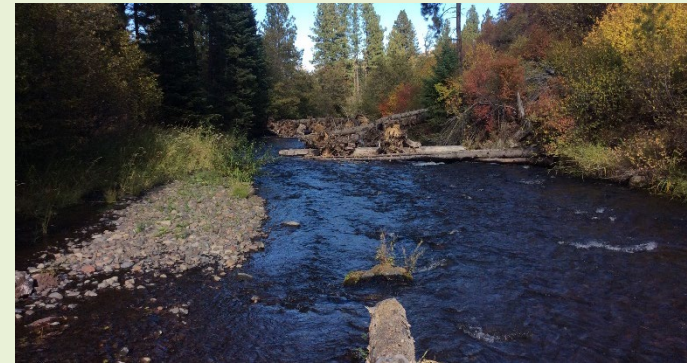
### Project Area 8

**Large engineered log jams interacting with flow at the upstream end of PA 8.**

A large log jam has caused a split flow towards the left bank, where bank erosion has occurred as the channel pushes into the left bank floodplain. Before the side channel confluence, a mid-channel bar has formed with noticeable deposition. Just downstream of the confluence, a channel-spanning log jam has

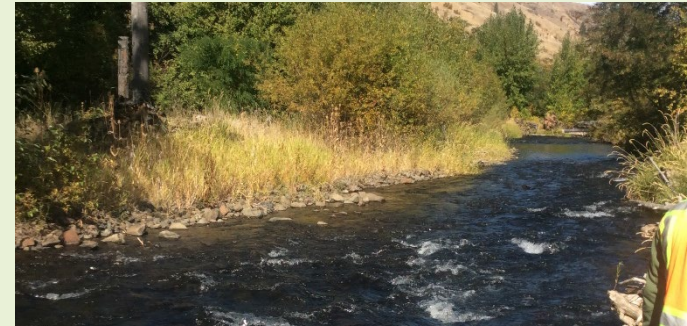
#### Project Area 10.3

**Floodplain structure near the upstream end of the long side channel that was reconnected as part of restoration work in PA 10.3.**

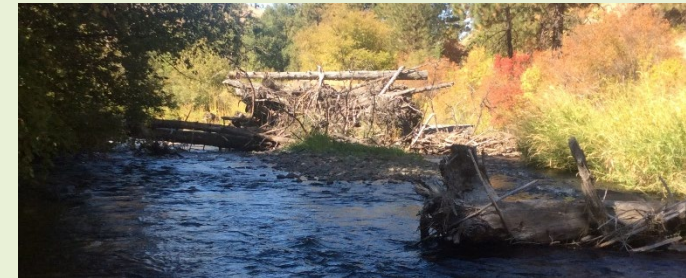
### Project Area 14.1

At the time of the site visit, the first engineered log jam at VM 34.71 had split flow as was designed, but accumulated woody material prevented any significant flow on one side. The side channel at VM 34.68 carries perennial flow. However, at VM 34.65, a side channel that was intended to be inundated for most of the year was completely dry and did not appear to be inundated during yearly flow events. A log jam on the right bank just downstream from this side channel opportunity was noted to be disengaged from the channel at this flow level but was close enough that it would likely be engaged during higher flow events.

**Looking downstream at an apex engineered log jam, a small amount of flow is present on the right side of the structure but has been partially blocked by woody material.**

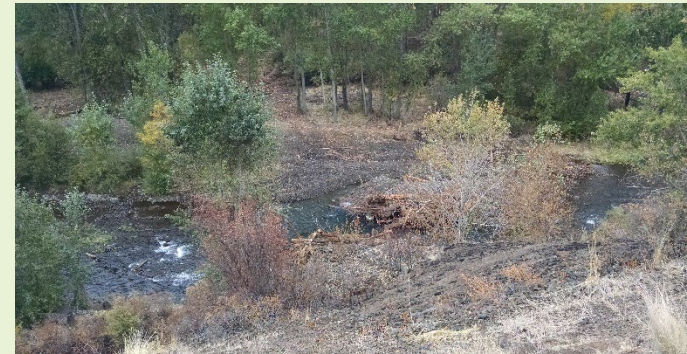
### Project Area 15.2

**Apex engineered log jams in PA 15.2, as seen from a nearby high vantage point.**

The first two locations of significant geomorphic change are related to the two large engineered log jams located in the main channel. Both log jams exhibit deposition in the wake of the structure and scour erosion along the sides. There are other examples of this type of change but not all have been noted in this narrative (boxes 1 and 2).

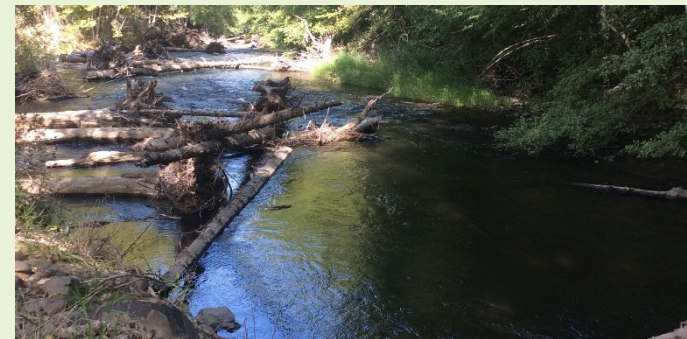
### Project Area 18.1

**Recently installed rootwad logs and large woody debris structures interacting with flow.**

Because of this recent avulsion, the geomorphic reaction to many of the structures has been mixed. Several structures have deep scour pools even around single log placements, often associated with a stretch of gravel bed material. Other structures have been placed on cobble and boulder material and have not caused much pooling. Because restoration work was so recent, it is possible that there has not been enough time or enough transport flow events to have caused significant change.

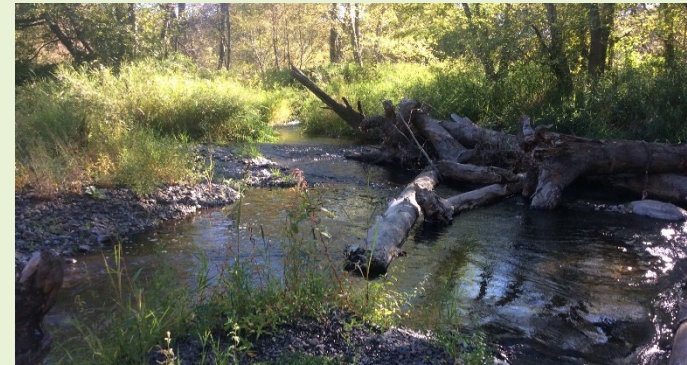
### Project Area 28.2

**Complex flow around an engineered log jam near the upstream end of PA 28.2.**

Finally, a large channel-spanning log jam and engineered apex jams have allowed deposition in the floodplain to either side of the log jam in one of the channels. Additionally, scour pools and erosional areas can be seen behind the two main log jams. (box 4). It should be noted this reach has a large amount of geomorphic change, not all of which is discussed as part of this narrative. For a complete picture of the geomorphic change analysis, see the GIS layers provided as part of this assessment.

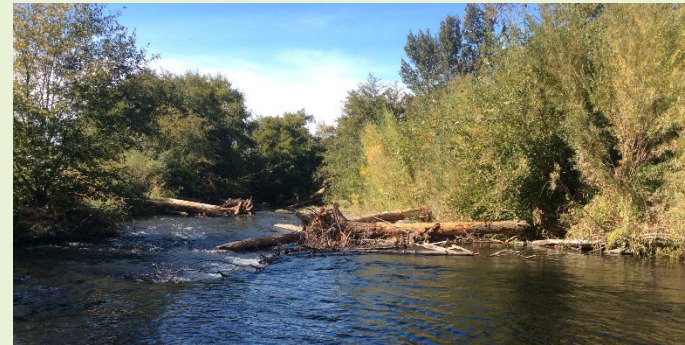
### Project Area 28.3

**Alternating engineered bank structures in a confined section of PA 28.3.**

event. An avulsion in this area was noted as having been reinforced with large woody material as part of recent restoration actions and may help to connect this area given more time for geomorphic change. Reports indicate that some of this change has occurred; however, if the ELJs begin to fail or disintegrate, remediation actions should be taken to maintain this inundation.

- Gravel augmentation
- Maintain side channels and LWD structures.

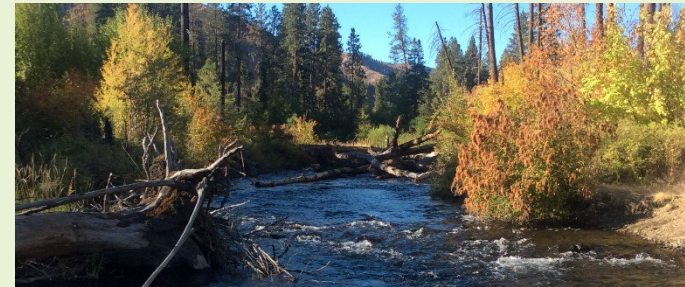
### Project Area 10.1

**Placed large woody material interacting with flow at the upstream end of PA 10.1, near where a large avulsion has caused much of the downstream aggregation, complexity, and floodplain connection.**

- Gravel augmentation
- Reconnect side channels and disconnected habitats
- Add instream structure (LWD)

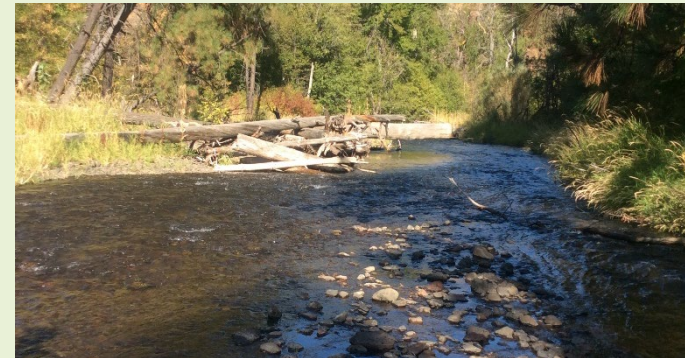
### Project Area 10.2

**Engineered log jam on left bank with wood recruits forcing flow towards the right bank.**

Downstream of here, a bank barb type log jam has caused bar building and channel aggradation immediately upstream of the log jam along with erosion on the outside bank (box 2). There are several more minor instances of similar processes occurring that are evident but have not been highlighted for discussion here. At VM 38.06, it appears the steep right valley wall is experiencing some bank failure and the material falling off the bank is evident as aggradation in the change analysis. It is unclear if this is occurring due to the log jam placed near the bend (box 3).

This reach has already been treated with wood placements and engineered log jams; however, based on field observations and the aerial imagery, it is likely that more wood and instream structure is needed in this reach. The work here was completed when unanchored wood placement was very new and at a density not tried in southeastern Washington at the time. Wood placement was conservative by current standards. Additionally, some of the placed materials are beginning to deteriorate and supplementation to the amount of wood would

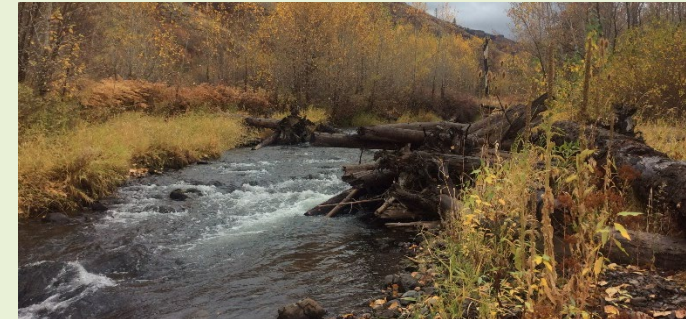
Publish Date: 2021/01/25, 3:42 PM | User: mgieschen  
Filepath: \\orcas\gis\Jobs\TucannonRiver\_1006\Maps\Conceptual Maps\Tucannon Treated Project Areas\_mg.mxd

The upper reach of PA 11.1 is still relatively plane-bed and uniform. At VM 37.35, a foot bridge from a parking lot to Watson Lake limits the floodplain with large riprap levees. Watson Lake itself takes up a large portion of the floodplain, loosely confining the channel in this section. At VM 37.25, just across the from the lake, the channel flows very close to Tucannon Road. Just downstream, a large mid-channel bar introduces some complexity. Further downstream, left bank erosion is evident where some instream wood has been placed.

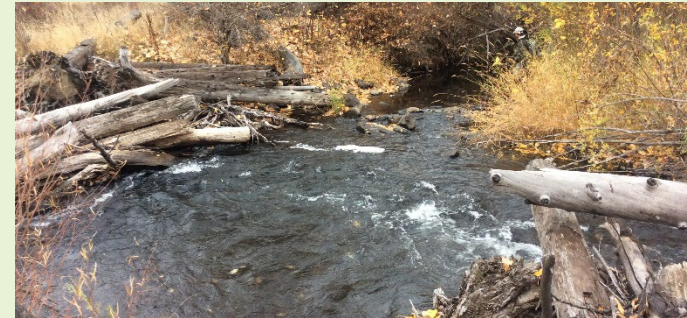
At VM 36.66 is a massive log jam in the floodplain on the right bank and several split flows and side channels just upstream of this location. A major flow path was observed to the right of this structure and a split flow to the left with several associated log jams. The side channel to the right flows for most of the remainder of the project area before joining with the main channel. A second side channel bisects the island at VM 36.45 and flows into this side channel, increasing the amount of

**Engineered log jam with accumulated woody material is causing a deep scour pool, split flow, and floodplain inundation.**

PA 11.2 would most benefit from a restoration management strategy, monitoring the connectivity and complexity of the reach and making changes if these levels are not maintained. Should complexity ever begin to decrease, it may be necessary to supplement the sediment supply to the reach with gravel augmentation and it may be possible that this reach is included as a larger gravel augmentation plan including multiple reaches, which would not damage the existing good complexity of the reach.

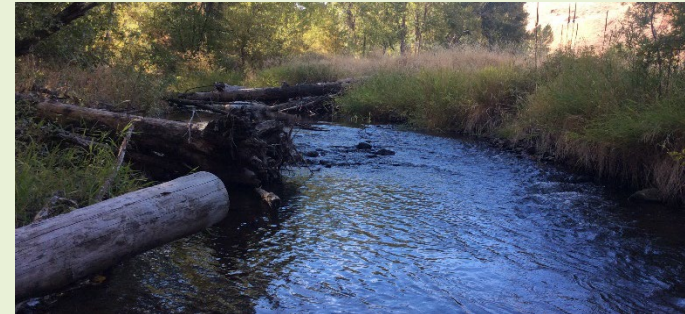
**Placed large woody material is interacting with flow in the side channel that has opened up as part of restoration work.**

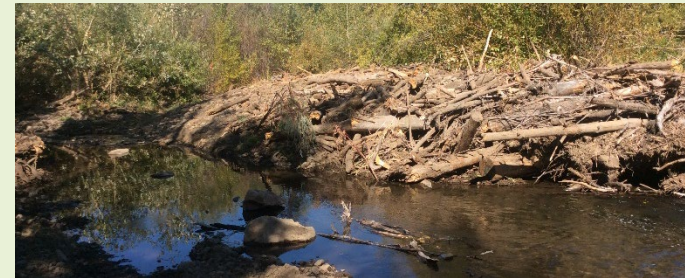
**Engineered log jam with accumulated small woody debris. The main flow is to the right of the structure and the backwater seen on the left forms a side channel at higher flows.**
