Meacham Creek Watershed Assessment and Action Plan

Summary

Prepared for the Confederated Tribes of the
Umatilla Indian Reservation

Prepared by Chip Andrus, Water Work Consulting
503.606.0575
andrusc@worldnet.att.net

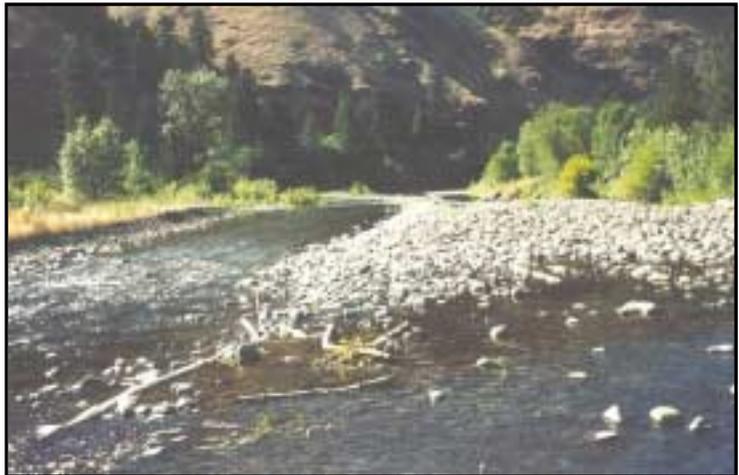
Meacham Creek at river mile 3.3 (reach 4a).

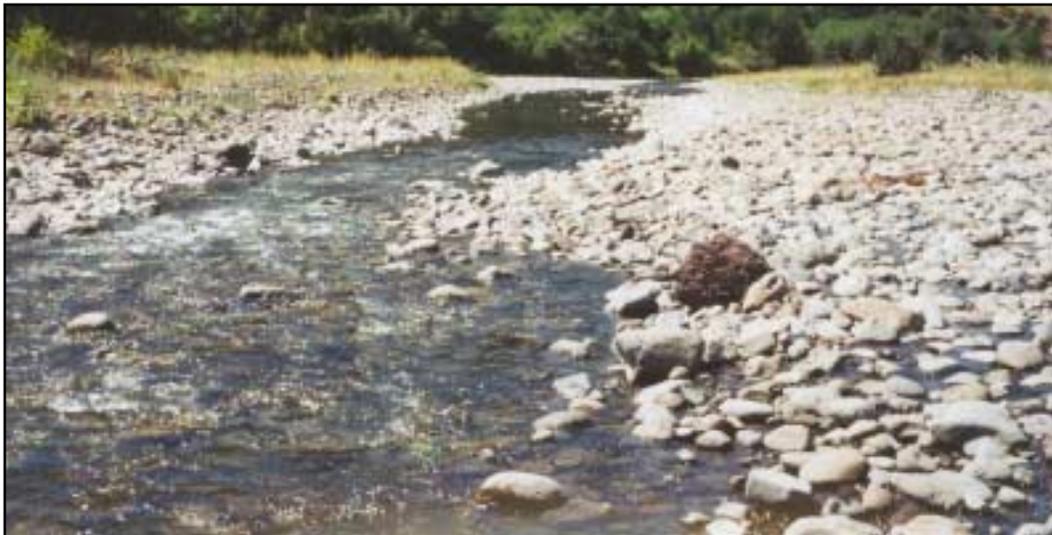
Meacham Creek at river mile 8.2 (reach 4b).

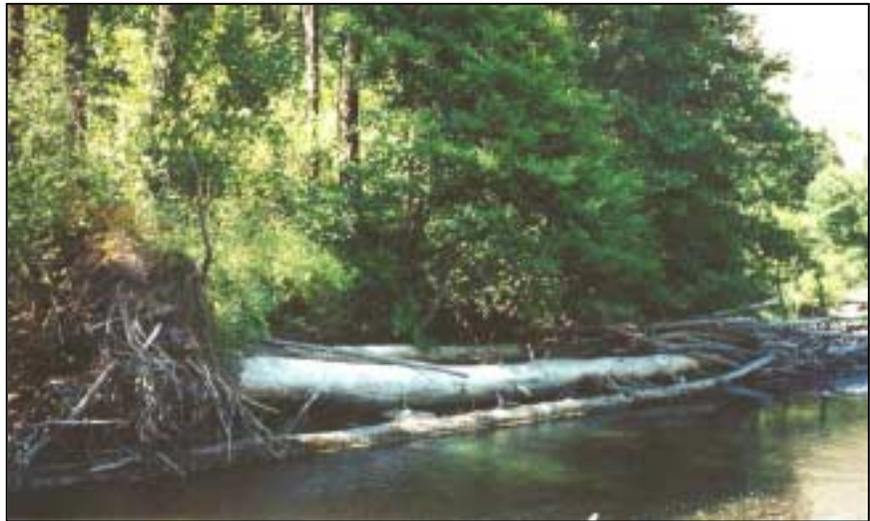
Very good fish habitat created by placed logs near river mile 2.5.
