## APPENDIX J.2 TIER 1: UNTREATED PROJECT AREAS

## Project Area 2 Description

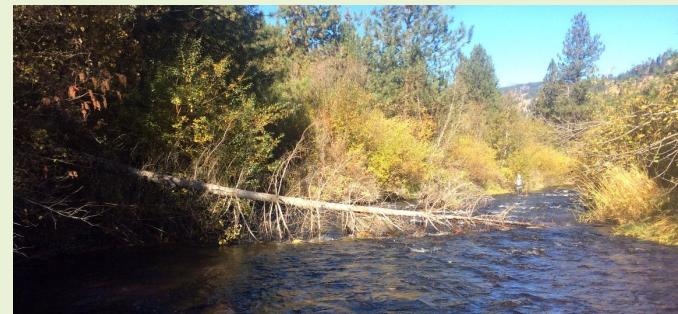
### Project Area 2

**Looking downstream at a single-thread, plane-bed channel. The single piece of wood is unlikely to stay in place for long.**

Additionally, long stretches of PA 2 are a single-thread, plane-bed channel that, at a minimum, could be improved to have more in-channel complexity with split flows, mid-channel bars, and wood features. Channel dynamics in these stretches should be promoted through the addition of instream wood to the main channel, separate from pilot channel cuts. During field observations, bed material in this reach was noted to mostly consist of large cobbles and boulders. For this reason, as well as the desire to raise the bed elevation, gravel augmentation

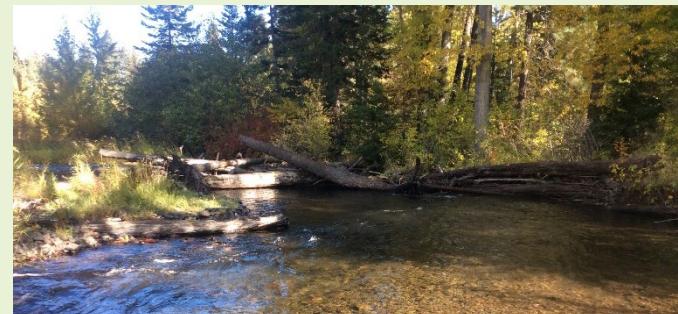
### Project Area 5

**Looking downstream at a large, natural, channel-spanning log jam forcing planform complexity, including an upstream pool and left bank high-flow path.**

Downstream, several more large, channel-spanning log jams have caused split flows, side channels, and excellent complexity. Deposition has occurred in the channel upstream of the channel-spanning log jam, and the channels downstream show signs of erosion and deposition causing more complexity and instream wood recruitment (box 2). Additional erosion and deposition as a result of another log jam has occurred just downstream of here (box 3).

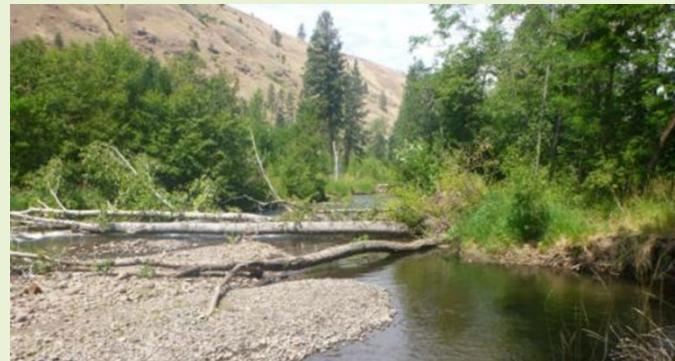
### Project Area 14.3

**Photograph taken from the 2011 prioritization showing wood recruitment in the channel.**

In PA 14.3, riparian trees are mixed deciduous and conifers, dominated by alder, cottonwood, locust, and ponderosa pine. Some areas contain several snags, dying trees, or burnt mature trees. In 2011, this reach was populated by several very large mature cottonwoods, some of which were being actively

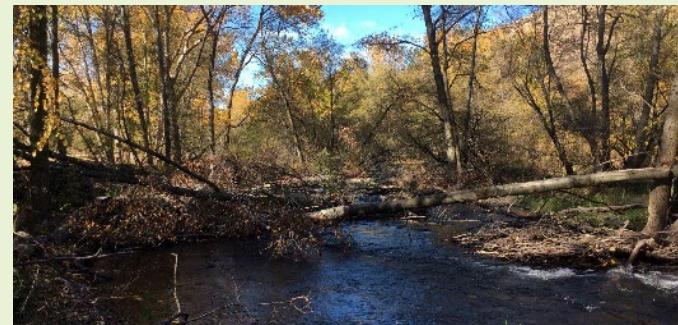
### Project Area 20

**Looking downstream, multiple pieces of instream wood and channel avulsions have caused floodplain connectivity and complexity.**

Regardless of the source, the deposition has caused major channel avulsions in the downstream half of the reach, with erosional areas on first the left bank and then the right bank as the channel begins to meander. These erosional areas are likely the source of the woody material observed during site visits throughout the reach. It is evident that the woody material has caused further erosional change downstream, and at about halfway down the reach the channel has left the location it occupied completely and moved into the right floodplain, creating split flow conditions at all but the lowest flows (boxes 2 and 3).

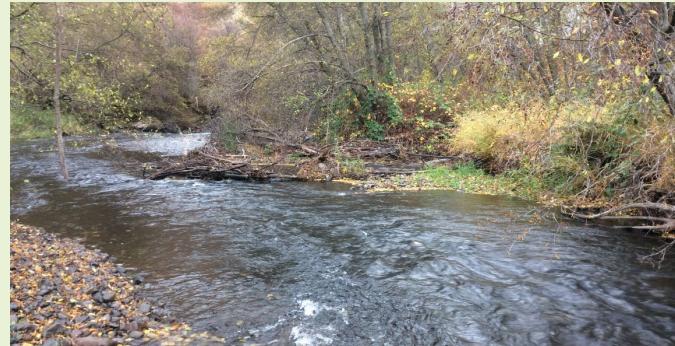
### Project Area 25

**Location of channel erosion on the right bank and bar build on the left bank.**

PA 25 is a short reach and experienced only one significant location of geomorphic change based on analysis of the difference between the 2010 and 2017 LiDAR data. This change occurs near the middle of the reach and was noted during field observations to correspond with the location of a channel-spanning log jam, with significant deposition upstream. In this location, erosion of the left and right banks is apparent (box 1). Additionally, patches of aggradation upstream of this location are evident in both the floodplain and main channel, particularly in a right bank side channel, and may represent deposition due to the log jam. Just upstream of the log jam a point bar is building along with erosion on the left bank.

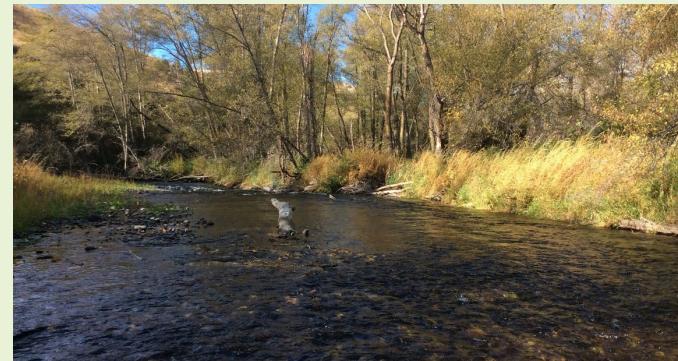
**Upstream end of side channel on right bank, looking downstream on PA 27.**

The upper and lower sections of the reach are pinned on the left bank against the bedrock valley wall, providing poor habitat conditions and little opportunity for geomorphic processes to progress. On the right bank, and on the left bank where not bounded by the valley wall, the floodplain is moderately accessible with established vegetation including cottonwoods and alders. Some wood has been recruited recently, forcing small side channels into the floodplain. The site photograph in the sidebar shows the upstream end of one such example. One

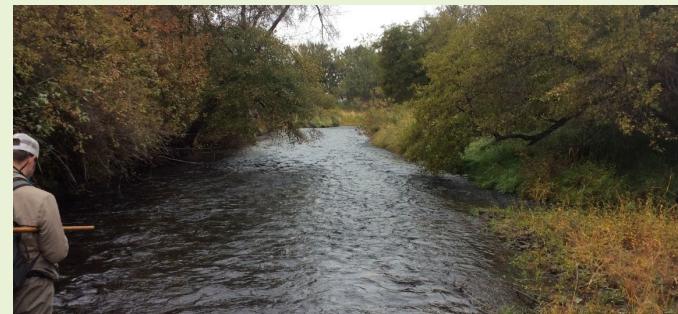
**Sparse riparian vegetation up against the left bank valley wall. On the right a small split flow is returning from upstream.**

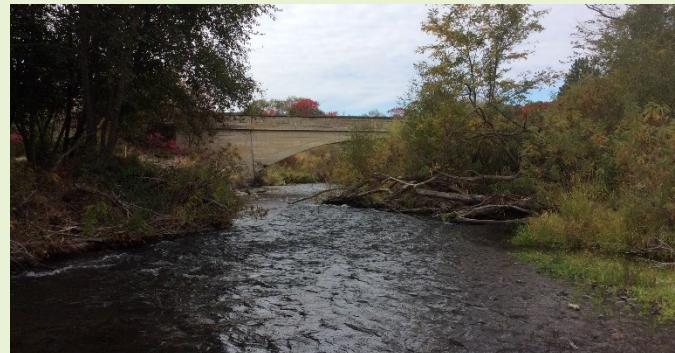
**Downstream end of PA 32.2 showing woody material on banks and instream complexity.**

A large channel-spanning log jam near the downstream end of the reach has caused multiple geomorphic changes in the immediate area; while the channel here is complex with multiple flow paths, these changes may be unstable in the future.

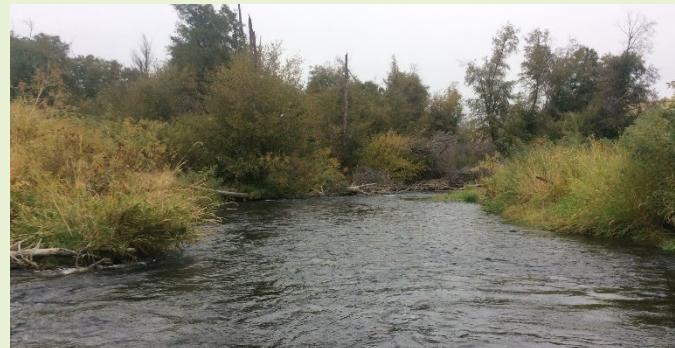
**Looking downstream from PA 40 to the log jam and avulsion at the beginning of PA 41.**

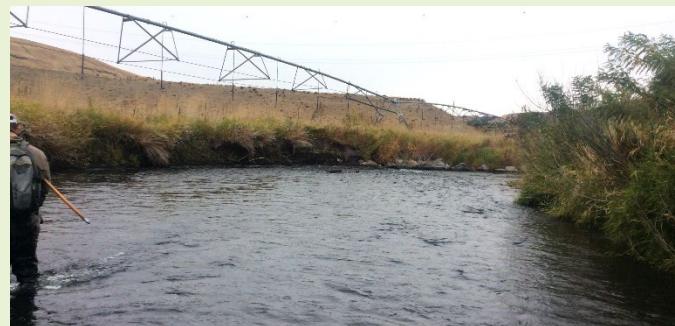
**PA 44 mid-reach, looking downstream at erosion into a field on the left bank on the outside of a meander bend.**

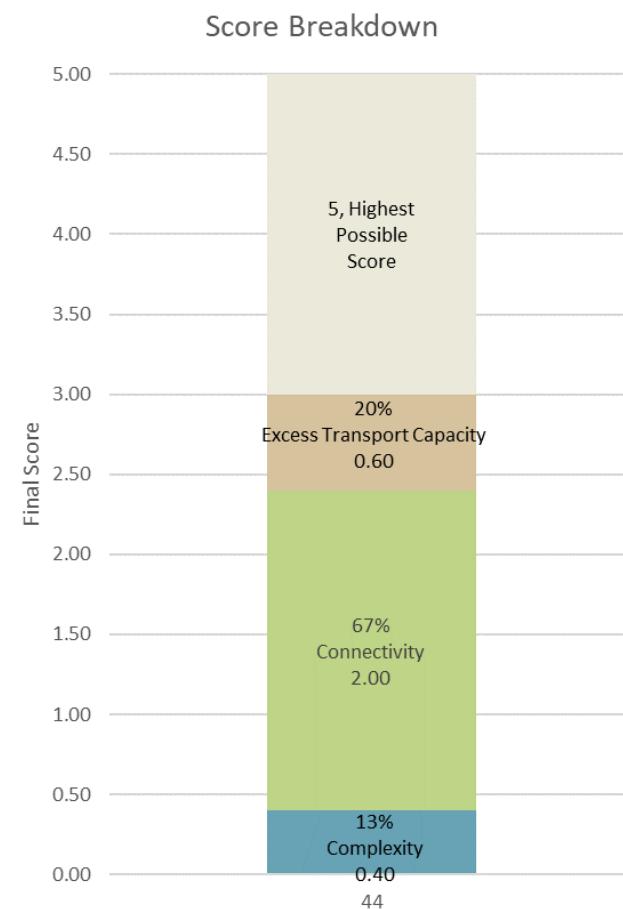
### PA 44 Score Breakdown

This score breakdown shows how the three prioritization metrics contribute to the final prioritization score.

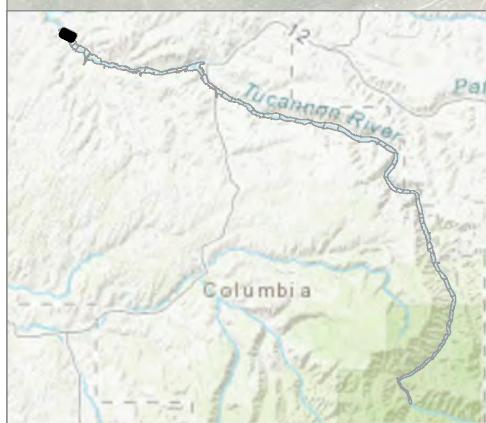
## PA 44 Prioritization Ranking

- Horizontal datum is WA State Plane South, NAD83, U.S. Feet.
- Vertical datum is North American Vertical Datum of 1988, feet.
- Aerial Imagery provided by GeoTerra. Flown April 19, 2018.
- LiDAR elevation data provided by QSI (2018).

5. The conditions and opportunities in this map are based on LiDAR and aerial imagery from 2018. Flood events and geomorphic changes have occurred since then and may have changed the topography relative to what is shown.

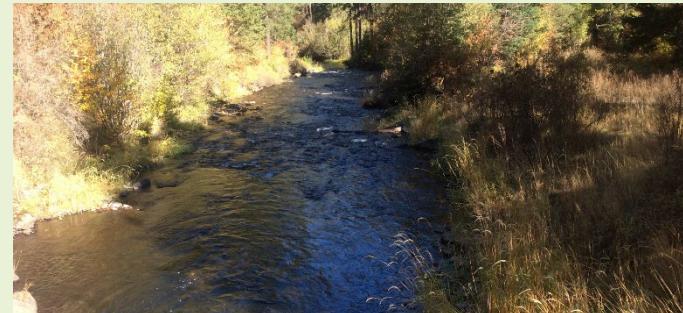
### Project Area 3.1

**Plane-bed, straight, and uniform section of river with little instream complexity. View is from the bridge upstream of PA 3.1 and looking downstream.**

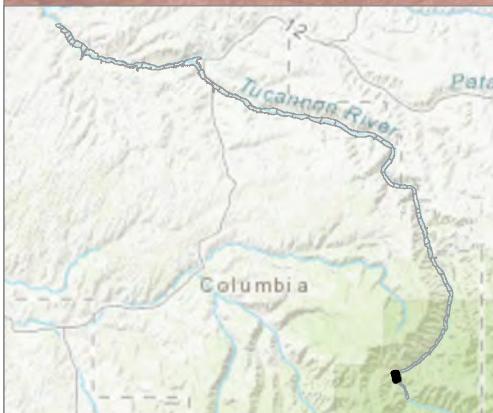
## PA 3.1 Prioritization Ranking

- Tucannon Project Areas
- Tucannon River Centerline
- Tucannon Valley Line
- Delineated Levees
- Bridges Limiting Channel Migration
- Wood Addition Throughout Project Area
- Reconnect Side Channel

5. The conditions and opportunities in this map are based on LiDAR and aerial imagery from 2018. Flood events and geomorphic changes have occurred since then and may have changed the topography relative to what is shown.

- Gravel augmentation
- Reconnect side channels and disconnected habitats
- Add instream structure (LWD)

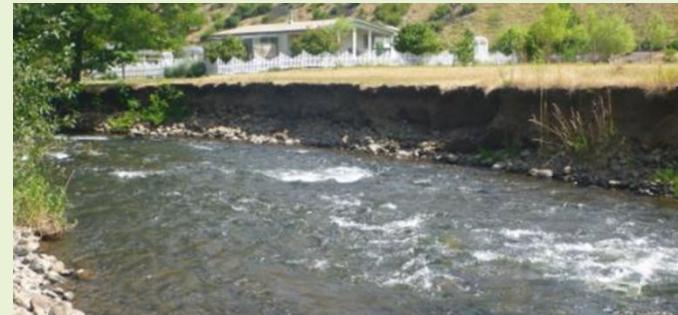
### Project Area 16

**Photograph taken from the 2011 prioritization showing bank erosion adjacent to a private infrastructure, looking across at the right bank.**

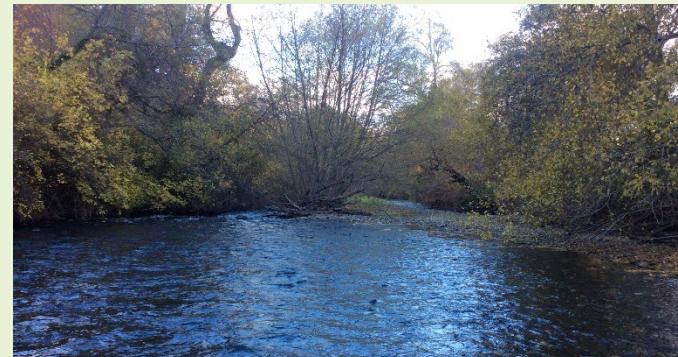
### Project Area 19

**Looking downstream at a split flow around a vegetated island with good riparian cover.**

The river through PA 19 is characterized as a single-thread, plane-bed channel. The channel is wide and shallow with little complexity. The 2011 assessment noted that a rock-armored levee was located along the right bank, and other large boulders and riprap were observed along the left bank upstream of the bridge. The bridge abutments were lined with corrugated steel sheeting. The bridge span and low chord elevation created a narrow opening beneath the bridge. This was likely constricting the river during high flows and creating high velocities through the bridge opening and on the downstream side. The bridge appeared to be old and in disrepair. No available off-channel areas other than a minor flow split near RM 32.0 were observed in this project area.

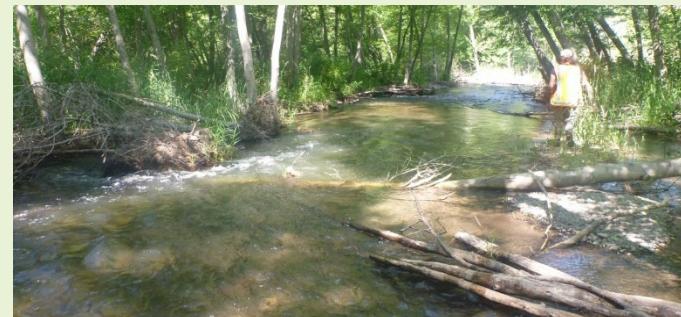
### Project Area 28.1

**Photograph taken from the 2011 prioritization showing forced pools and riffles near the upstream end of the reach.**

The channel through PA 28 contains primarily a dynamic, multiple-thread channel with forced pools, riffles, and rapid sections. The 2011 assessment noted that, for the majority of this reach, the channel was actively migrating and aggrading. Several recently recruited trees and newly formed side channels were observed throughout this area, along with a high volume of temporary sediment storage in the form of gravel point bars and islands. Deep pools were observed at rootwad logs, larger log jams, and along the outside of meander bends. One engineered log jam was observed that contained a very large pool and ample cover that many fish were utilizing. This section of the project area did not contain any significant bank

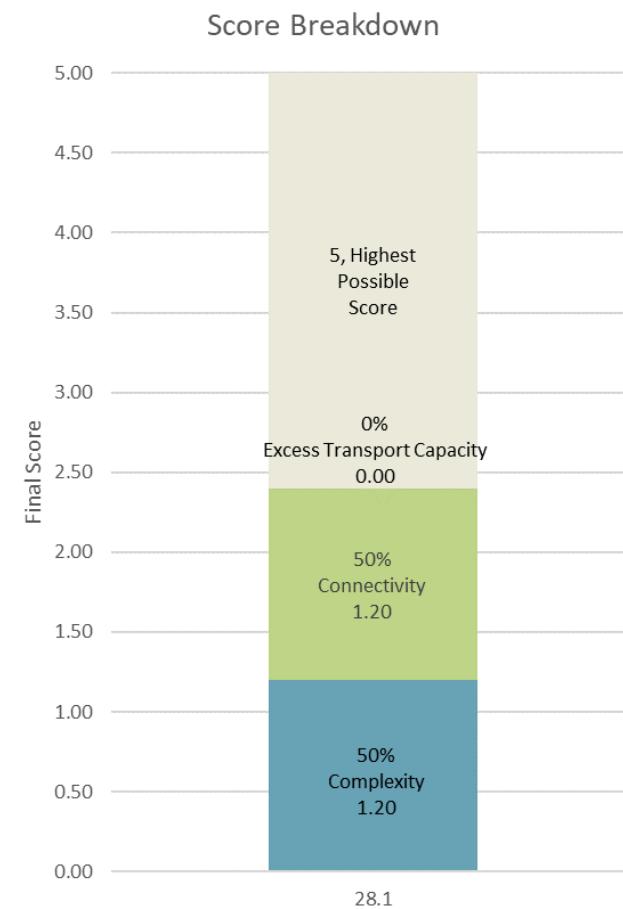
### PA 28.1 Score Breakdown

This score breakdown shows how the three prioritization metrics contribute to the final prioritization score.

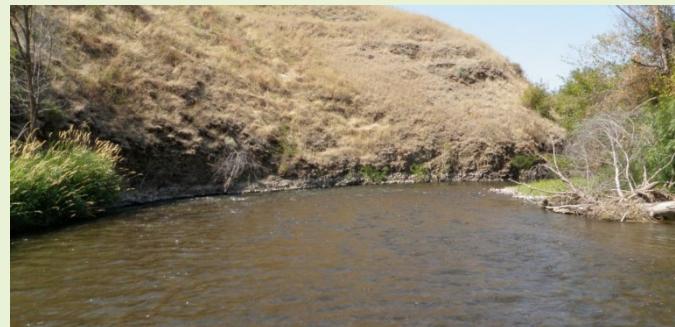
### Project Area 31

**Photograph taken from the 2011 prioritization showing the plane-bed channel with a bedrock bank, looking downstream.**

The river through PA 31 is primarily characterized by a low-sinuosity, single-thread, plane-bed channel, with local areas of split flow, LWD, or bedrock-forced pools, and depositional areas. The 2011 assessment noted that the project area was highly influenced in places by bedrock outcrops along the left bank and in the channel bed. Bedrock maintained the grade of the channel and controlled the left bank along the valley wall. Pools were found throughout the project area and were associated with bedrock, armored banks, and locally recruited LWD. In the upper extent of the project area, the channel was highly confined between the valley wall (along the left bank) and levees and revetments along the right bank. Minimal bedrock was exposed along the channel bed in this confined segment.

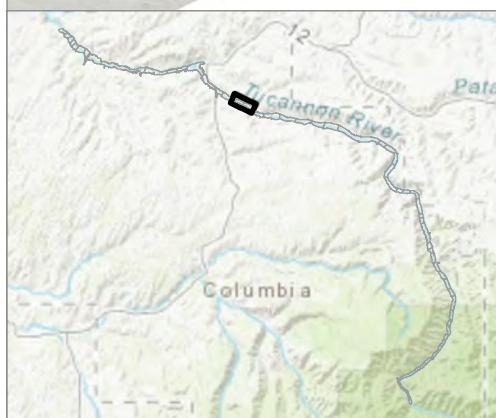
## PA 31 Prioritization Ranking

- Tucannon Project Areas
- Tucannon River Centerline
- Tucannon Valley Line
- Delineated Levees
- Bridges Limiting Channel Migration
- Wood Addition Throughout Project Area
- ▨ Reconnect Floodplain or Levee Setback Potential

5. The conditions and opportunities in this map are based on LiDAR and aerial imagery from 2018. Flood events and geomorphic changes have occurred since then and may have changed the topography relative to what is shown.

A short distance downstream of here, a log jam and mid-channel bar have caused a small side channel where significant erosion has occurred in the left bank floodplain. Deposition is seen shortly downstream of here and is likely the sediment sourced from the upstream erosion (box 2).

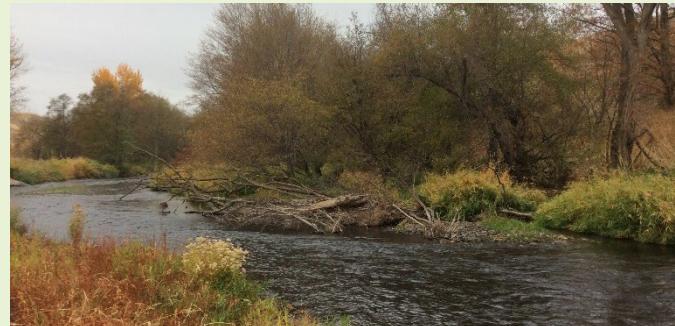
### Project Area 34.2

**Instream wood from an upstream avulsion is forcing water towards the right bank where the channel is migrating into the floodplain with sparse vegetation.**

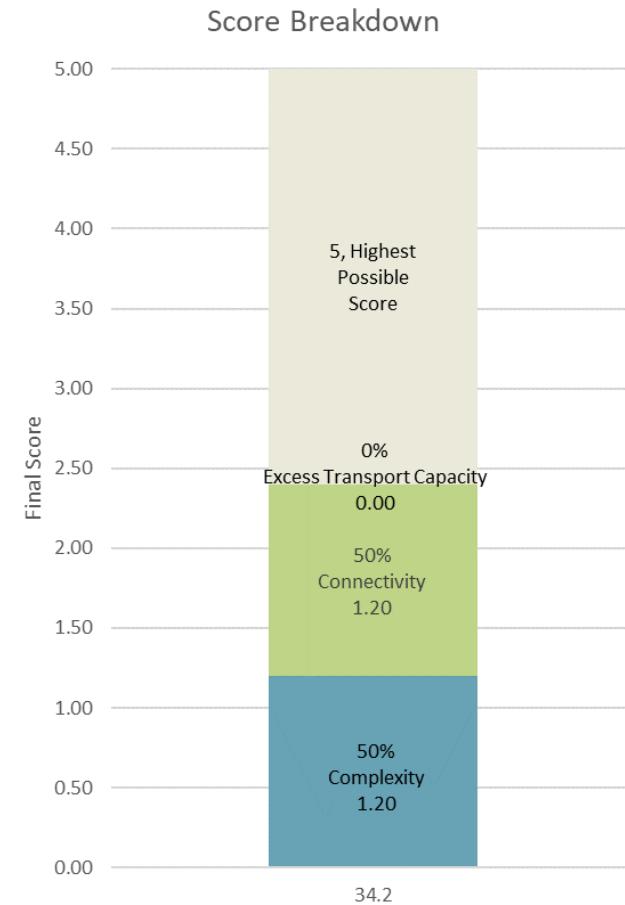
#### PA 34.2 Score Breakdown

This score breakdown shows how the three prioritization metrics contribute to the final prioritization score.

PA 34.2 also receives a low score in the Connectivity metric, indicating that it ranks in the 25th to 50th percentile of all project areas. This low score is driven mostly by the Encroachment Removal analysis result, which ranks PA 34.2 well above average. The opportunity for encroachment removal exists almost entirely at the upstream end of the project area. A large portion of the floodplain that appears to be outside of the agricultural fields nearby, based on the 2018 aerial imagery, is disconnected by a levee that extends from the road and bridge at the upstream end of this project area. It should be noted that this levee has been built up since 2011, as noted in the LiDAR change analysis above. Reconnection of this area

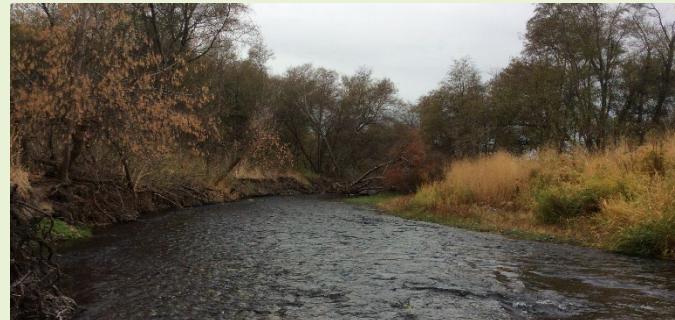
### Project Area 35

**The reach is confined by a levee on the left bank in PA 35. The instream wood seen in the distance has fallen in from the old levee.**

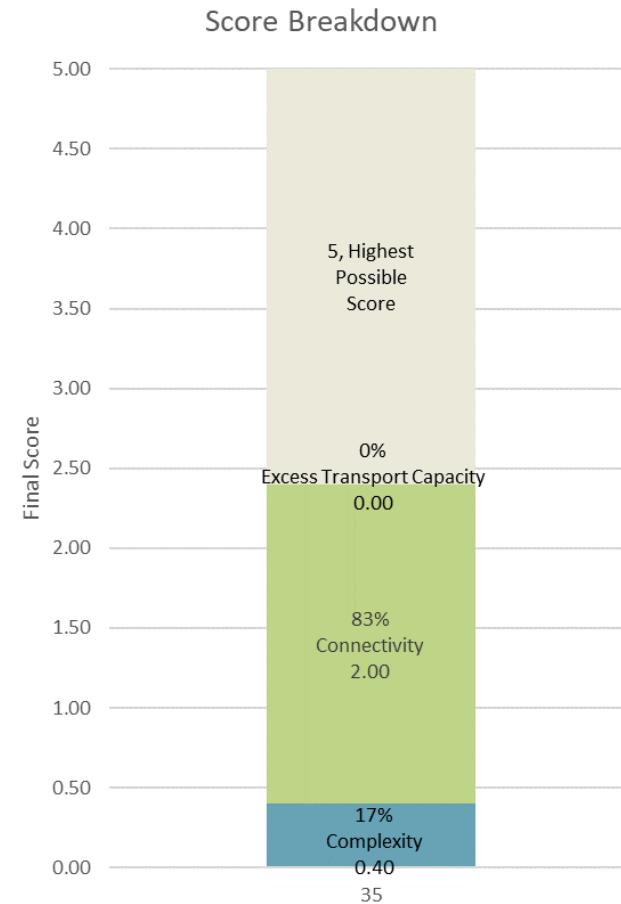
#### PA 35 Score Breakdown

This score breakdown shows how the three prioritization metrics contribute to the final prioritization score.

Another reason to consider the gravel augmentation restoration strategy is to promote complexity throughout the reach. PA 35 receives a low score for the Complexity metric, indicating that it ranks in the 10th to 40th percentile of all project areas, and complexity in this reach may be difficult to achieve. Complexity ranks well below average in all three flows for this project area, and the little complexity that does exist consists of a few in-channel split flows. However, gravel augmentation, along with adding instream wood structure, could greatly improve the

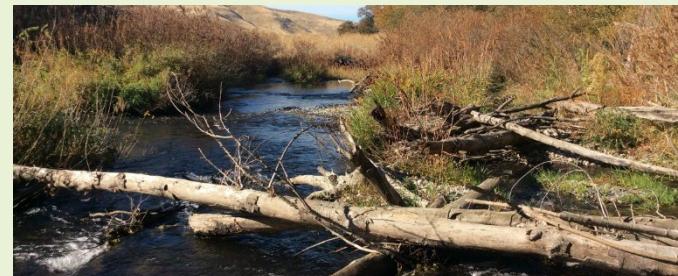
### Project Area 36

**Natural wood material in the river downstream of a large avulsion through the floodplain trees. This section of riparian habitat has thick undergrowth but very few mature trees.**

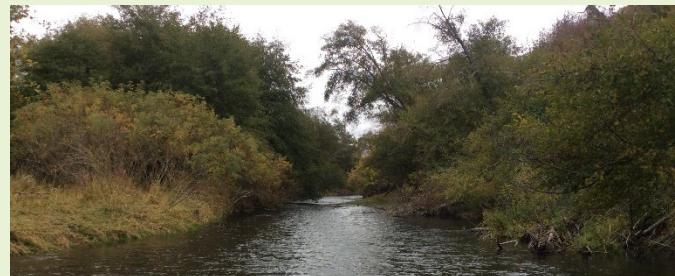
### Project Area 38

**Looking upstream near the upstream end of the reach at a straight, plane-bed channel with fringe floodplain pockets behind levees (left) and high banks (right).**

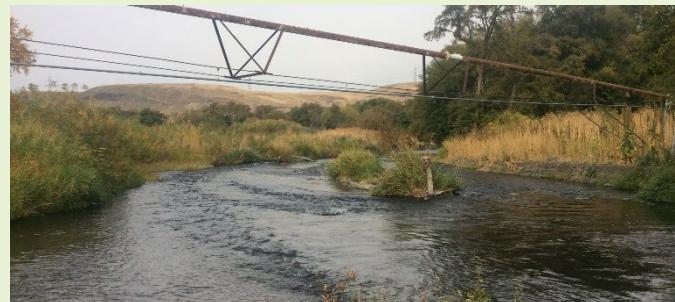
### Project Area 42

**Looking downstream at an irrigation pipe crossing. The channel has complex planforms but little instream wood and poor riparian cover.**

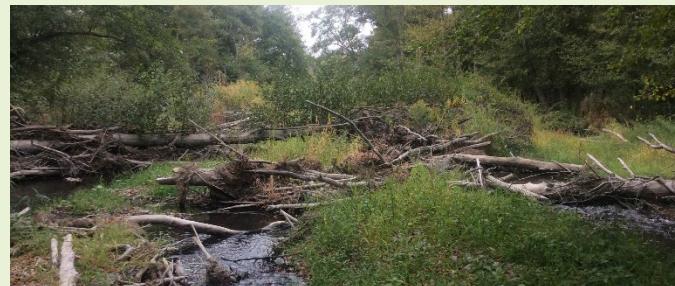
### Project Area 43

**Looking downstream at a recent avulsion area with multiple areas of channel-spanning woody material. This section of PA 43 was extremely complex at the time of the site visit.**

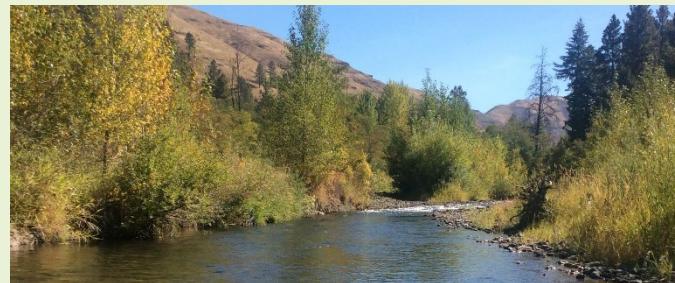
### Project Area 1.2

**Looking upstream at the end of the side channel that marks the delineation between PA 1.1 and PA 1.2. PA 1.2 has more sections that are single-thread, plane-bed channels as shown here.**

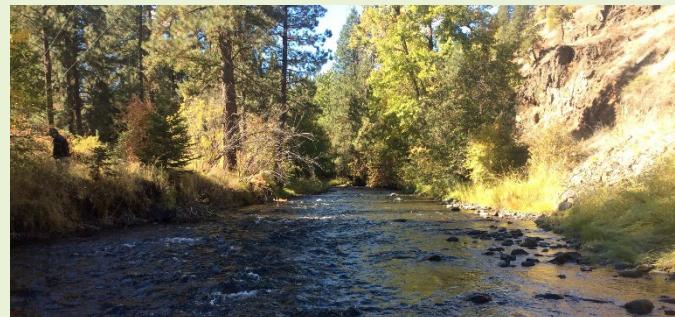
### Project Area 4

**Looking upstream at PA 4 from the top of PA 5. The channel is straight, uniform, and tightly confined by the right bank levee.**

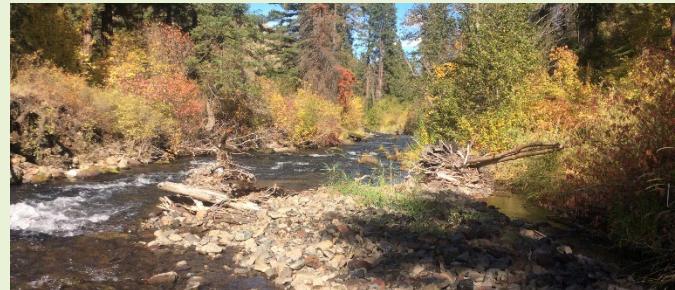
### Project Area 7

**Looking downstream at PA 7, which is a straight, confined channel largely disconnected from the riparian area with upland vegetation, but with some instream wood and geomorphic planforms.**

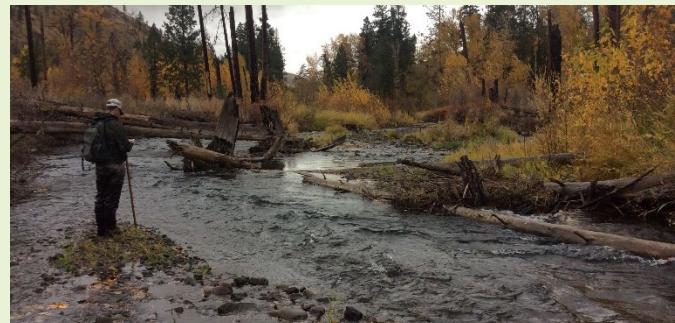
### Project Area 12

**Looking downstream. The channel has highly complex flow, high wood loading, and floodplain inundation, but with little riparian vegetation.**

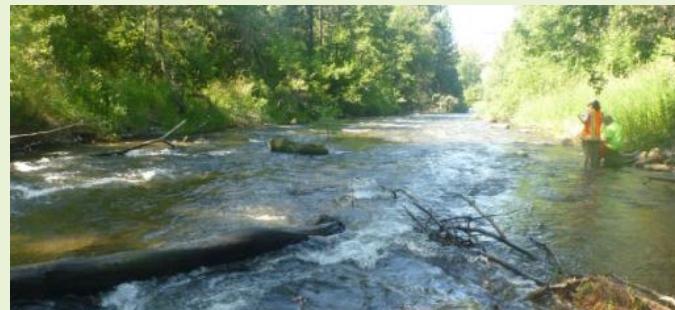
### Project Area 13

**Photograph taken from the 2011 prioritization showing the main channel just upstream of the large levee on the right bank, looking downstream.**

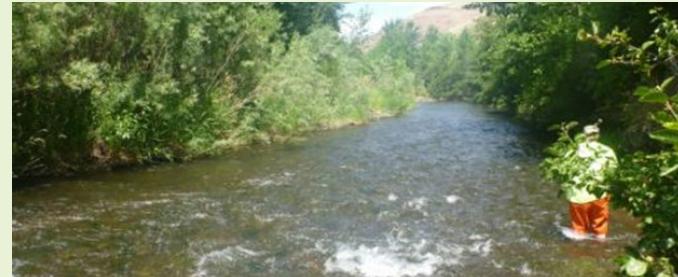
### Project Area 17.1

**Looking downstream on plane-bed uniform channel in PA 17.1.**

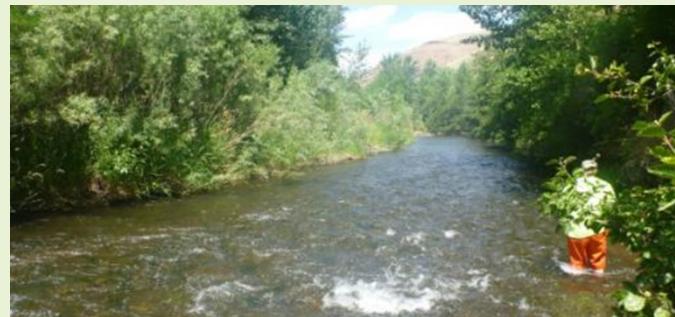
### Project Area 17.2

**Photograph taken from the 2011 prioritization showing a plane-bed section of the channel that flows along the base of a high terrace (right bank).**

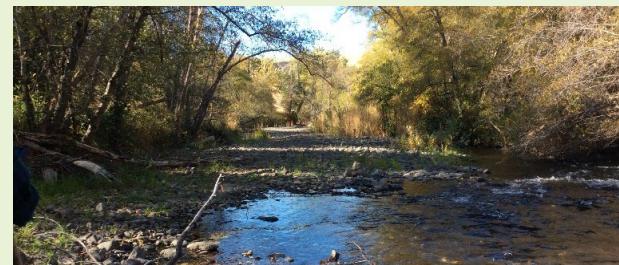
### Project Area 21

**Looking downstream towards the location of a major avulsion. The former channel is a plane-bed gravel bar with little vegetation. The flow now goes through a confined steep section as shown on the right side of the photograph.**

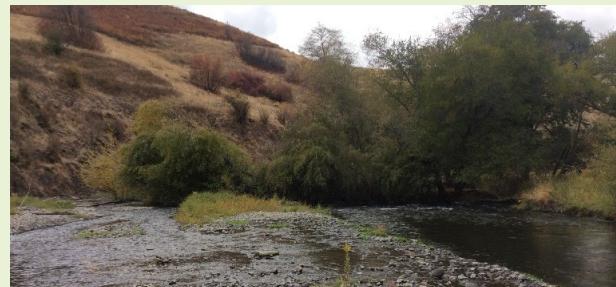
### Project Area 30

**Looking downstream. The channel has complex flow but exposed gravel bars with little vegetation or instream wood structure, making the current conditions geomorphically unstable.**

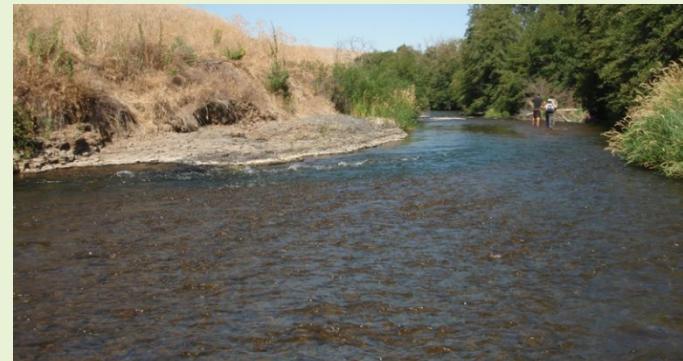
### Project Area 33

**Photograph taken from 2011 prioritization showing a bedrock sill (left) and plane-bed channel conditions.**

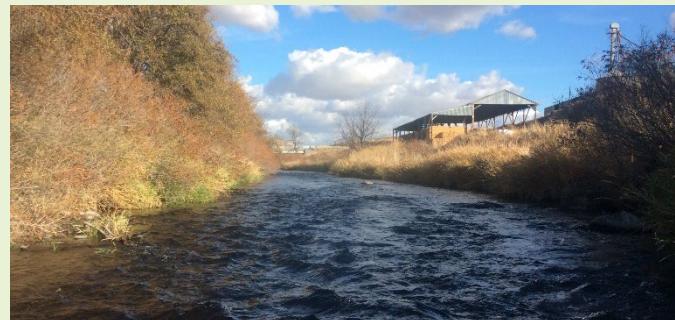
### Project Area 37

**Looking upstream.** The reach is a straight, uniform channel that is highly confined by levees and high banks.

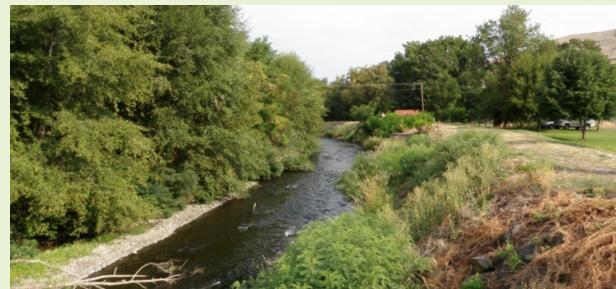
### Project Area 39.2

**Photograph taken from the 2011 prioritization showing the main channel just downstream of the Kellogg Road bridge with the Starbuck levee along the right bank. View is looking downstream.**
