January 2021
Tucannon Basin Habitat Restoration

Geomorphic Assessment and Restoration Prioritization

Prepared for Columbia Conservation District

Habitat Restoration Prioritization and Conceptual Restoration Plans

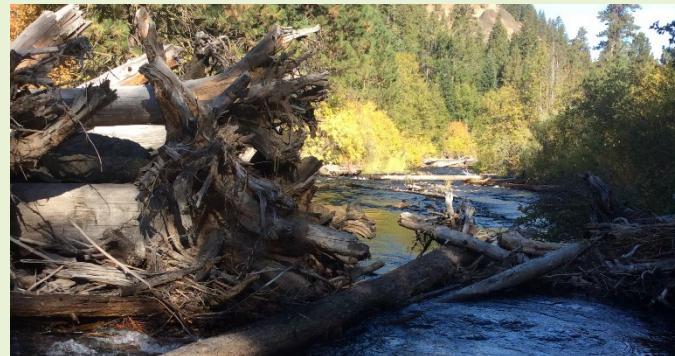
Project Area 1.1

Engineered log jam with large wood recruits at the upstream end of PA 1.

In 2014, restoration work in PA 1.1 included placing 38 log jams using 231 key logs within the channel and side channels, as well as excavating two side channel pilot cuts to activate about 0.3 mile of side channel habitat and reducing a WDFW campsite located on river right floodplain from 3.3 acres to 1.2 acres. Restoration in this project area had the objective of floodplain connectivity and channel complexity, including increasing perennial side channels and increasing pool frequency. A detailed as-built map of the project in pre/post conditions can be viewed in the Webmap.

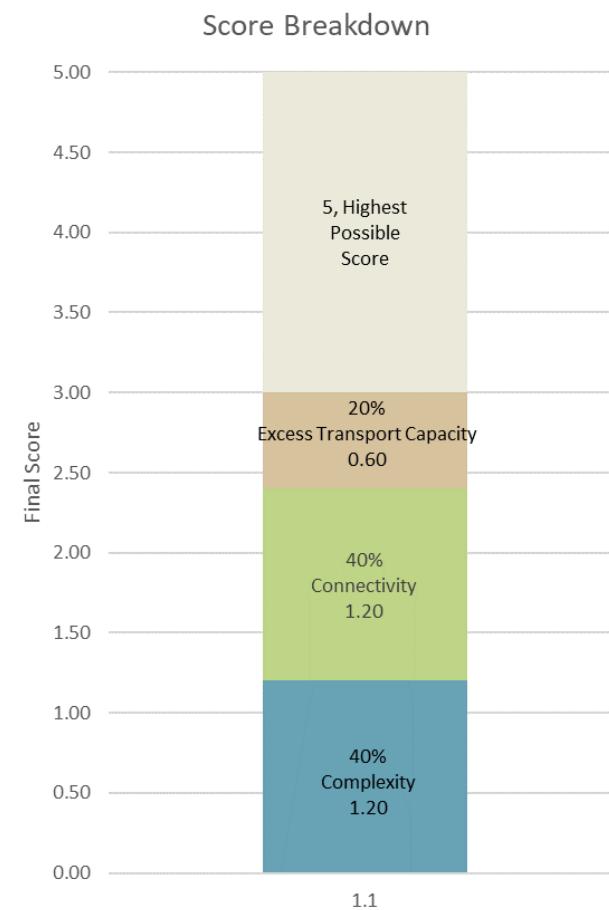
PA 1.1 Score Breakdown

This score breakdown shows how the three prioritization metrics contribute to the final prioritization score.

As shown in the following graphs and table, PA 1.1 received the highest score possible in the Connectivity metric and moderate scores for both Complexity and Excess Transport Capacity metrics. PA 1.1 falls in the 60th to 90th percentile for complexity, a range that still shows moderate complexity but does not place it in the top 10% of project areas; this project area may need some additional restoration work to reach that

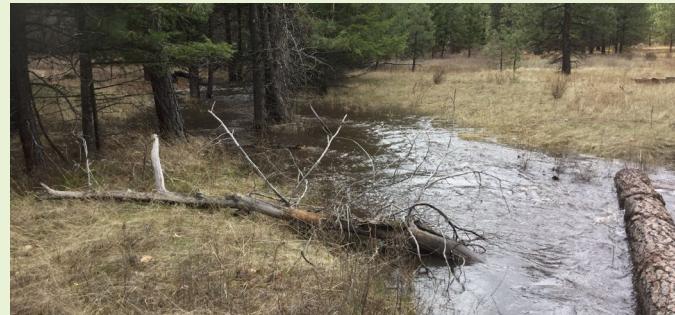
Project Area 3.2

Post-project photograph taken May 7, 2019, post high flow. The log jams placed in 2018 captured disconnected floodplain channels.

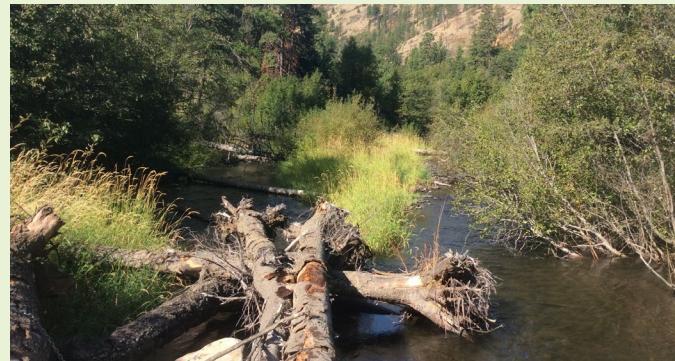
Project Area 6

Engineered log jam placed by helicopter 2 years following construction in 2017.

About 0.25 river mile downstream, the channel was more complex in 2011, with a multi-channel configuration with forced pools and riffles at LWD and along the bedrock valley wall. Instream habitat conditions in the main channel were generally good, due to the presence of large LWD that retained additional mobile wood and forced deep pools. Two large side channels met the main river near the middle and downstream end of the reach, providing good off-channel rearing habitat with ample cover, depth, and low velocities. The large natural log jam that had existed in 2011 at this site had become undercut by the summer of 2017, reducing the number of side channels and complexity within the reach. In July 2017, a new channel-spanning jam was constructed to aid in reforming the initial natural jam's function (Webmap VM 40.5).

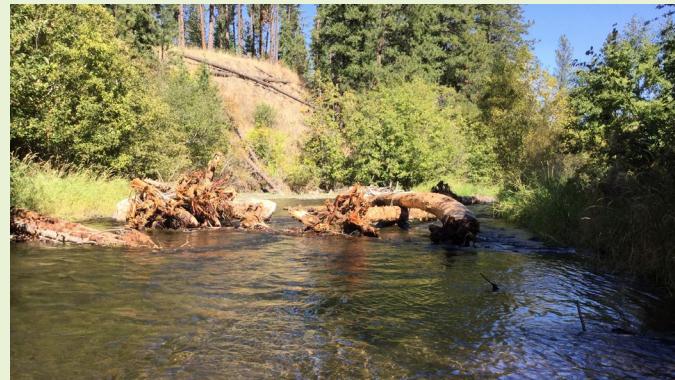
Project Area 9

Channel-spanning ELJ placed using a helicopter in July 2017; photograph taken in September 2017.

The complex sections of channel within this project area provide a variety of hydraulic conditions, including a relatively high amount of off-channel habitat, that provide preferred habitat throughout different life stages over the water year. In 2010, instream habitat conditions in the main channel were generally good in these complex sections due to the presence of large LWD that retained additional mobile wood, forced deep pools, formed side channels, and provided cover and hydraulic refuge. These areas had several well-connected side channels and a wide, active channel and floodplain, which has allowed the channel to migrate. However, the plane-bed sections of the project area lack sufficient volume and size of LWD necessary for instream complexity, which has led to wide, shallow conditions during low flows and high velocities during seasonal high flows. The LWD observed in these reaches did not appear substantial enough to persist and retain additional LWD over time, and by 2016 detreating conditions prompted WDFW to design a wood loading project funded through the Programmatic and implemented in July 2017 five months prior to the collection of LiDAR data in December 2017.

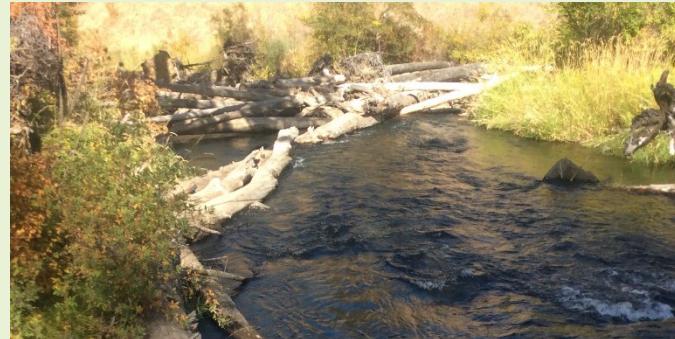
Project Area 14.2

Engineered log jam with channel-spanning recruits likely from upstream structure losses.

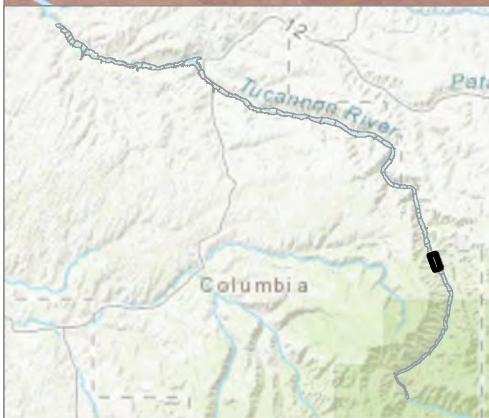
- Tucannon Project Areas
- Tucannon River Centerline
- - - Tucannon Valley Line
- Delineated Levees
- Bridges Limiting Channel Migration
- Wood Addition
- Reconnect Side Channel
- ▨ Reconnect Floodplain
- ← Long Term: Relocate Road

5. The conditions and opportunities in this map are based on LiDAR and aerial imagery from 2018. Flood events and geomorphic changes have occurred since then and may have changed the topography relative to what is shown.

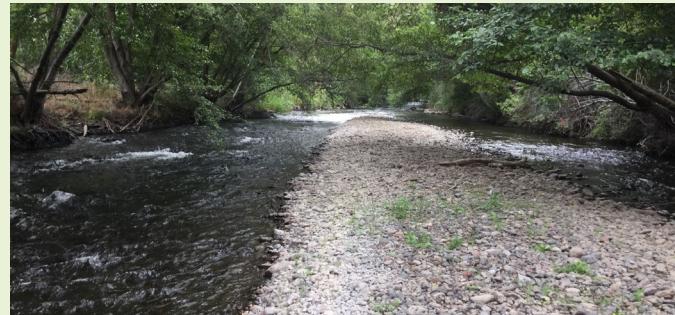
Project Area 26

Looking downstream near the upper end of the 3-mile project area in July 2019. Note mobile gravel material forming the mid-channel bar.

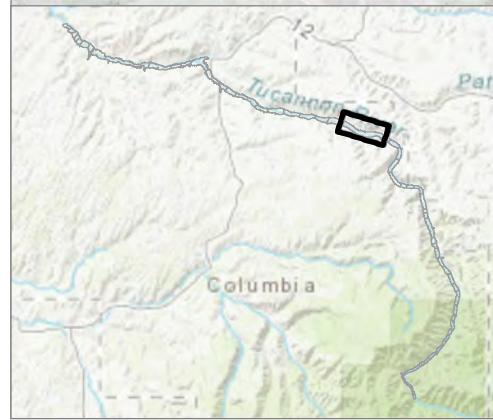
- Tucannon Project Areas
- Tucannon River Centerline
- Tucannon Valley Line
- Delineated Levees
- Bridges Limiting Channel Migration
- Wood Addition
- Reconnect Side Channel
- Reconnect Floodplain
- Riparian Enhancement

5. The conditions and opportunities in this map are based on LiDAR and aerial imagery from 2018. Flood events and geomorphic changes have occurred since then and may have changed the topography relative to what is shown.

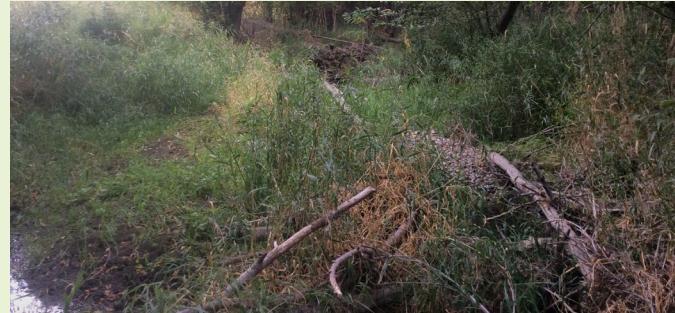
Project Area 40

Side channel opened up as part of PA 40 project, no flow was present at time of site walk but would be connected at a slightly high-flow stage.

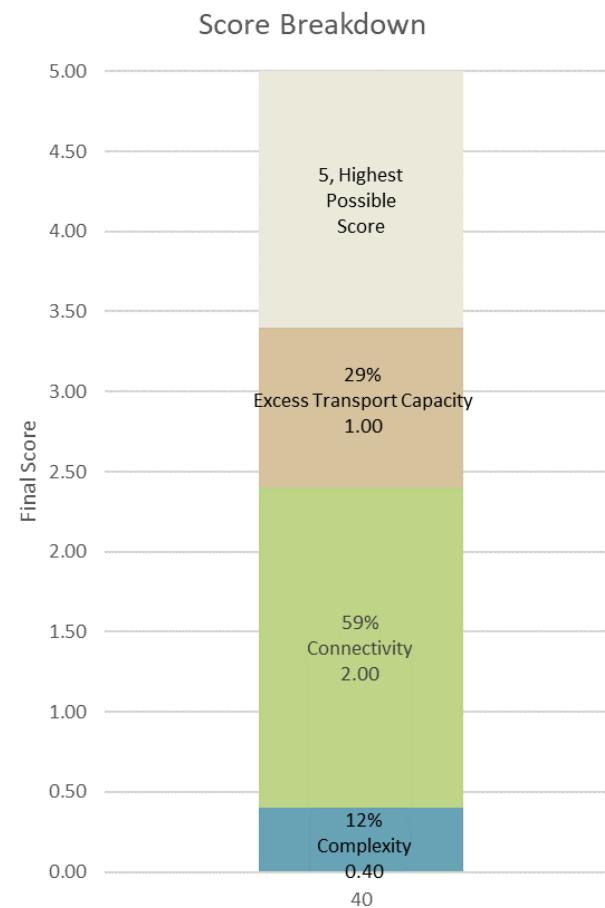
PA 40 Score Breakdown

This score breakdown shows how the three prioritization metrics contribute to the final prioritization score.

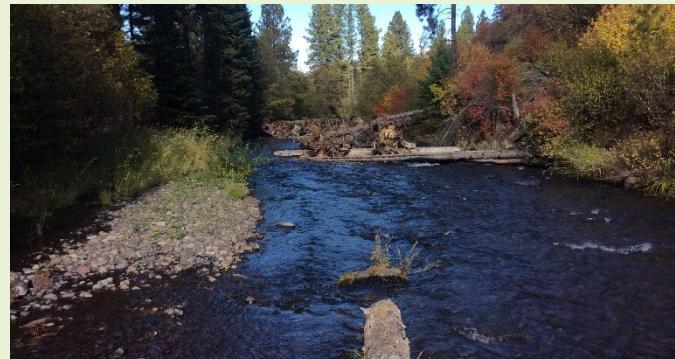
Project Area 8

Large engineered log jams interacting with flow at the upstream end of PA 8.

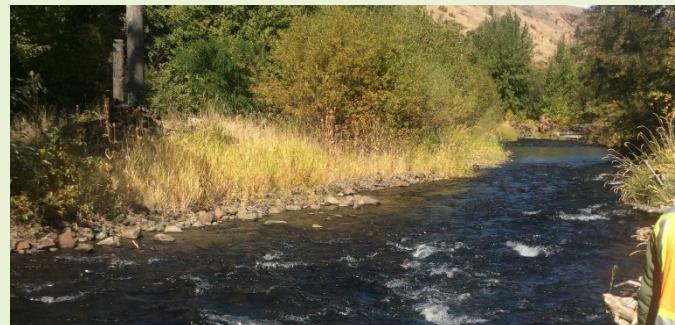
Project Area 10.3

Floodplain structure near the upstream end of the long side channel that was reconnected as part of restoration work in PA 10.3.

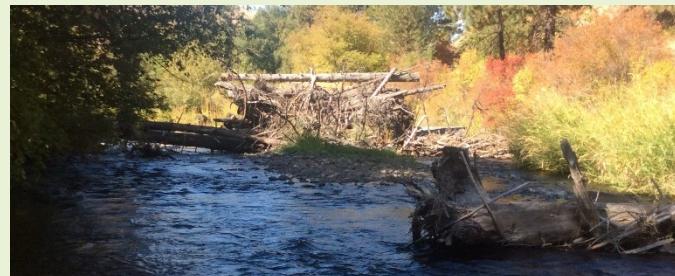
Project Area 14.1

Looking downstream at an apex engineered log jam, a small amount of flow is present on the right side of the structure but has been partially blocked by woody material.

At the time of the site visit, the first engineered log jam at VM 34.71 had split flow as was designed, but accumulated woody material prevented any significant flow on one side. The side channel at VM 34.68 carries perennial flow. However, at VM 34.65, a side channel that was intended to be inundated for most of the year was completely dry and did not appear to be inundated during yearly flow events. A log jam on the right bank just downstream from this side channel opportunity was noted to be disengaged from the channel at this flow level but was close enough that it would likely be engaged during higher flow events.

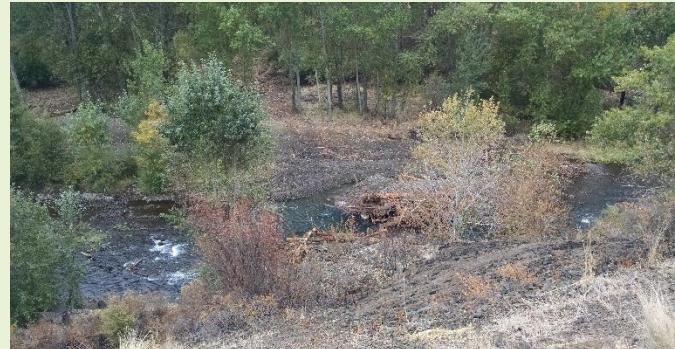
Project Area 15.2

Apex engineered log jams in PA 15.2, as seen from a nearby high vantage point.

The first two locations of significant geomorphic change are related to the two large engineered log jams located in the main channel. Both log jams exhibit deposition in the wake of the structure and scour erosion along the sides. There are other examples of this type of change but not all have been noted in this narrative (boxes 1 and 2).

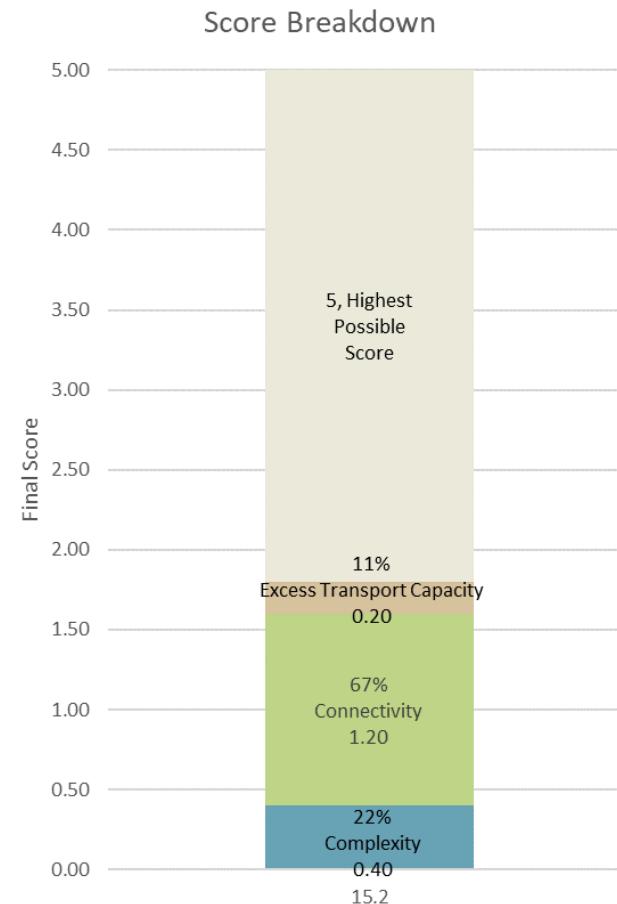
PA 15.2 Score Breakdown

This score breakdown shows how the three prioritization metrics contribute to the final prioritization score.

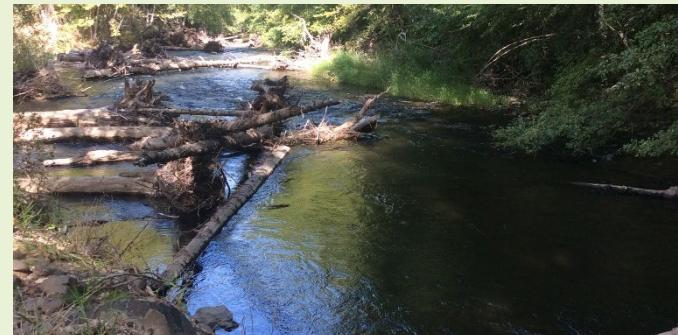
Project Area 18.1

Recently installed rootwad logs and large woody debris structures interacting with flow.

Because of this recent avulsion, the geomorphic reaction to many of the structures has been mixed. Several structures have deep scour pools even around single log placements, often associated with a stretch of gravel bed material. Other structures have been placed on cobble and boulder material and have not caused much pooling. Because restoration work was so recent, it is possible that there has not been enough time or enough transport flow events to have caused significant change.

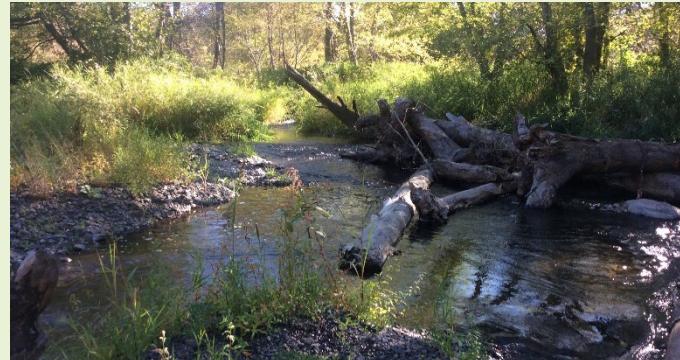
Project Area 28.2

Complex flow around an engineered log jam near the upstream end of PA 28.2.

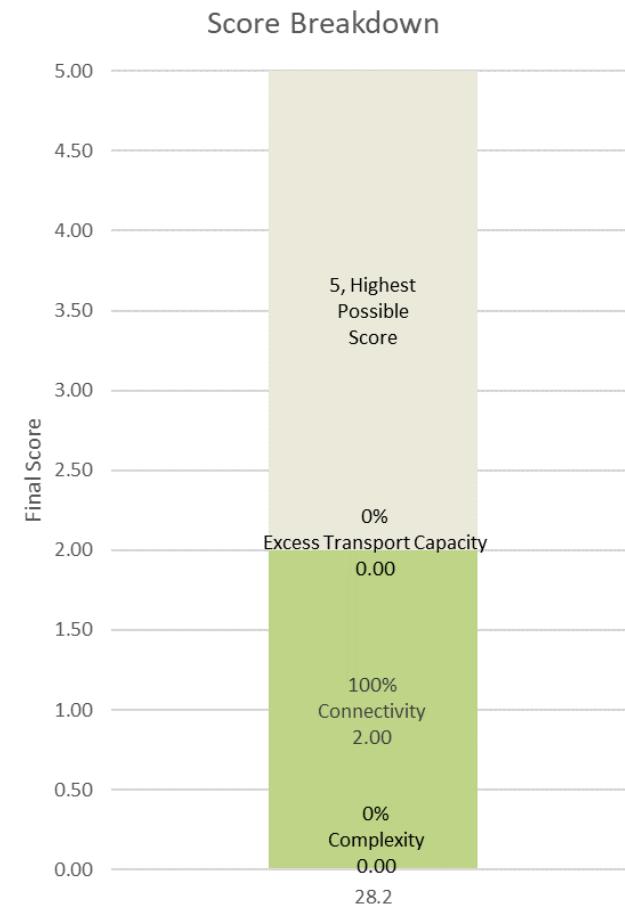
PA 28.2 Score Breakdown

This score breakdown shows how the three prioritization metrics contribute to the final prioritization score.

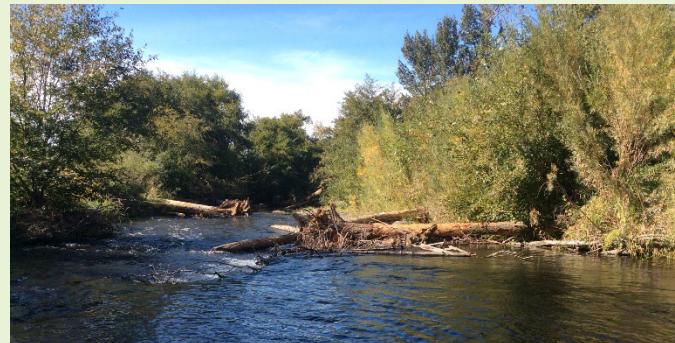
Project Area 28.3

Alternating engineered bank structures in a confined section of PA 28.3.

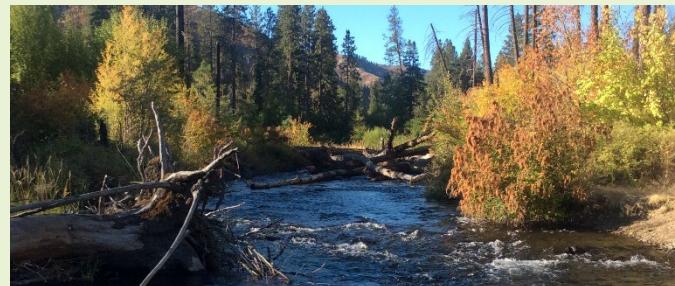
Project Area 10.1

Placed large woody material interacting with flow at the upstream end of PA 10.1, near where a large avulsion has caused much of the downstream aggregation, complexity, and floodplain connection.

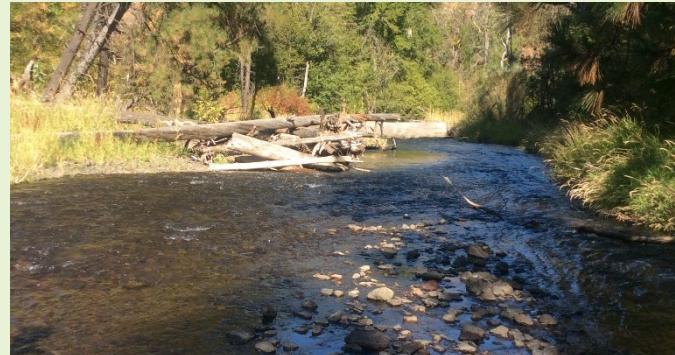
Project Area 10.2

Engineered log jam on left bank with wood recruits forcing flow towards the right bank.

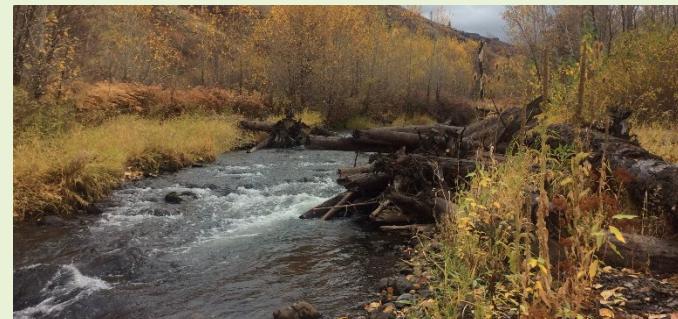
Project Area 11.1

Looking upstream, an engineered bank barb promotes flow towards the right bank, but was not causing split flow at the time of this photograph.

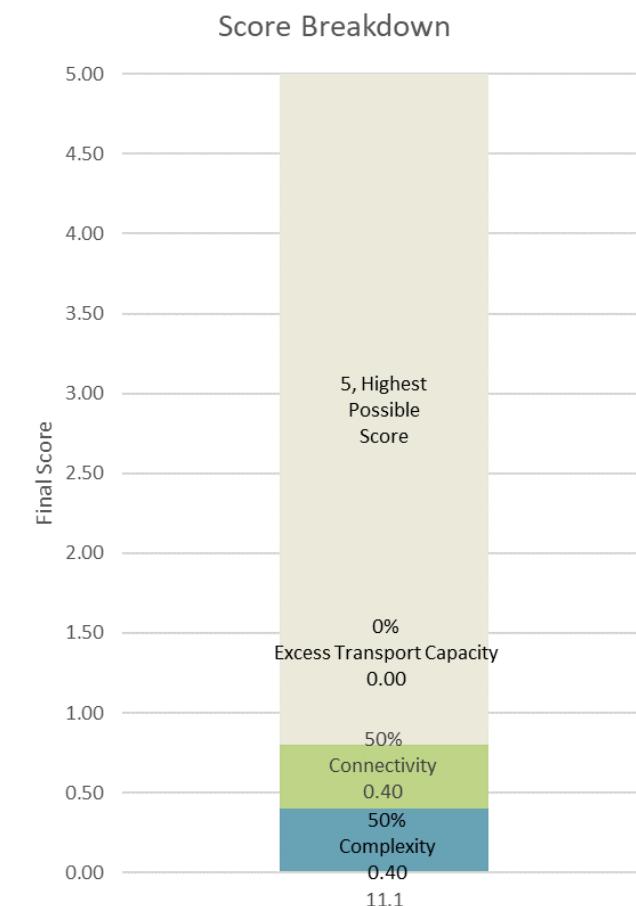
PA 11.1 Score Breakdown

This score breakdown shows how the three prioritization metrics contribute to the final prioritization score.

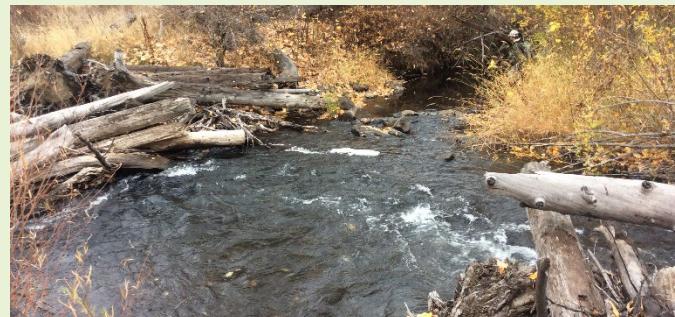
Project Area 11.2

Engineered log jam with accumulated woody material is causing a deep scour pool, split flow, and floodplain inundation.

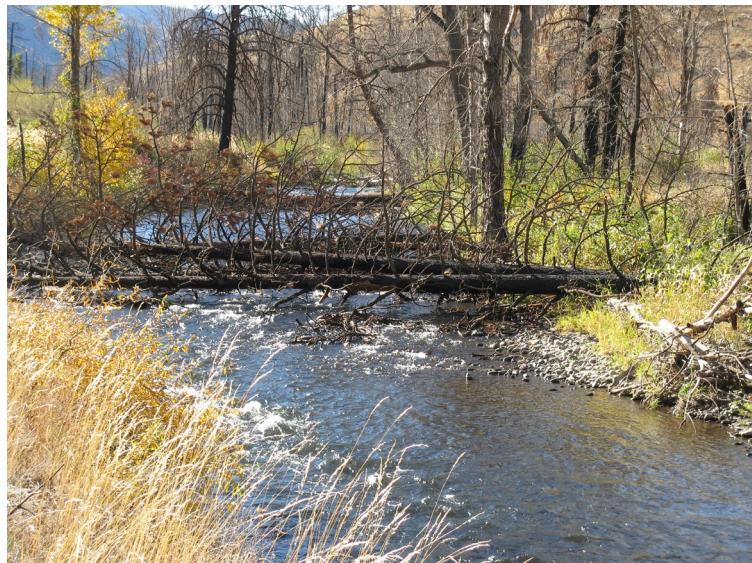
formed following wood loading in fall 2008 as part of the WDFW and USFS efforts to cull hazard trees following the fire. In the main channel, a log jam has triggered a minor channel avulsion and erosion towards the left bank (box 3).

Culling fire killed trees in 2008, dropping them into the river channel in box 2.

Further downstream in the main channel, a log jam has caused a split flow with erosional areas on both banks and deposition in the wake of the log jam forming a small bar (box 4).

After the confluence of the two channels and near the downstream end of the reach, a log jam has caused a minor avulsion and erosion towards the right bank and deposited

sediment on a bar in the wake (box 5). At the very downstream end of the reach, two large channel-spanning log jams have allowed deposition in the main channel and caused a small cut-off side channel into the right bank floodplain (box 6).

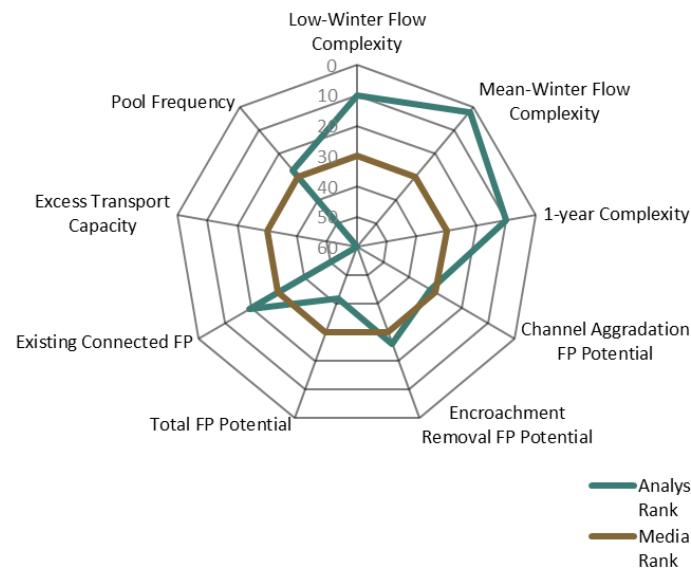
PA 11.2 Analysis Results Ranks

This analysis results summary shows how this project area ranks in relation to the rest of the basin for the nine metrics from the Geomorphic Assessment. The results are used as indicators for the geomorphic characteristics and restoration strategies. The median rank is highlighted in brown for comparison.

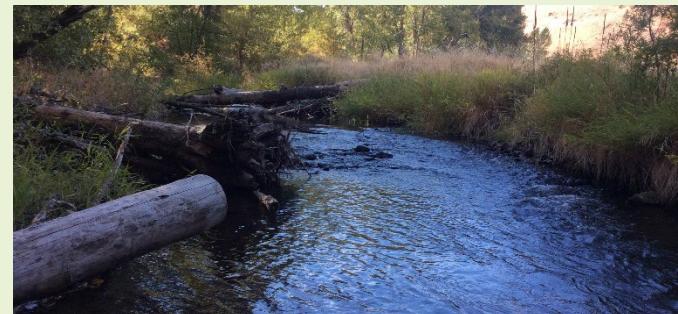
Project Area 15.1

Placed large woody material is interacting with flow in the side channel that has opened up as part of restoration work.

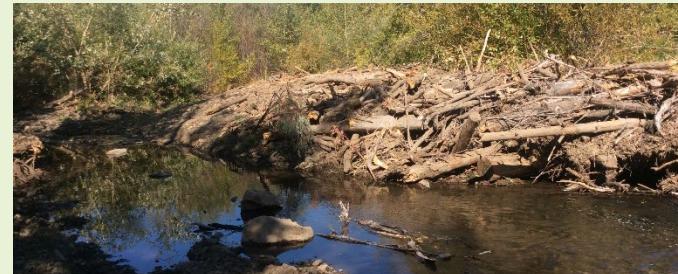
Project Area 24

Engineered log jam with accumulated small woody debris. The main flow is to the right of the structure and the backwater seen on the left forms a side channel at higher flows.

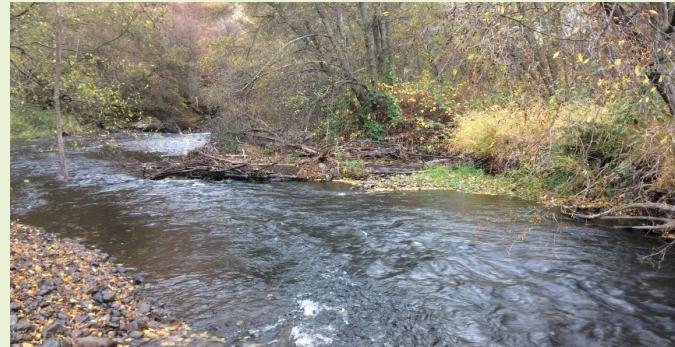
Project Area 25

Location of channel erosion on the right bank and bar build on the left bank.

PA 25 is a short reach and experienced only one significant location of geomorphic change based on analysis of the difference between the 2010 and 2017 LiDAR data. This change occurs near the middle of the reach and was noted during field observations to correspond with the location of a channel-spanning log jam, with significant deposition upstream. In this location, erosion of the left and right banks is apparent (box 1). Additionally, patches of aggradation upstream of this location are evident in both the floodplain and main channel, particularly in a right bank side channel, and may represent deposition due to the log jam. Just upstream of the log jam a point bar is building along with erosion on the left bank.

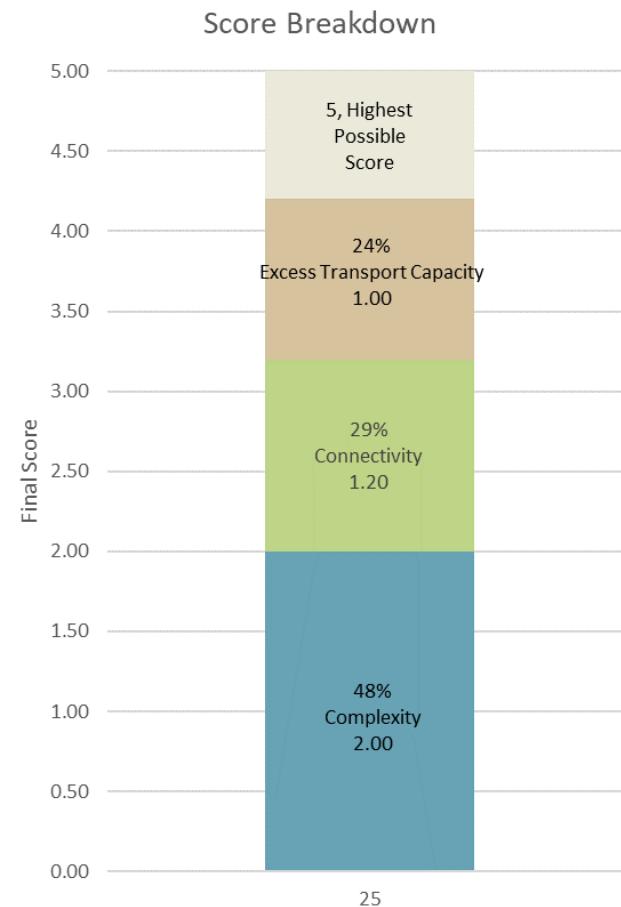
PA 25 Score Breakdown

This score breakdown shows how the three prioritization metrics contribute to the final prioritization score.

While the reach only scores in the 25th percentile for the Connectivity metric, the majority of the area that drives this is a large, low spot located on the right bank floodplain in a field with little to no mature vegetation and over 100 feet from the active floodplain. Additionally, since this score comes mostly from the Total Floodplain Potential analysis result, this area would require both channel aggradation and encroachment removal to be successful. There are several other small pockets for floodplain that could be reconnected with the removal of encroachments, but this restoration strategy should be seen as secondary to the goal of developing complexity and encouraging channel dynamics as already discussed.

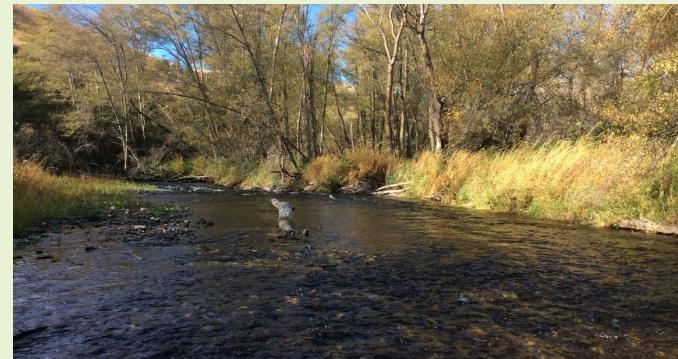
Project Area 27

Upstream end of side channel on right bank, looking downstream on PA 27.

The upper and lower sections of the reach are pinned on the left bank against the bedrock valley wall, providing poor habitat conditions and little opportunity for geomorphic processes to progress. On the right bank, and on the left bank where not bounded by the valley wall, the floodplain is moderately accessible with established vegetation including cottonwoods and alders. Some wood has been recruited recently, forcing small side channels into the floodplain. The site photograph in the sidebar shows the upstream end of one such example. One

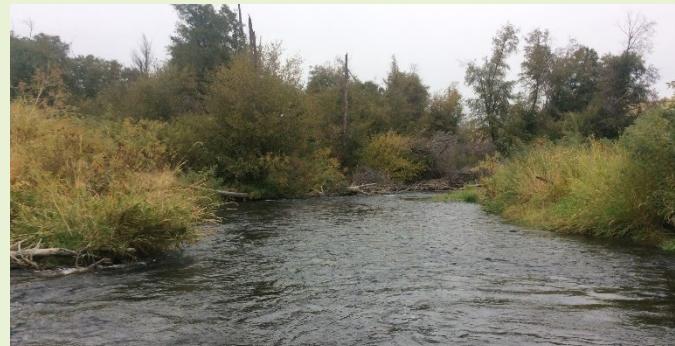
Looking downstream from PA 40 to the log jam and avulsion at the beginning of PA 41.

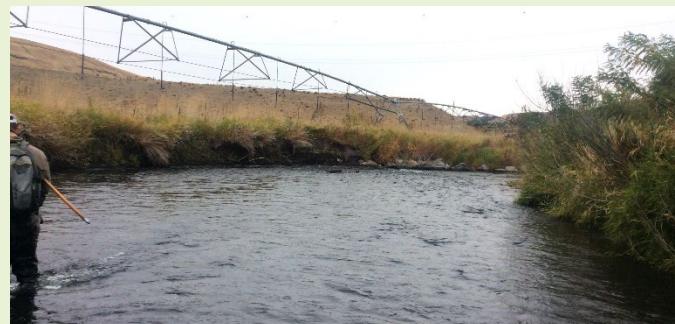
PA 44 mid-reach, looking downstream at erosion into a field on the left bank on the outside of a meander bend.

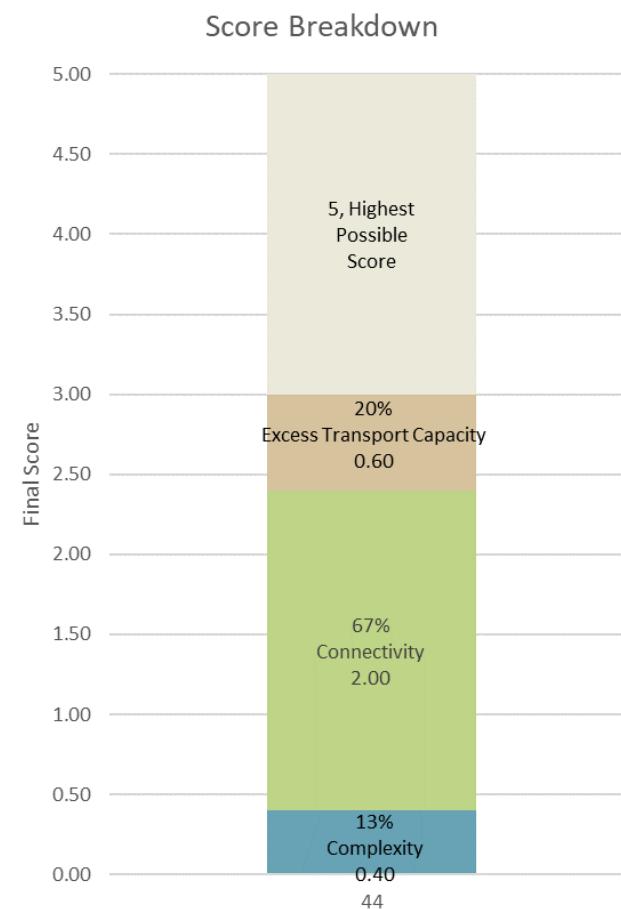
PA 44 Score Breakdown

This score breakdown shows how the three prioritization metrics contribute to the final prioritization score.

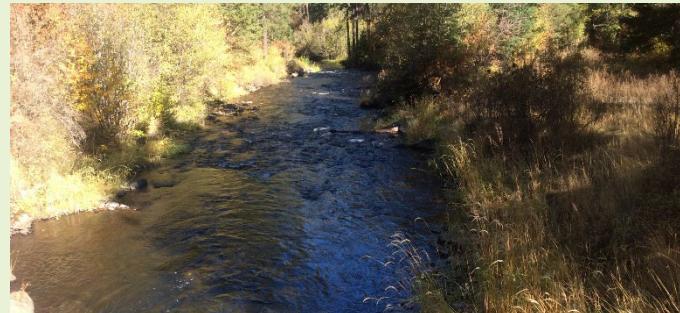
Plane-bed, straight, and uniform section of river with little instream complexity. View is from the bridge upstream of PA 3.1 and looking downstream.

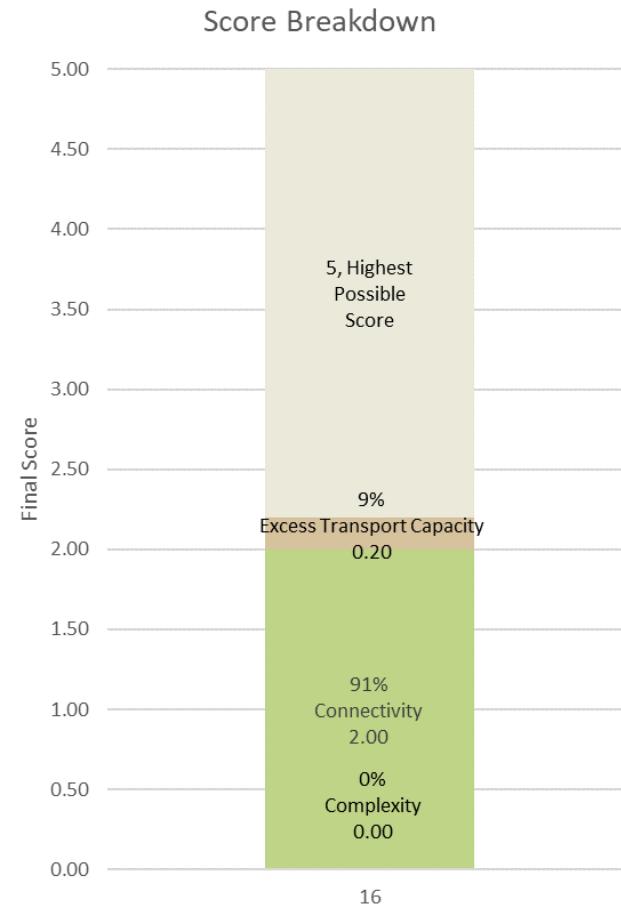
PA 16 Score Breakdown

This score breakdown shows how the three prioritization metrics contribute to the final prioritization score.

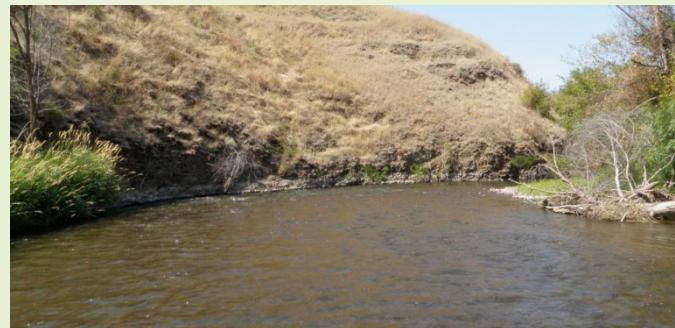
Project Area 31

Photograph taken from the 2011 prioritization showing the plane-bed channel with a bedrock bank, looking downstream.

The river through PA 31 is primarily characterized by a low-sinuosity, single-thread, plane-bed channel, with local areas of split flow, LWD, or bedrock-forced pools, and depositional areas. The 2011 assessment noted that the project area was highly influenced in places by bedrock outcrops along the left bank and in the channel bed. Bedrock maintained the grade of the channel and controlled the left bank along the valley wall. Pools were found throughout the project area and were associated with bedrock, armored banks, and locally recruited LWD. In the upper extent of the project area, the channel was highly confined between the valley wall (along the left bank) and levees and revetments along the right bank. Minimal bedrock was exposed along the channel bed in this confined segment.

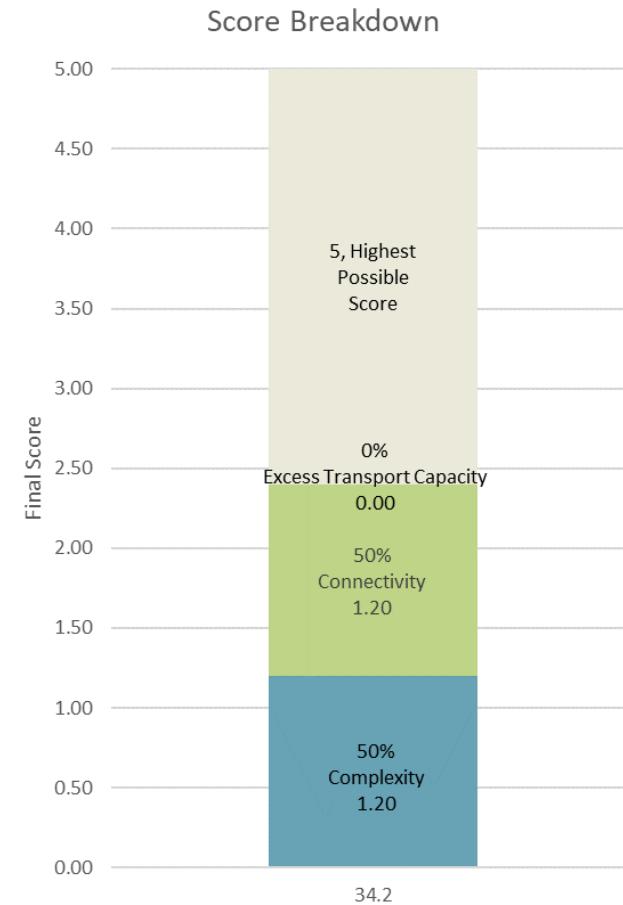
PA 34.2 Score Breakdown

This score breakdown shows how the three prioritization metrics contribute to the final prioritization score.

PA 34.2 also receives a low score in the Connectivity metric, indicating that it ranks in the 25th to 50th percentile of all project areas. This low score is driven mostly by the Encroachment Removal analysis result, which ranks PA 34.2 well above average. The opportunity for encroachment removal exists almost entirely at the upstream end of the project area. A large portion of the floodplain that appears to be outside of the agricultural fields nearby, based on the 2018 aerial imagery, is disconnected by a levee that extends from the road and bridge at the upstream end of this project area. It should be noted that this levee has been built up since 2011, as noted in the LiDAR change analysis above. Reconnection of this area

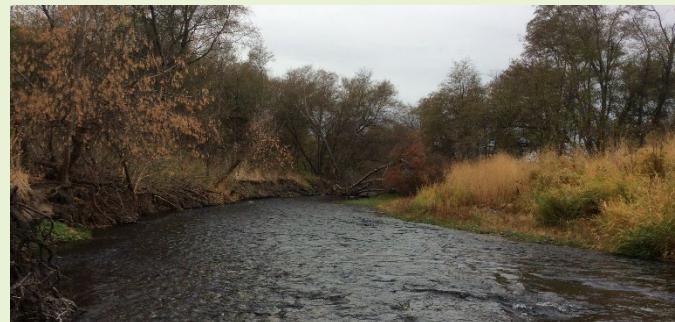
Project Area 35

The reach is confined by a levee on the left bank in PA 35. The instream wood seen in the distance has fallen in from the old levee.

A small amount of instream wood was noted during field observations, possibly from upstream avulsions, but the channel in general seems to be straight and uniform without much instream complexity. Mid-way through the reach there is a bridge for River Ranch Lane.

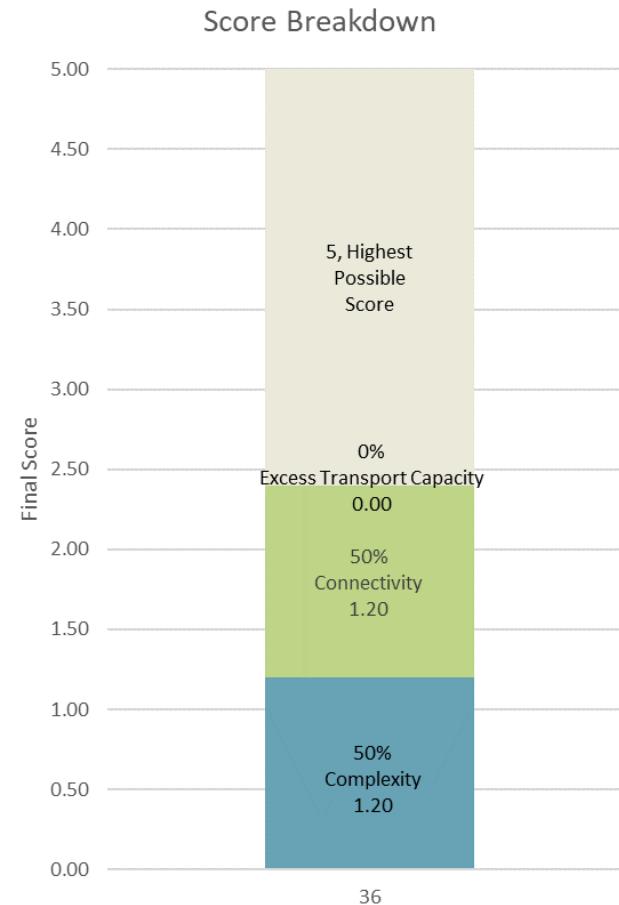
PA 36 Score Breakdown

This score breakdown shows how the three prioritization metrics contribute to the final prioritization score.

PA 36 falls in the 60th to 90th percentile for complexity, a range that still shows moderate complexity but does not place it in the top 10% of project areas, an objective that could be achieved with relatively little effort. Because the complexity in this project area already falls close to the 90th percentile mark, which no longer receives any points for prioritization, there appears to be good complexity across the whole reach. All three flows score at or above the assessment average, but the highest score for complexity is the 1-year flow. This increase is driven in large part by the connection of several side channels at the very upstream end of the project area; connecting these year-round would be an easy way to increase overall complexity. Adding wood structure and opening or lowering high-flow channels should be the restoration strategy employed for increasing complexity. It should be noted that

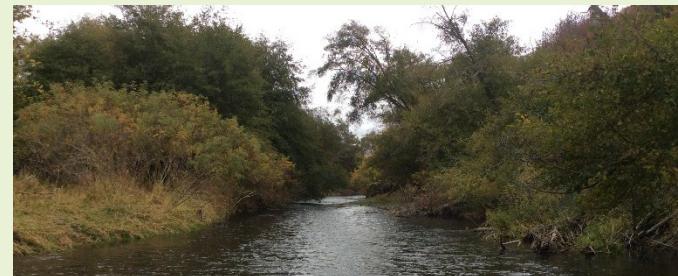
Project Area 38

Looking upstream near the upstream end of the reach at a straight, plane-bed channel with fringe floodplain pockets behind levees (left) and high banks (right).

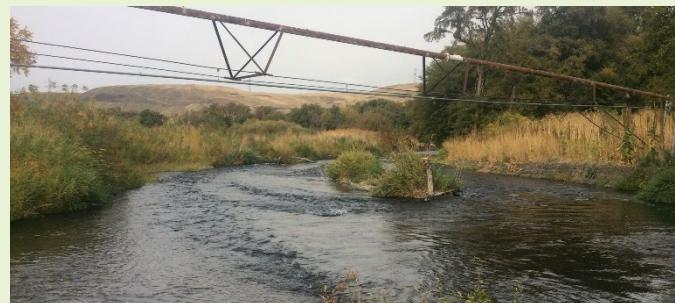
Project Area 42

Looking downstream at an irrigation pipe crossing. The channel has complex planforms but little instream wood and poor riparian cover.

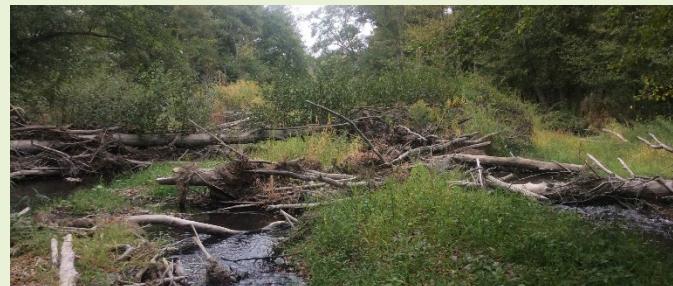
Project Area 43

Looking downstream at a recent avulsion area with multiple areas of channel-spanning woody material. This section of PA 43 was extremely complex at the time of the site visit.

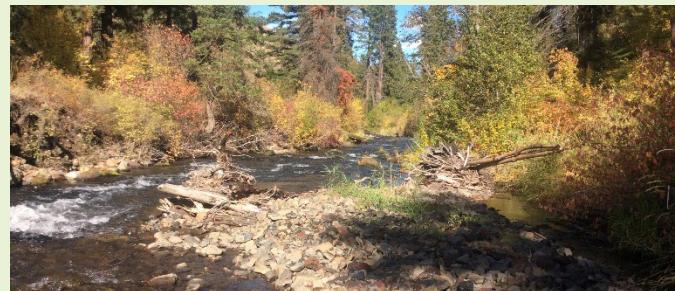
Project Area 7

Looking downstream at PA 7, which is a straight, confined channel largely disconnected from the riparian area with upland vegetation, but with some instream wood and geomorphic planforms.

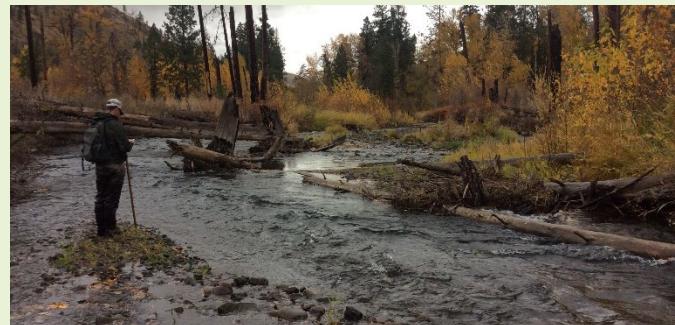
Project Area 12

Looking downstream. The channel has highly complex flow, high wood loading, and floodplain inundation, but with little riparian vegetation.

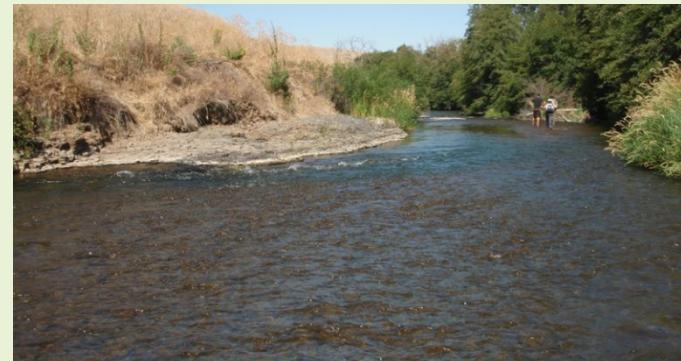
Project Area 33

Photograph taken from 2011 prioritization showing a bedrock sill (left) and plane-bed channel conditions.

Within PA 33, the river is largely confined and incised within a relatively straight, single-thread channel. The 2011 assessment noted that some portions of the channel had cut down to expose historical compacted alluvium along the banks and LWD had been unburied. The channel was primarily a transport reach with a low volume of temporary sediment storage and low volume of wood material. In the upper project, occasional bedrock outcrops were located in the channel bed, which forced local pools and rapids and likely contributed to holding the channel grade. A majority of the upper reach was confined by riprap and unarmored levees. A significant bedrock sill was located along the left bank and in the channel. The bedrock sill area contained split flow, a large log jam, and active migration of the channel into the right floodplain (which was a field at the time of the 2011 assessment). The lower portion of the project reach was primarily a plane-bed channel with local forced pools where the channel was located along the toe of the bedrock valley wall, and sporadic LWD pools. The right bank contained

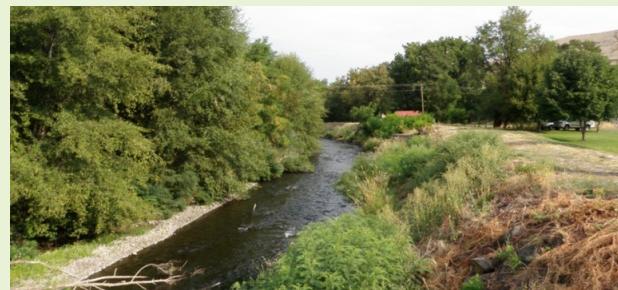
Project Area 39.2

Photograph taken from the 2011 prioritization showing the main channel just downstream of the Kellogg Road bridge with the Starbuck levee along the right bank. View is looking downstream.

The 2011 assessment noted that there was limited floodplain within the project area and the channel was highly confined due to the alignment of the Starbuck levee. The levee extends along the right bank throughout the entire project area, limiting channel migration and floodplain development along the right bank. This levee protects the town of Starbuck from high flood waters during peak flows. Along the left bank is a bedrock outcrop that limits floodplain connectivity and channel migration along the left bank. Some overbank area exists along the left bank immediately downstream of the Kellogg Hollow Road bridge. Along with the confluence with Kellogg Creek.

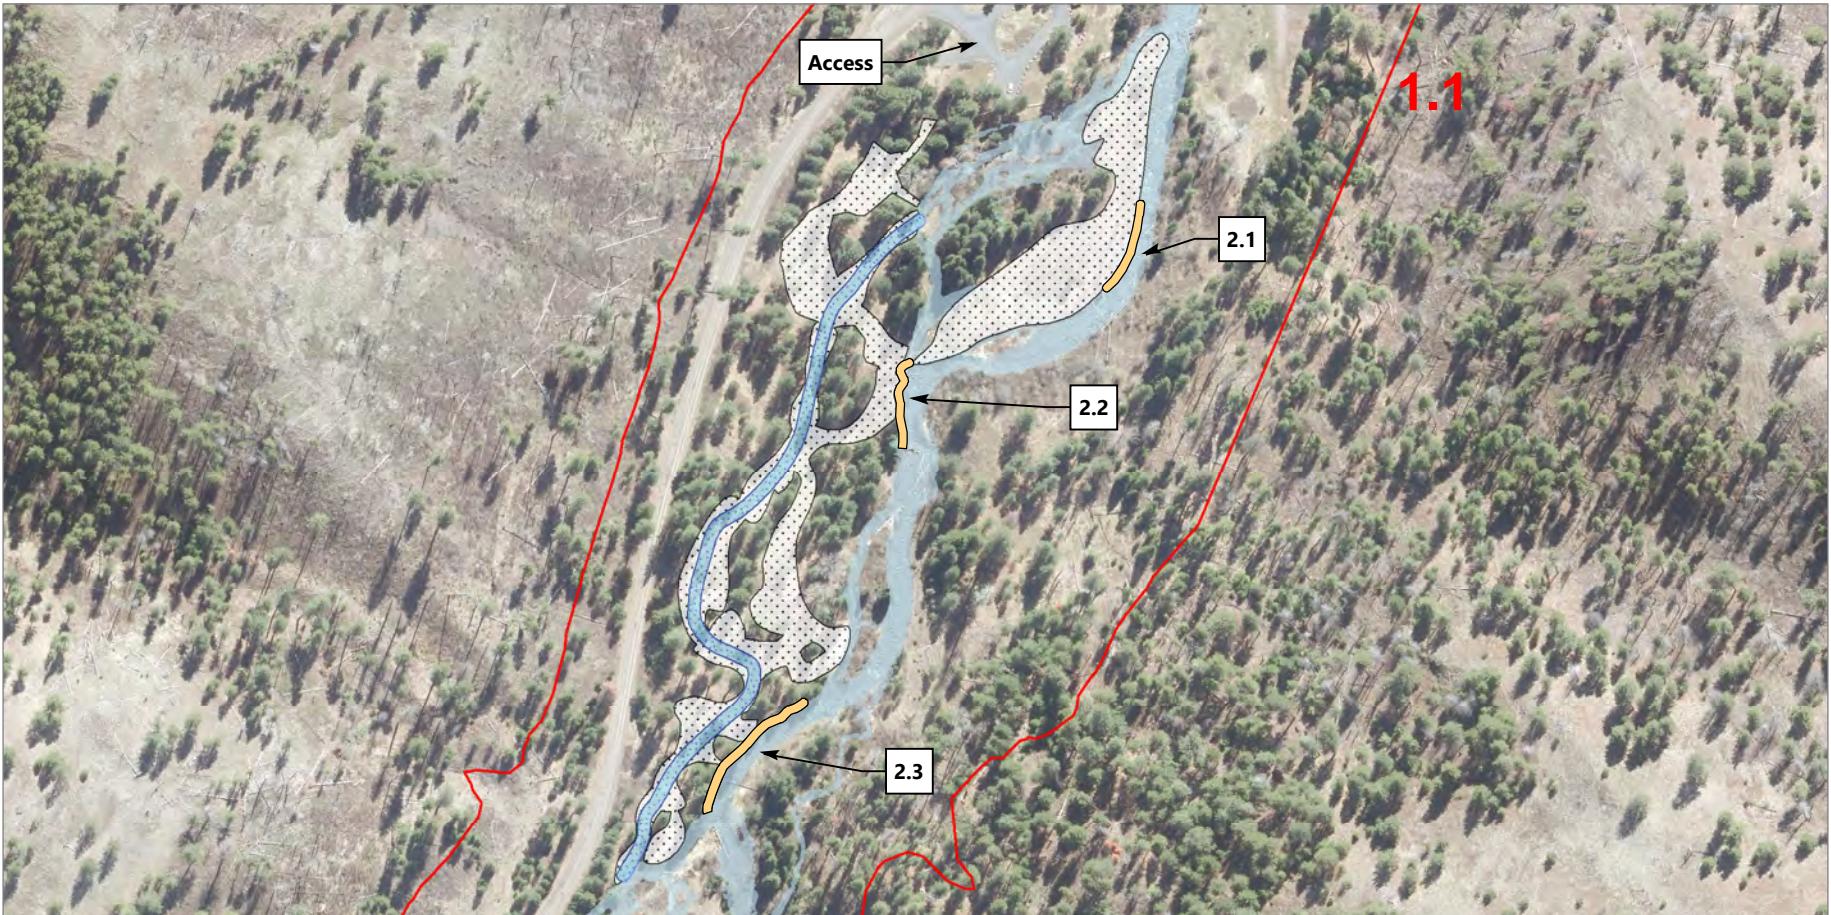
GA-2 Gravel Placement Locations

Location 2.1 This material will be sourced from the adjacent floodplain on the bank of the island. This material is relatively low already, so benching the entire floodplain features will not take long. It will begin at the upstream end of the island and expand until the entire island has been benched. Following this, material will be sourced from the portion of the floodplain between the floodplain channel and the road.	Location 2.2 Sourcing for this location will begin by opening the upstream end of the floodplain channel and benching the floodplain directly adjacent. Following this, the floodplain bordering the placement location will be benched and expand upstream and downstream until it connects with the floodplain channel. Sourcing will continue down the floodplain channel until it meets with sourcing efforts coming up the floodplain channel from Location 2.3.
Location 2.3 Initial material will be sourced by opening the floodplain channel and benching the surrounding floodplain. This effort will expand up the floodplain channel, benching the adjacent floodplain along the way. Finally, the area upstream of the placement location that is between the floodplain channel and the main channel will be benched.
