January 2021
Tucannon Basin Habitat Restoration

Geomorphic Assessment and Restoration Prioritization

Prepared for Columbia Conservation District

Habitat Restoration Prioritization and Conceptual Restoration Plans

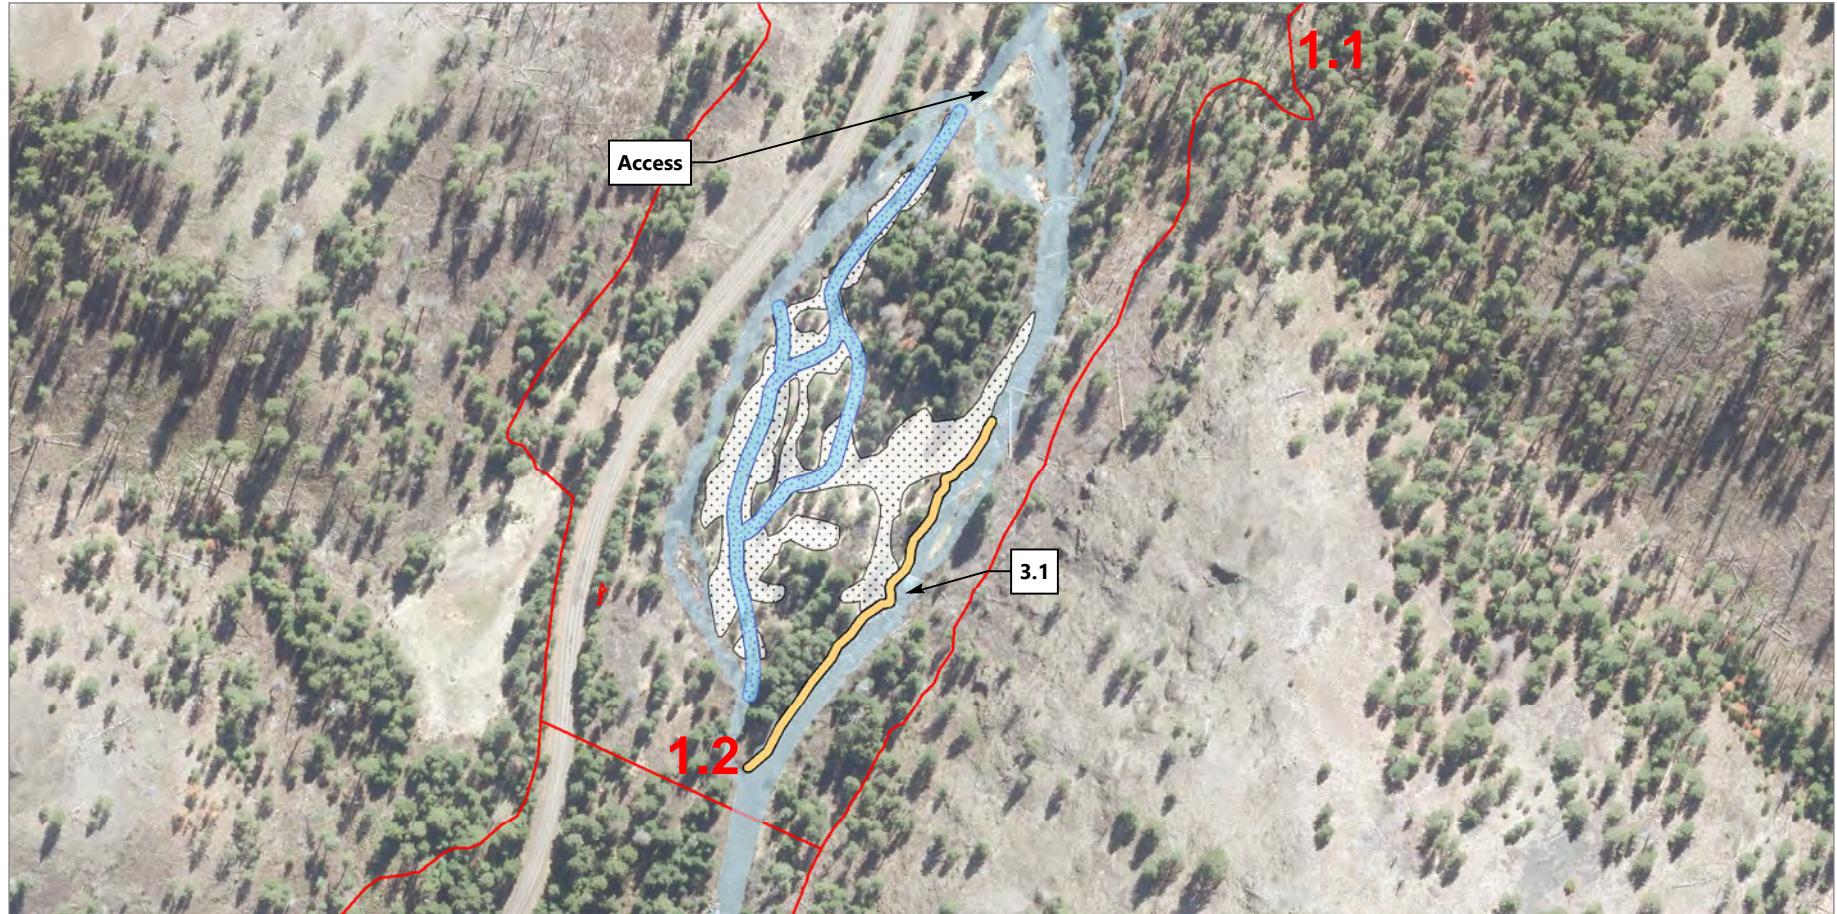
Location 3.1

Material for this location will be sourced first by opening the top and bottom of the floodplain channel. Floodplain channel creation will then expand from the upstream end along with floodplain benching adjacent to the floodplain channel. The floodplain along the main channel adjacent to the placement location will be benched once the floodplain channels are completed.

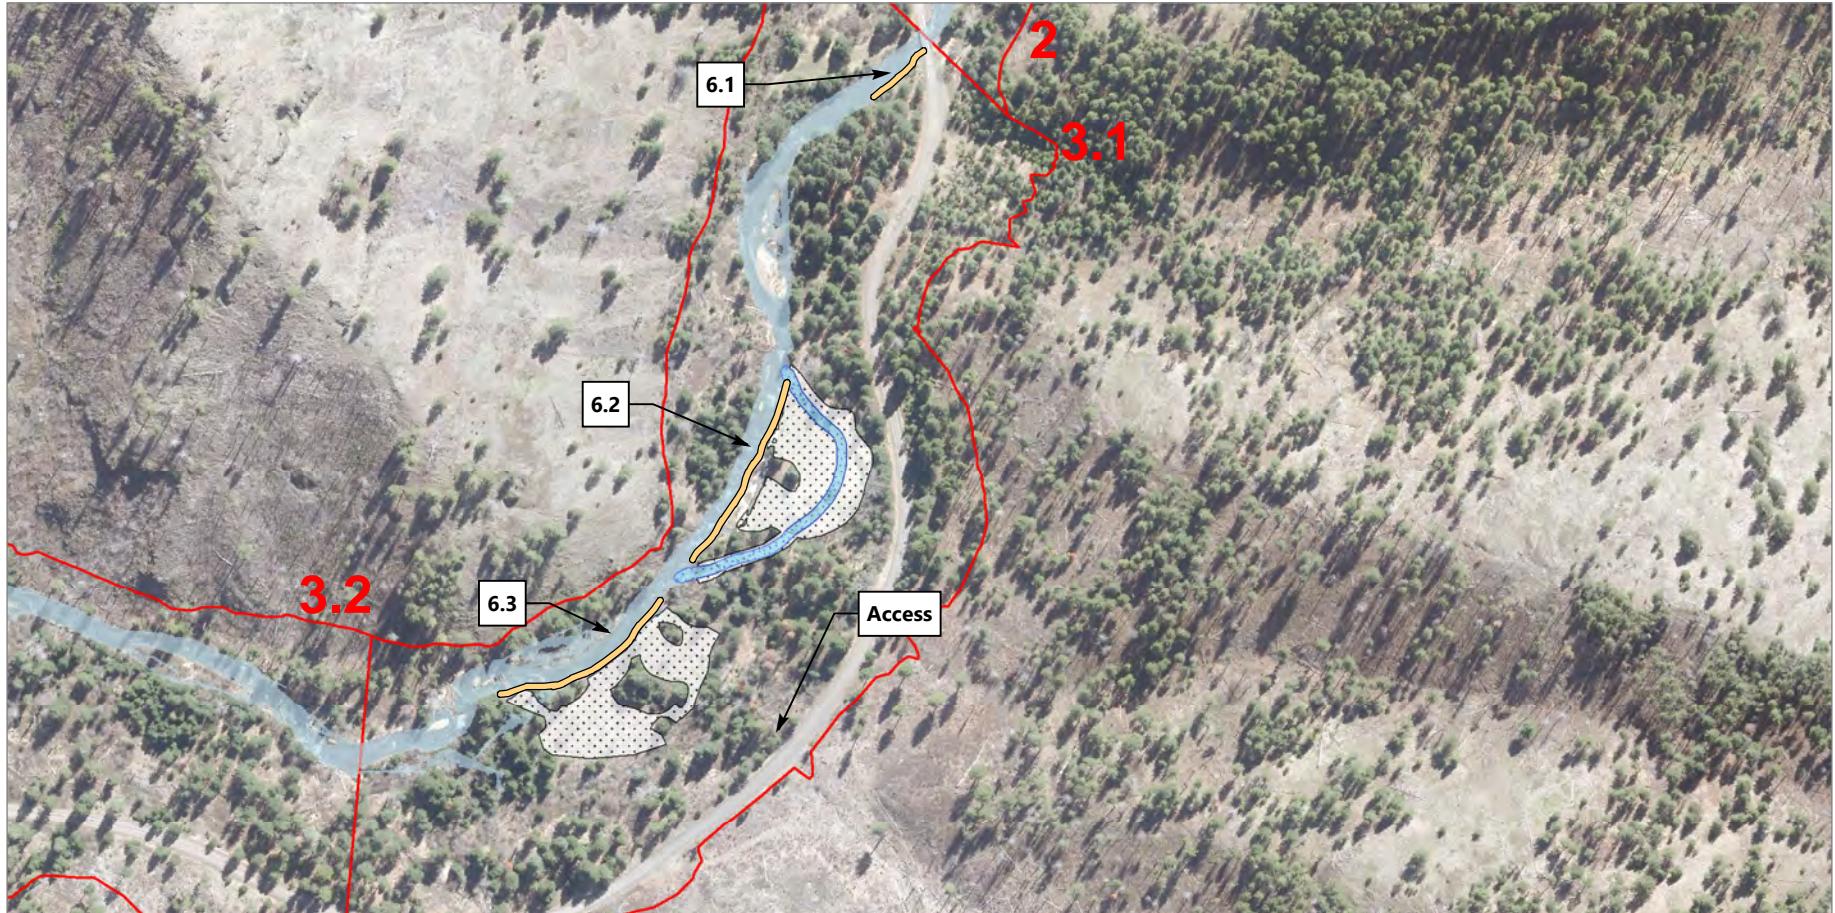
**GA-6 Gravel Placement Locations**

Location 6.1 <p>Material will be transported here via dump truck and placed with the given dimensions during low flows, or placed en masse in the channel during high-flow events when the material will be entrained immediately.</p>	Location 6.2 <p>Material will be sourced first by opening the upstream and downstream ends of the floodplain channel and then by benching the floodplain along the main channel and expanding up the bank until the floodplain channel is reached. Then the floodplain channel will be connected before benching continues farther up the bank.</p>
Location 6.3 <p>Material will be transported to this placement location from the immediately surrounding floodplain area. Material will be sourced first from the upstream and downstream ends of the source area closest to the river to allow more floodplain connection as material is transported away from the placement location.</p>

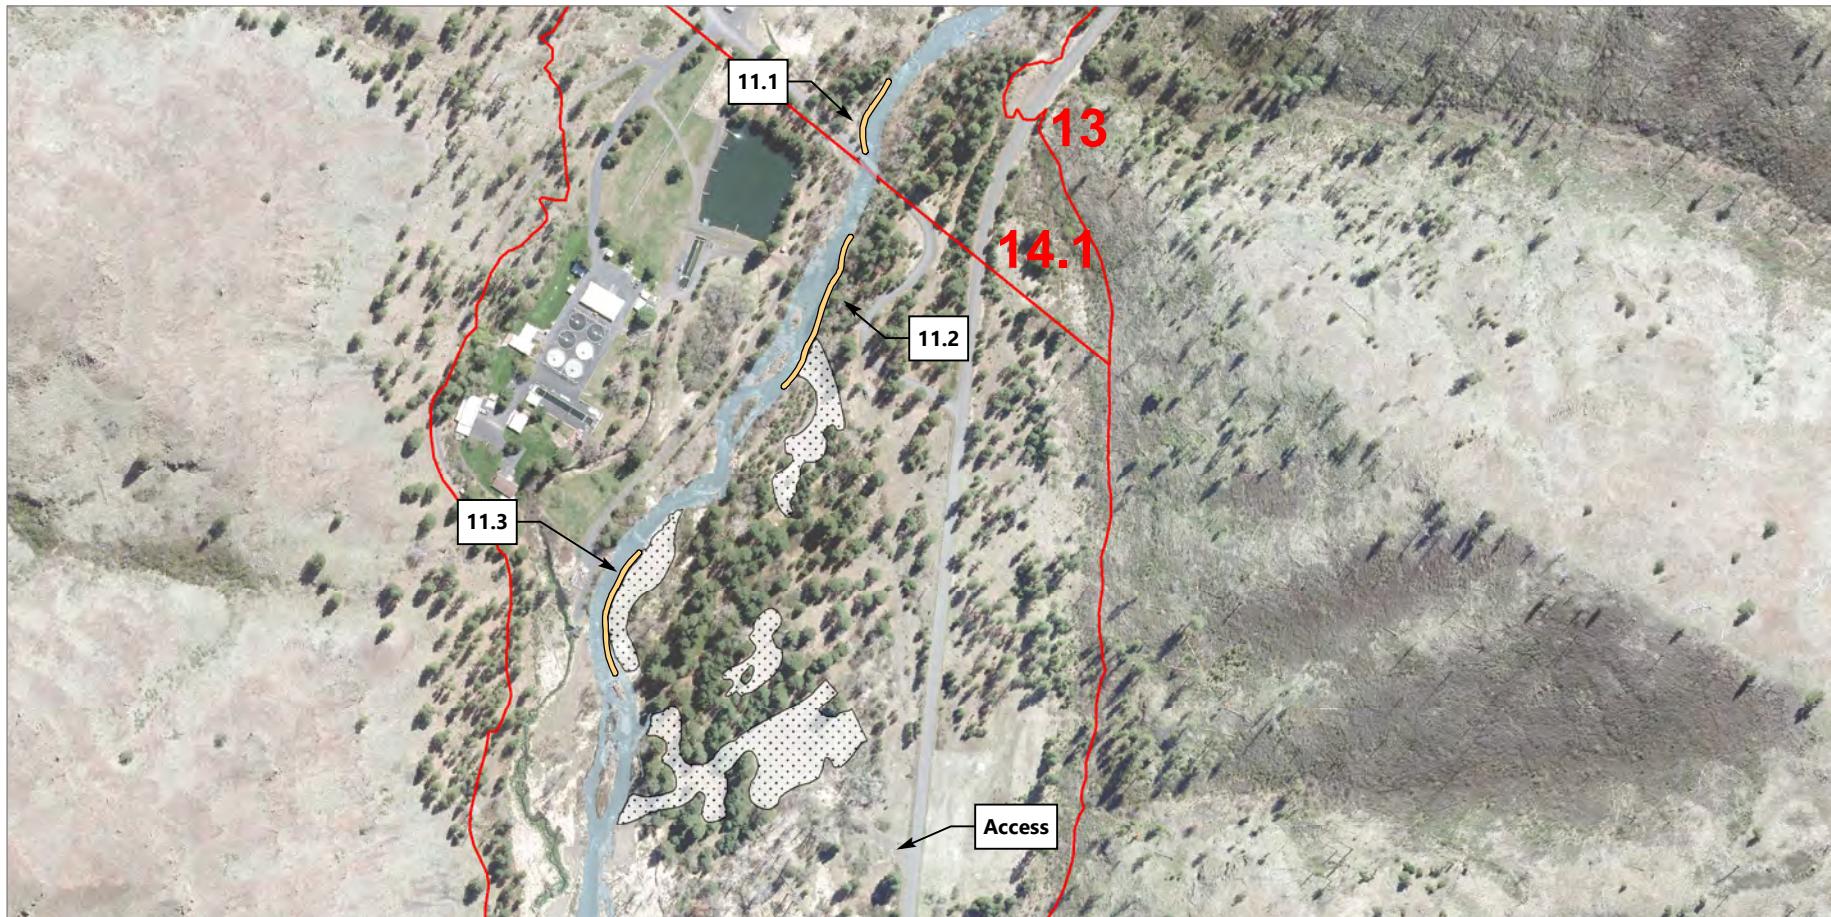
**GA-11 Gravel Placement Locations**

Location 11.1 Material associated with the management of the fish hatchery will be placed at this location upstream of the dam. It can be placed with the given dimensions at low flow or en masse during high-flow events when it will be immediately entrained.	Location 11.2 Material for this location will be sourced from benching of the unvegetated floodplain. Benching will begin adjacent to the main channel at the lower end of the placement area and continue up the bank and downstream until the entire marked area is benched. Following this, material will be sourced from the high unvegetated areas in the downstream part of the site. Sourcing material from here will require transporting it up through the site, which can be accomplished mostly using established dirt roads.
Location 11.3 Material for this location will be sourced by benching the floodplain directly adjacent to it. This benching will begin on the upstream end and expand up the bank and then in the downstream direction. When benching is complete in this area, material will be sourced from the larger area downstream starting adjacent to the channel and moving up the bank.

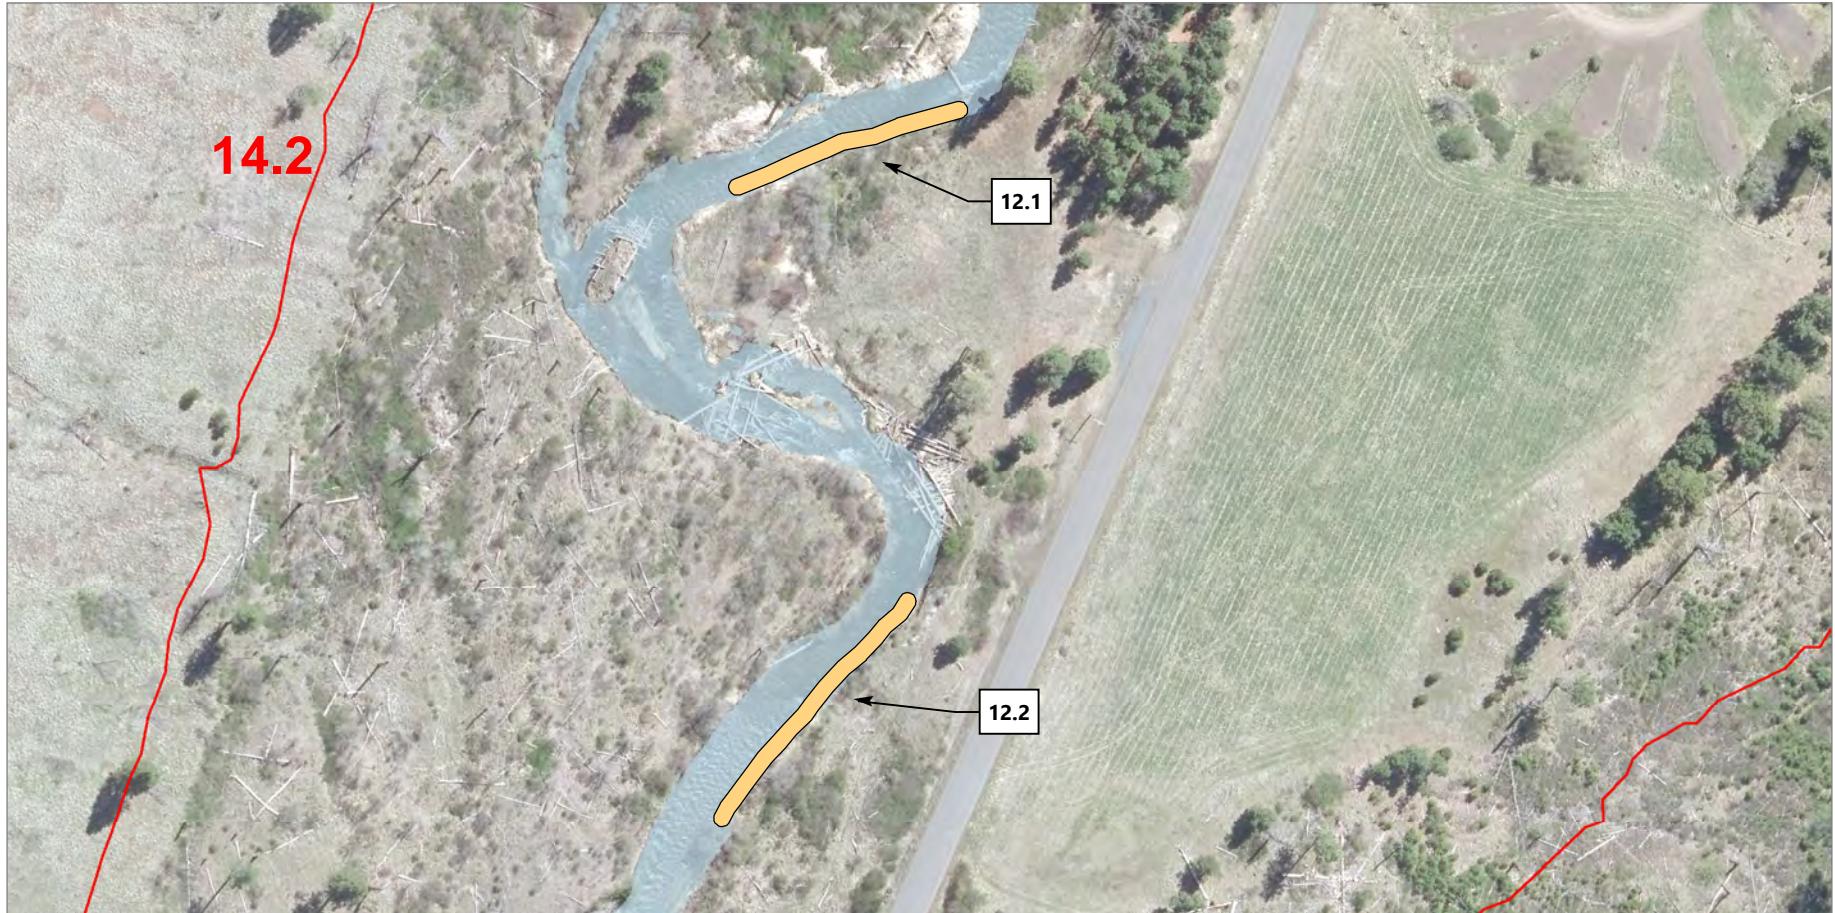
**GA-12 Gravel Placement Locations**

Location 12.1	Location 12.2
Material placed here will be sourced from GA-13.	Material placed here will be sourced from GA-13.
