# W.T. Wooten Floodplain Management Plan

Washington Department of Fish and Wildlife

11/08/2012

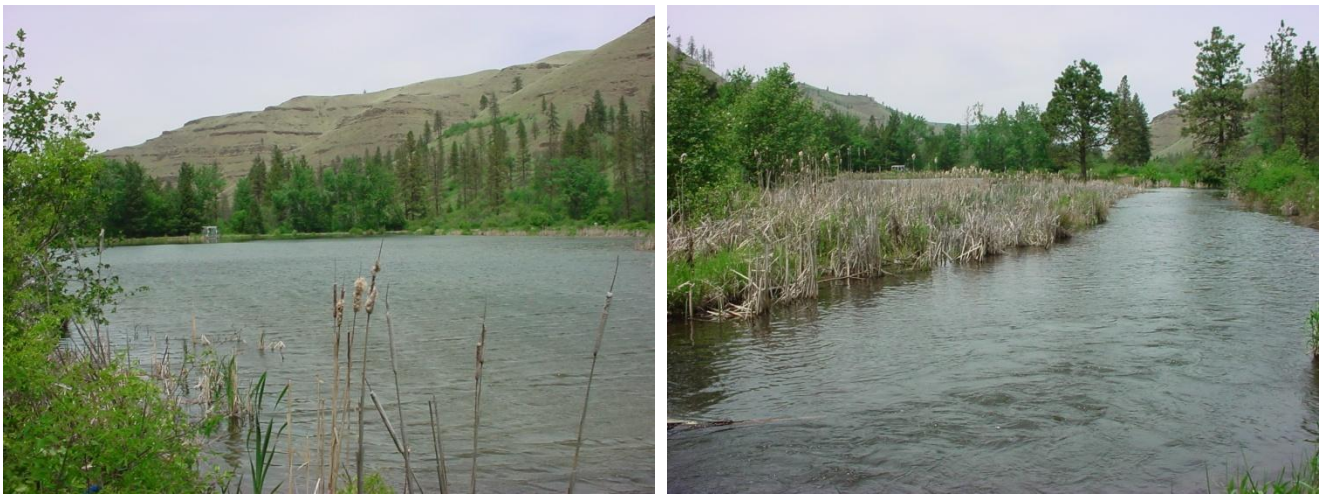
**Figure 2: Current photos of Rainbow Lake at left and inlet channel at right (May 2012).**

The outlet water flow structure is in need of restoration and repair work. The outlet structure consists of a large drop-inlet concrete structure with a revolving drum screen and adjustable stop logs. The mechanically screened outlet structure provides constant water flows back to the river, or through an above ground pipeline that runs north approximately 2,000 feet to the hatchery facility. . This pipeline was replaced in 2005 following the School Fire. It is the sole source of water for the earthen pond that typically is utilized for rearing catchable-sized rainbow trout for the area lakes, including Rainbow Lake. The water supply from Rainbow Lake is not used for hatchery operations during the late spring and summer months due to increased temperatures. During the fall and winter months, the water supply is critical for fish rearing and the reservoir is a vital safety factor for maintaining flows. Icing on the river, and reduced flows at the intake that supplies Rainbow Lake, can impact water availability to the lake and hatchery. In these events, the lake acts as an important reserve for continued water supply to the hatchery.

In recent years, the buildup of sediment and vegetative growth has diminished the capacity of Rainbow Lake and hatchery trout stocking levels have been reduced. Not only has it reduced the amount of water available to the hatchery in low flow events, it is reducing carrying capacity for stocked trout and it may be causing increased water temperatures in the spring and summer months. The shallow water column is not conducive to maintaining a cool environment for the fish or the fishery. Trout that carry over through the winter into the next spring are currently uncommon because of high water temperatures in the lake. Also, any increase in temperature of the river potentially caused by Rainbow Lake outflow is a concern for ESA listed fish in the river because river temperatures are near upper limits of tolerance for salmonids. If the lake was dredged and/or excavated to restore impoundment capacity and improve water quality for fish, it is possible that not only carryover trout would survive to the next year, but water could be used for hatchery rearing year around. This is especially important considering that rearing ESA listed spring Chinook is being tested as a future production option at the Tucannon Fish Hatchery.

Prior to some repair efforts in 2009, the intake structure for the lake was being undermined at the front of the concrete slab (in the fishway), reducing head for flows to the lake and hatchery. In a low flow season, this undermining was potentially harmful to the fish program. With reduced flows and warmer temperatures in the summer months, the potential for pathogen outbreaks increases dramatically. Restoration work is also necessary to resolve current safety issues with various components of the lake impoundment structures, to improve water flows within Rainbow Lake, and water flow from this storage lake to the Tucannon Fish Hatchery.

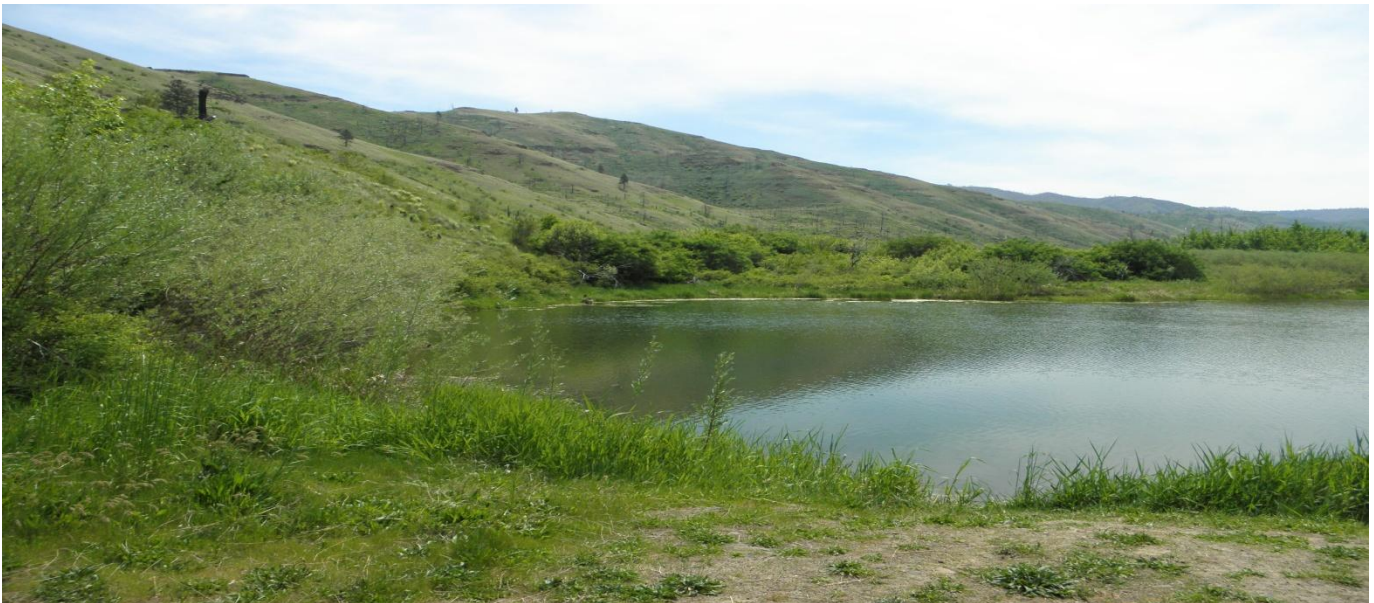
**Figure 4: Deer Lake.**

Deer Lake is approximately 4.4 acres in size and is the fourth lake in the valley traveling north to south. It is designated as a walk-in only lake and it is located about  $\frac{3}{4}$  of a mile South of Rainbow lake. From a parking area the public must walk  $\frac{1}{4}$  mile south to access the lake. Historically, an aluminum foot bridge was used to access the lake from a nearby campground located on the west side of the Tucannon River. High water and flooding in 1996 and 1997 destroyed the footbridge and campground. The river now flows through the remains of the old campground. Deer Lake is adjacent to the Tucannon River and on the eastern portion of the floodplain.

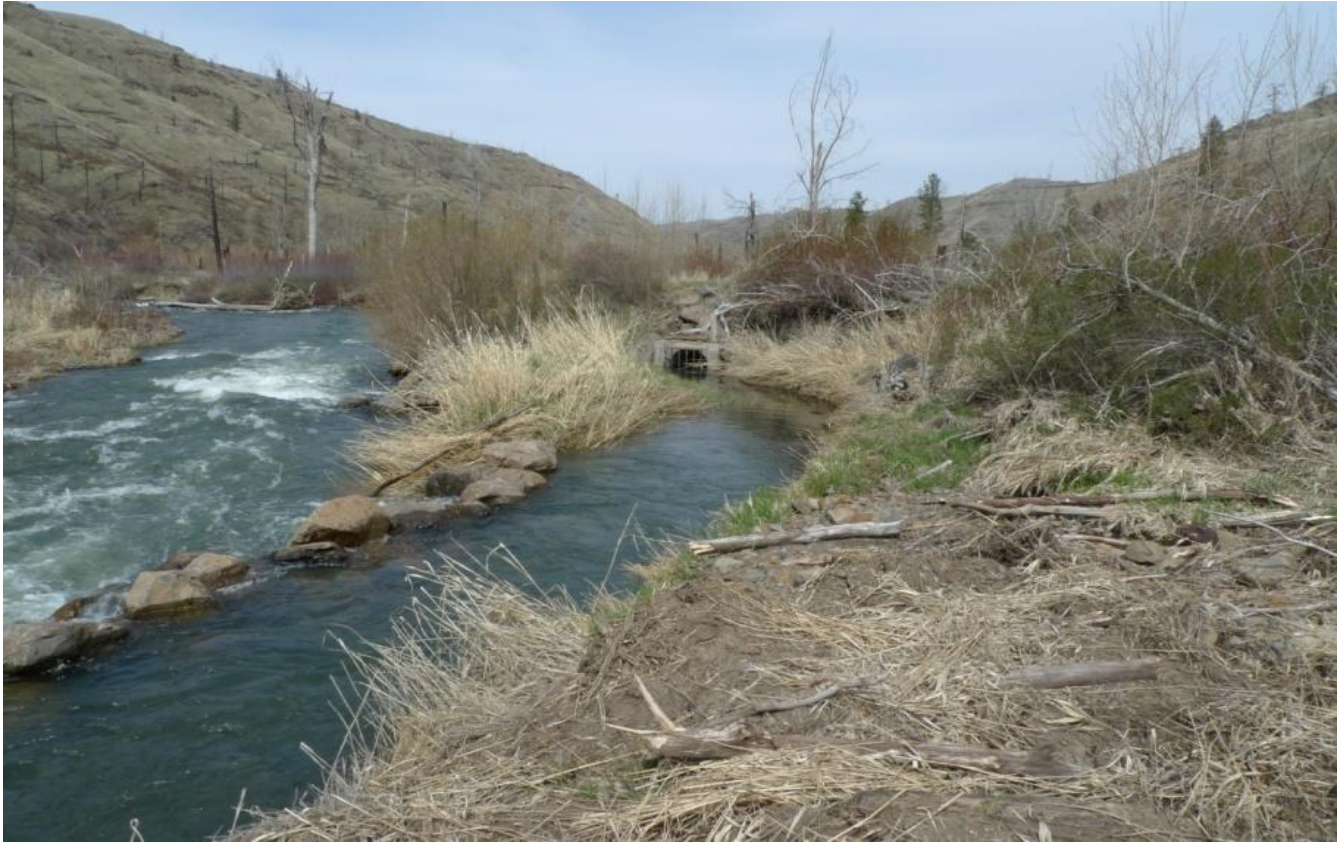
**Figure 6: Beaver-Watson intake, with the Tucannon River in the left channel.**

The impounding dams are covered in woody vegetation, plus Watson Dam has substantial leaks. Both of these dams are in violation of WDOE Dam Safety regulations to protect public safety, and therefore they require substantial and costly repairs.

So little water currently flows into Watson Lake and/or leaks out of the dam that water does not flow out of the lake outlet for a majority of the summer. In 2011, the problem with inflow and outflow was increased because the river channel changed near the intake and very little water was able to be directed into the diversion canal and into these two lakes. A temporary project was constructed in March 2012 to try and improve inflow into these lakes so Watson Lake could be stocked with trout and provide a fishery. Watson Lake normally has a very popular trout fishery because it is one of the larger Tucannon Lakes and it is easily accessible.

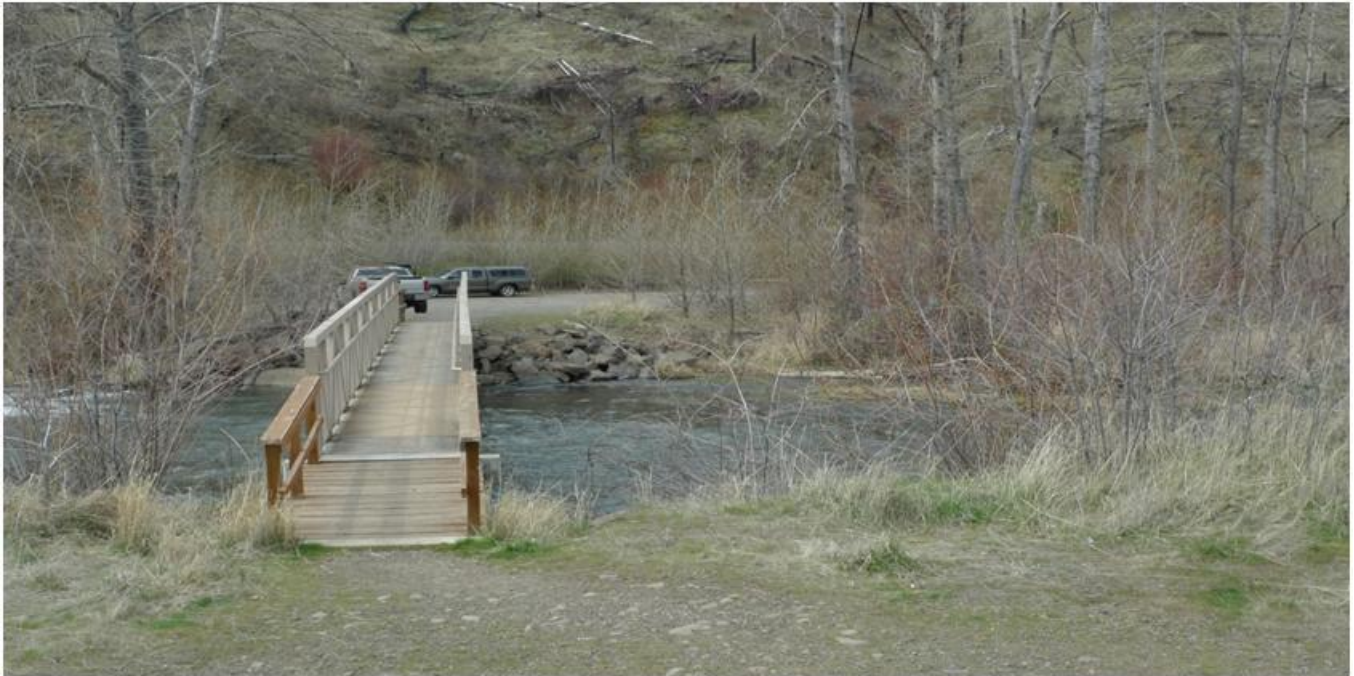
**Figure 7: Access Bridge to Beaver Watson.**

Some major infrastructure will need to be changed in this proposed plan. The current footbridge will probably be replaced with a suspension bridge in a different location with a much longer span so the river does not have to remain in its current constrained channel. The current parking lot will be removed and a new parking lot will be constructed on higher ground next to the new footbridge. The administrative access road (from Deer Lake) on the east side of the river will be moved towards the east to reduce its footprint in the floodplain to allow the river to meander.

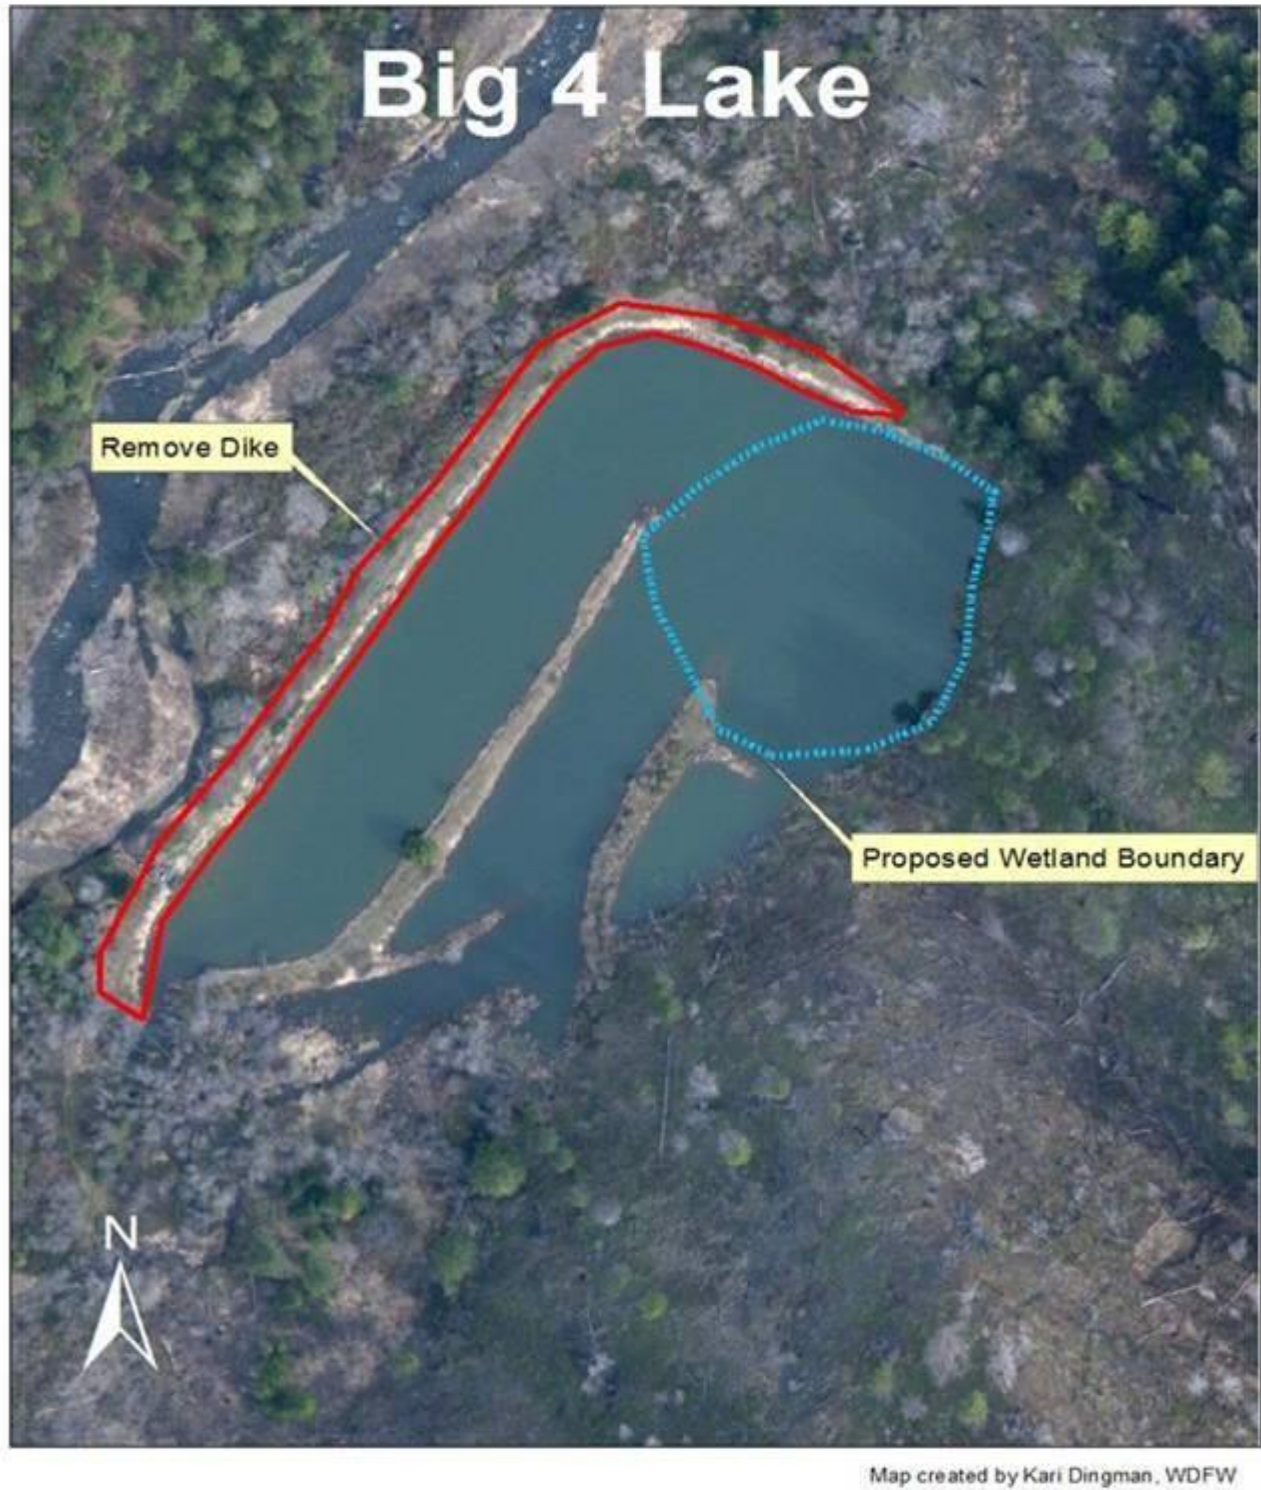
Figure 9: Big 4 Lake Conceptual Design.

Big 4 Lake is proposed by WDFW to be closed and removed because of its need for substantial maintenance and the difficulty in repairing and maintaining this lake. There are no roads for vehicle access for maintenance, repair, or fish stocking in this lake. The lake has become shallow and weedy because of sediment and vegetation accumulating over the years, resulting in reduced trout stocking rates and frequency of stocking. The dam is overgrown by woody and herbaceous vegetation and it leaks substantially, violating the WDOE Dam Safety regulations. The lake is very difficult to stock with fish and requires a temporary pipeline across the river when flows are low enough in February or March so fish can be planted, and therefore it is only stocked once per year. A beaver dam has blocked the outlet of the lake in the past. The Tucannon River has been threatening to erode the west dam and potentially capture the lake. The lake would need to be dredged, the dams repaired, and protection from the river, if it were to be maintained.

Removal of this impoundment will consist of breaching and/or removal of much of the dam material, including the intake and outlet structures. Some portions of the dams or spit structures near the east side of the floodplain will be left to reduce costs and promote wetland development with some ponding of water. Permits, timing, and manner of heavy equipment access to decommission this lake will be sensitive because of potential adverse effects on ESA listed fish and their habitats.

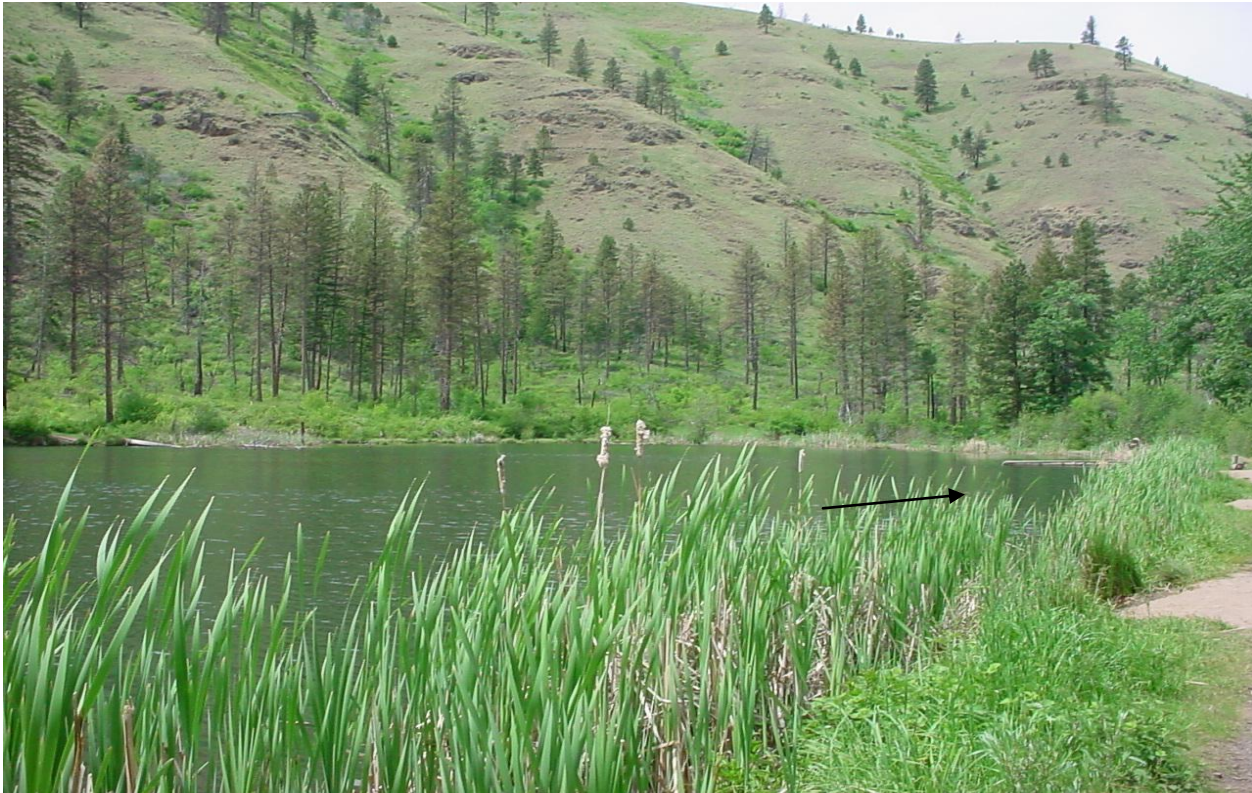
**Figure 10: Spring Lake with direction of flow towards the outlet shown.**

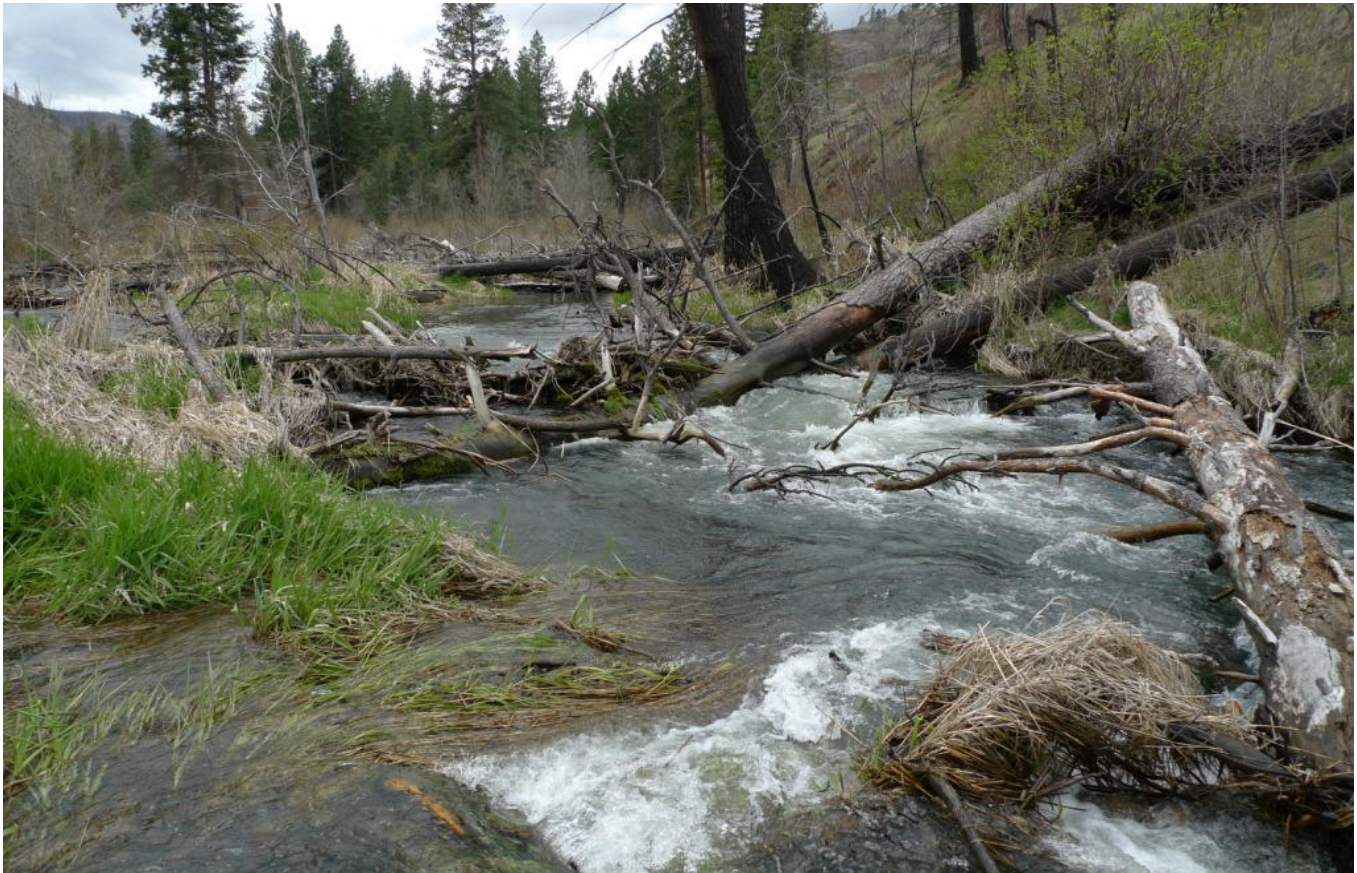
**Figure 12: Habitat complexity resulting from LW restoration in the Tucannon River (site treated 2006, 2008), photo 2011.**

LWD restoration efforts for the Wildlife Area started in 2006 following the 2005 School Fire. Fires have historically played a major role in LWD recruitment to rivers, and subsequently, WDFW staff concluded that the event was a natural starting point for LWD restoration for the Tucannon River and its tributaries on the Wildlife Area. Two small scale LWD projects were conducted (2006, 2008), one in Cummings Creek and the other in the Tucannon River. Both projects were successful at meeting project objectives and goals, most noteworthy the enhancement to instream habitat complexity and reconnecting the river and its floodplain (Figure 12).

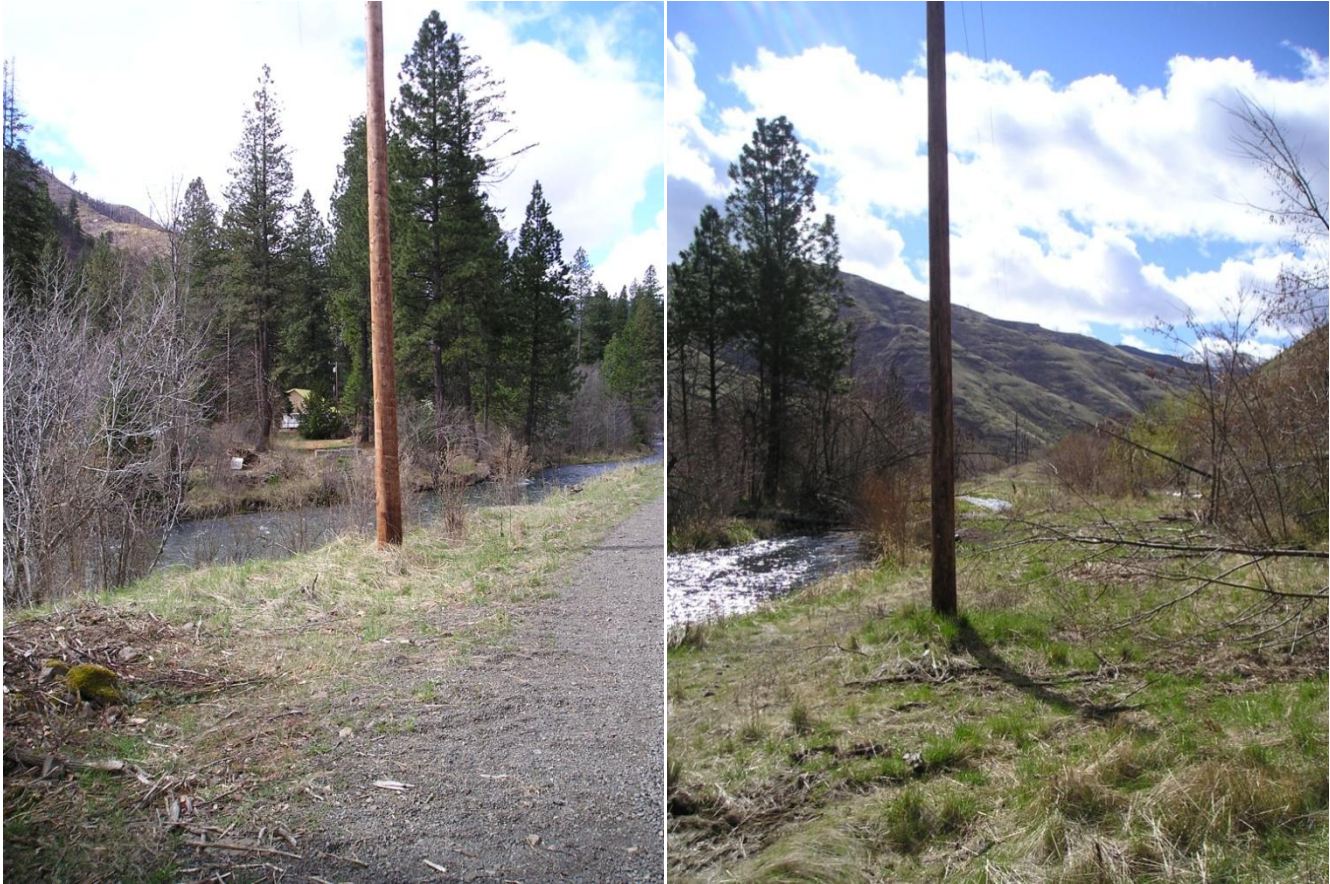
**Figure 13: (Left) Power line crossing Tucannon River to Camp Wooten. (Right) Power line within cleared riparian area.**

The School Fire of 2005 damaged much of the Wildlife Area, burning and destroying large areas of timber, and some of the electrical power lines and poles crossing the area. It was the largest fire of 2005 in the lower 48 states at about 52,000 acres. The cause of the fire was determined to be a tree or tree branch falling on the power line and damaging the line near the Tucannon Guard Station at the mouth of School Canyon. Burying the power line would preclude this from happening again, and reduce required maintenance of the line, and prevent habitat degradation from the power line maintenance activities.

This project consists of working with the Columbia REA to bury the electrical power line that serves the Wildlife Area, Tucannon Fish Hatchery and associated infrastructure, Tucannon Lakes' fish screens, USFS Guard Station, and Camp Wooten. This project would eliminate the main overhead power line and associated poles and replace it with a buried line across the Wildlife Area from at least the Tucannon Fish Hatchery to its terminal end at Camp Wooten, approximately 7 miles. If buried along its current route, the line would cross approximately 12 small tributary streams to the Tucannon River, and cross the river once on the Camp Wooten bridge (tentatively). Most, if not all, of these tributaries are non-fish bearing. There may still possibly be 4 or 5 overhead lateral lines that service the lakes' fish screens, however, under the Tucannon Lakes Projects, most of these fish screens and river withdrawals would be removed.

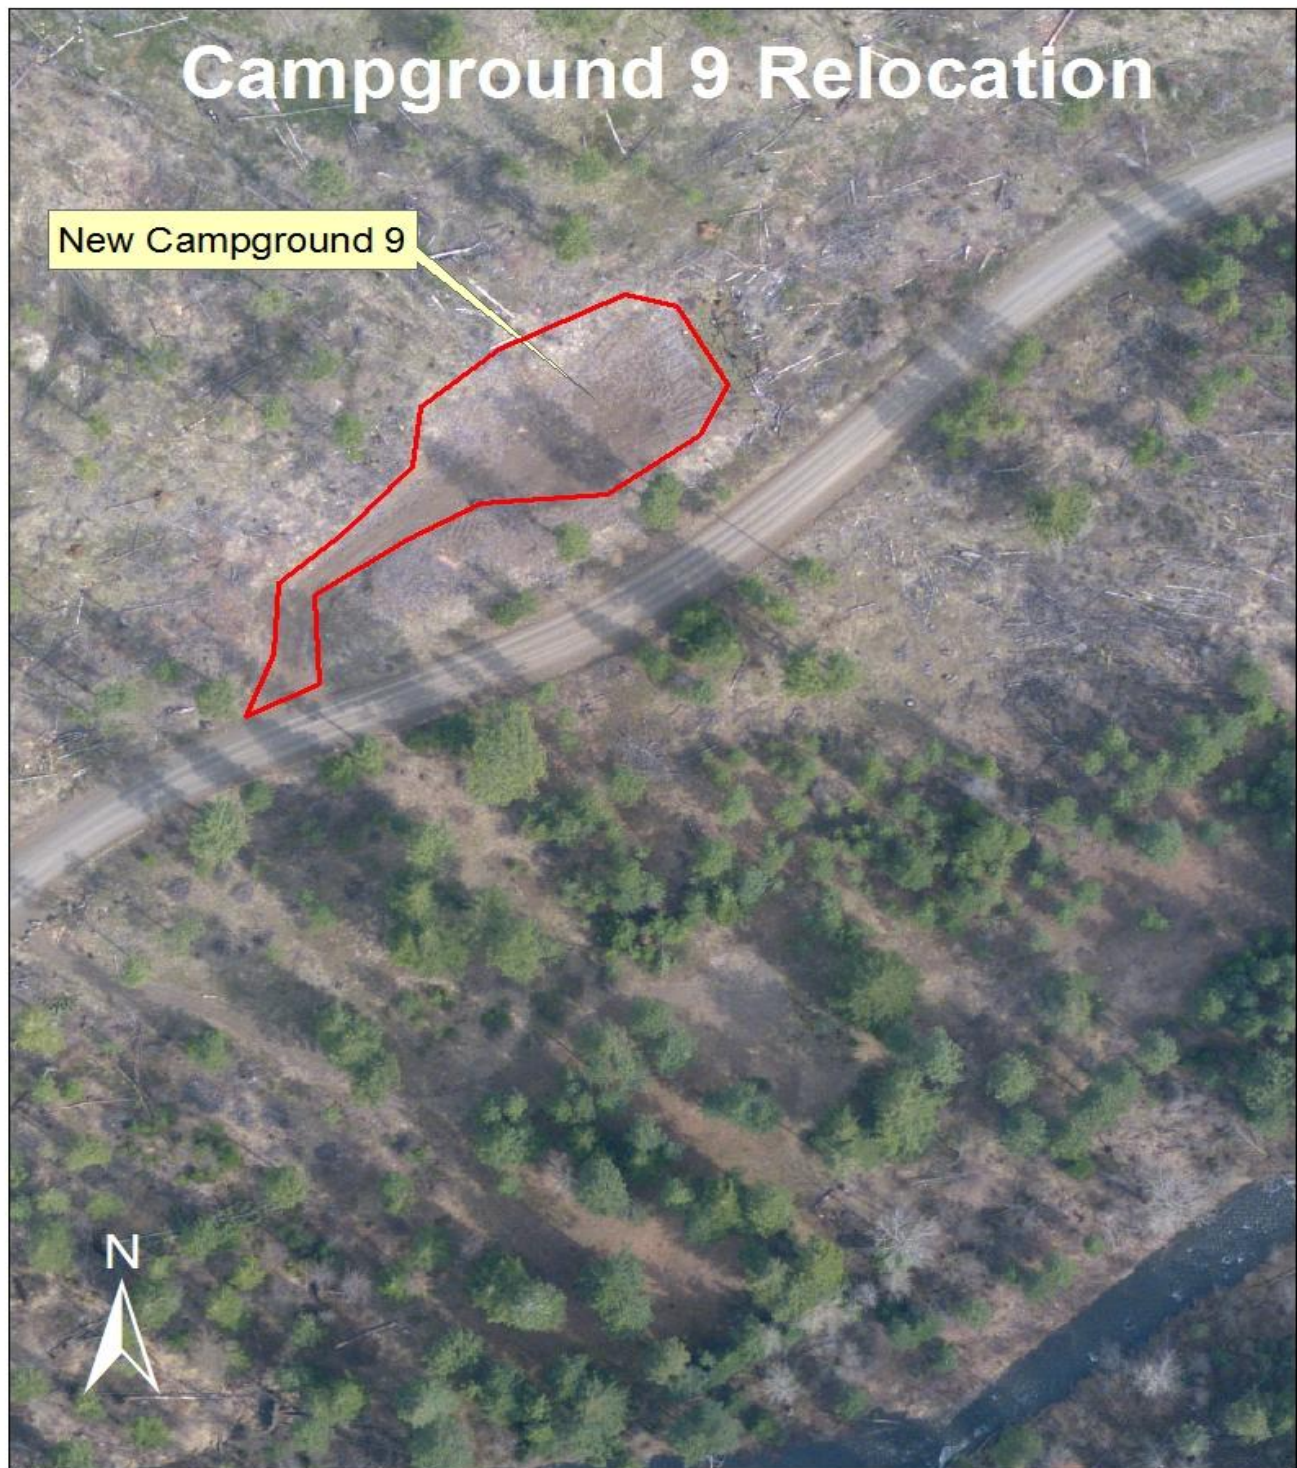
**Figure 16: New Campground 9 Location.**

The second replacement campground will be located in the log landing site located northeast of the mouth of the Little Tucannon River, across the Tucannon Road from a previous WDFW campground that was closed because it was located in the floodplain. This new campground will give the public another campground that is near the section of the Tucannon River that is open to fishing. The driveway into the new campground will be improved and graveled. The second concrete outhouse from the current Campground 9 will be moved and installed in the new campground. Four campsites will be constructed in the campground with gravel placed on the parking pads and the campfire rings set in concrete. Trees

will be planted in the new campground to provide future shade trees for the campground. The new campground will be named Campground 9.
